## 6.3 Damage to Reinforced Concrete Buildings

### 6.3.1 Introduction

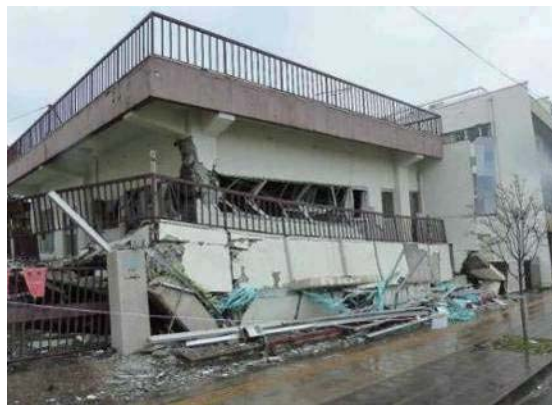
The first story in a two-story RC office building shown in Photo 6.3-1 was completely collapsed in Wakabayashi ward, Sendai city. In addition, the shear failure and the axial deformation of the columns on the second floor of this building caused the buckling of the longitudinal reinforcements and the fracture of the hoops of columns in the first story.

Photo 6.3-1 First-story collapsed building (Wakabayashi ward, Sendai city)

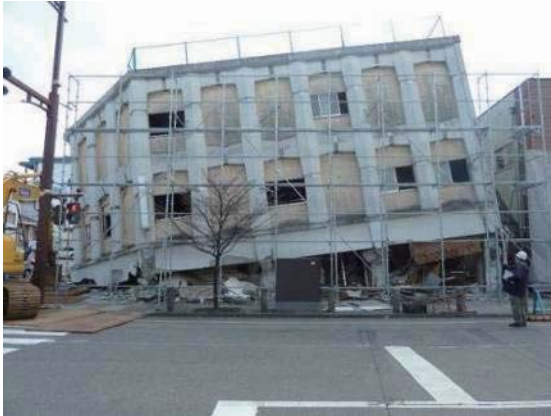
A three-story RC building shown in Photo 6.3-4 was severely damaged on the first story, which was located at the intersection in Sukagawa city, had a few walls on the facade on the first story and many walls on the back of the first story and the second story and higher. The corner columns faced to the intersection were significantly destroyed as shown in Photo 6.3-5. The loss of axial load carrying capacity of the first-story columns caused the drop of the second and higher stories.

Photo 6.3-4 First-story collapsed building (Sukagawa city)

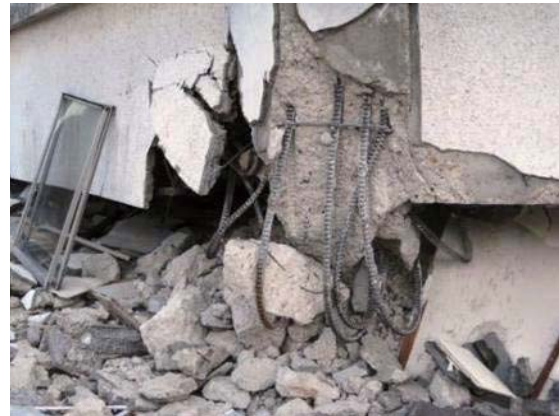
Photo 6.3-5 Close-up view of the fallen story

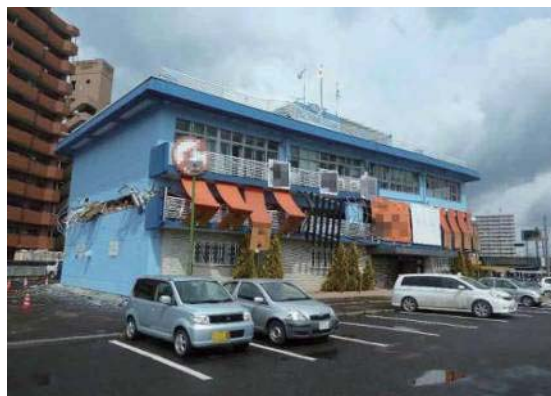
A three-story office building shown in Photo 6.3-6 in Wakabayashi ward, Sendai city partially collapsed on the second story and the building tilted. Only the second story has openings on the wall at the gable side, as shown in the left of Photo 6.3-6. For this reason, it was assumed that the openings were intensively deformed and resulted in shear failure of the short columns formed by the hanging and spandrel walls. The shear failure of the long columns on the third story was observed possibly due to the effect of the collapse of the second story. The damage to the columns and beams on the first story was not seen, while shear cracks were observed on the nonstructural walls.

Photo 6.3-6 Mid-story collapsed building (Wakabayashi ward, Sendai city)

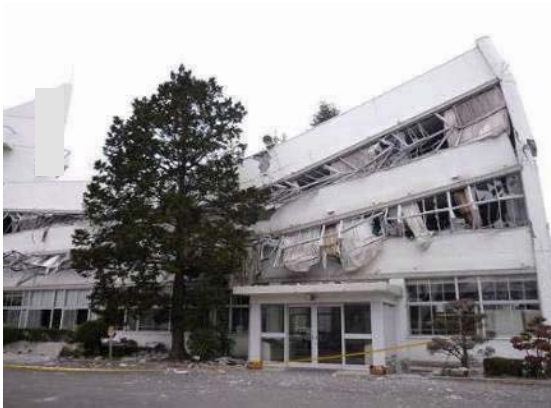
1966 and has a Y-letter shape plan in Fukushima city. The mid-story collapse occurred on the second story, and the part of the third story was heavily damaged. In addition, the shear failure also occurred on the columns in the first story, as shown in Photo 6.3-8. Visual damage was not seen in other school buildings and the gymnasium on the same site. The seismic indices of the structure,  $I_S$  on the first and second stories of the building were below the seismic demand index of structure,  $I_{S0}$  by the seismic evaluation method <sup>6.3-1)</sup>, therefore the seismic retrofit of the building had been planned.

Photo 6.3-7 Mid-story collapsed building (Fukushima city)

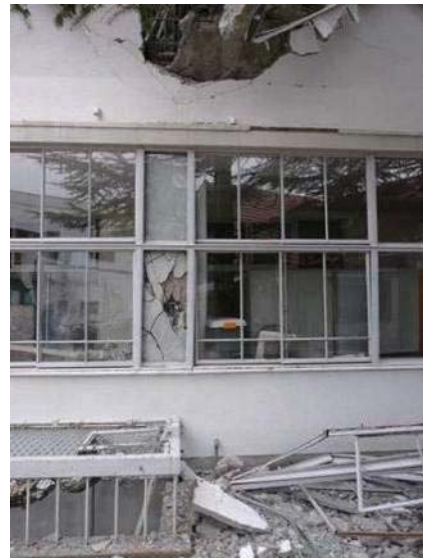
Photo 6.3-8 Shear failure of the first-story column

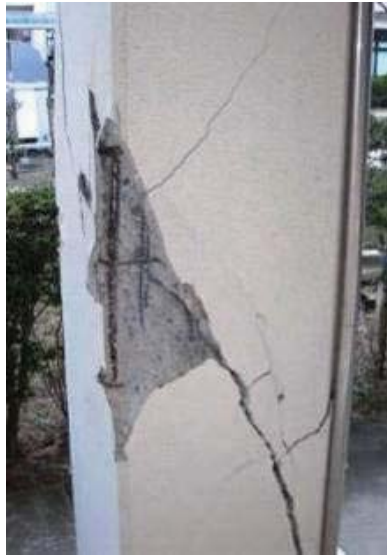
The next case is that the shear failure occurred on the first-story columns in a two-story RC building in Aoba ward, Sendai city (Photos 6.3-12 and 6.3-13). Some columns of the building were intact after the mainshock on March 11, but aftershocks caused shear failure to some of them, as shown on the right of Photo 6.3-13. It was confirmed that the aftershocks accelerated the damage level of this building.

Photo 6.3-13 Shear cracks of first-story columns

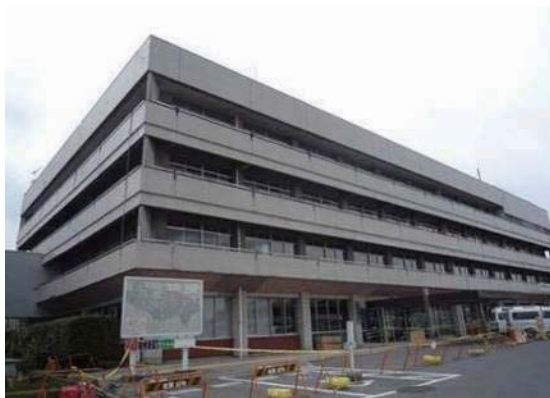
Photo 6.3-14 shows the four-story RC building that was constructed in 1970 in Sukagawa city. The columns with the spandrel wall on the first story were heavily damaged in shear and shorten in the axial direction as shown in Photo 6.3-15. The same damage was observed on the second-story exterior columns. Some of the reinforcing bars of the damaged columns that were raised from the foundation were anchored with a 180-degree hook near the mid height of story. It is considered that the shear failure began at this point. Two shear walls were severely damaged, which were arranged in the center core of the building to resist mainly horizontal forces. In particular, the second-story core wall was failed in shear in both of the span and longitudinal directions, and the longitudinal reinforcements in the boundary column of shear wall were heavily buckled as shown in Photo 6.3-16.

Photo 6.3-14 Appearance of damaged building (Sukagawa city)

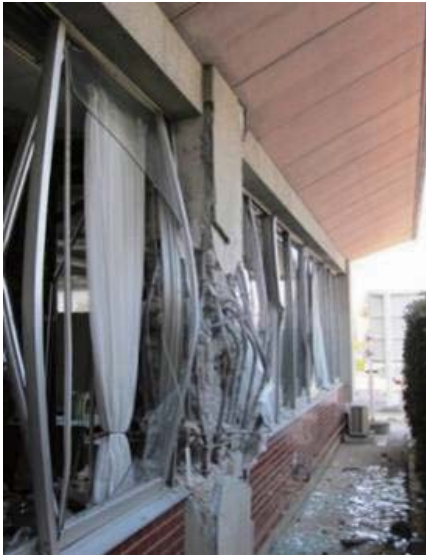
Photo 6.3-15 Shear failure of short column

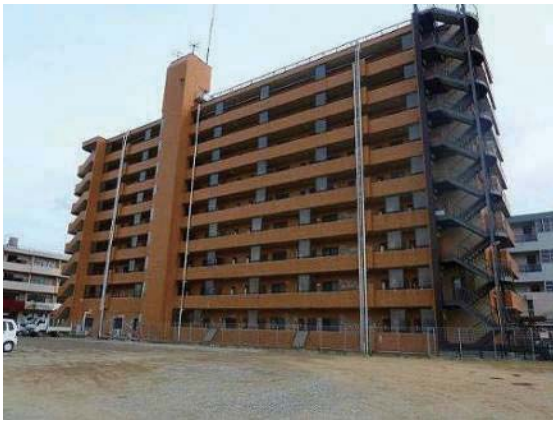
Photo 6.3-22 shows the appearance of a damaged building, which is the nine-story SRC residential building constructed in 1991 in Koriyama city of Fukushima prefecture. Pullout of anchor bolts, buckling of reinforcing bars and compressive failure of concrete occurred at the corner column and the bottom of multi-story shear wall in the first story, as shown in Photo 6.3-23, and shear cracks and bond splitting cracks were observed on the first story columns.

Photo 6.3-22 Appearance of damaged building (Koriyama city)

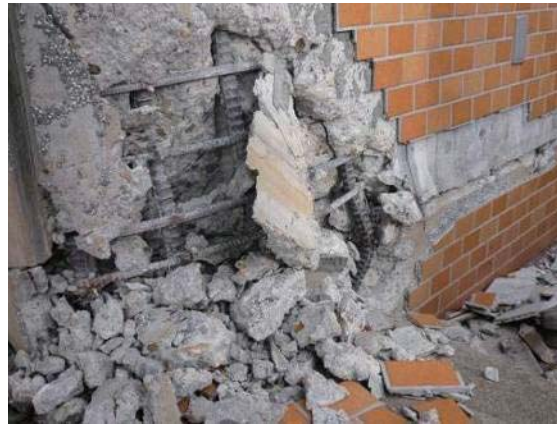
Photo 6.3-23 Damage at the bottom of SRC column

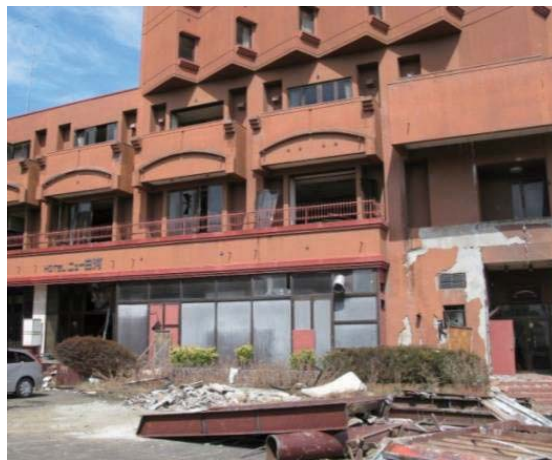
The damage at the bottom of SRC column and shear wall was also observed on a building in Shirakawa city shown in Photos 6.3-24 and 6.3-25, which was composed of RC and SRC structures. Pullout of anchor bolts of the exposed-type column base occurred. In consequence, the reinforcing bars were forced to stretch large and the buckling of them occurred around the base plate, as shown in Photo 6.3-26.

Photo 6.3-24 Appearance of damaged building (Shirakawa city, Fukushima pref.)

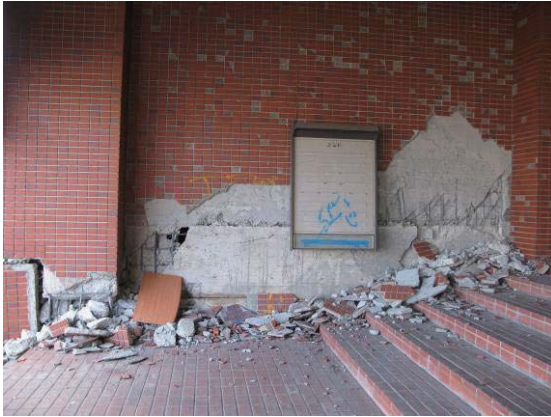
Photo 6.3-25 Damage of the bottom of SRC column and shear wall

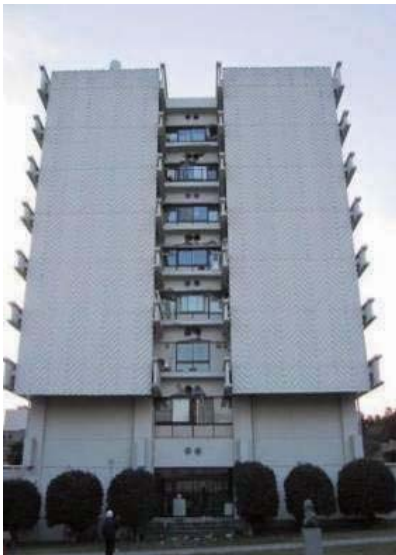
The shear failure or bond splitting failure occurred on the link beam connecting coupled shear walls from low-rise to high-rise stories on a eight-story RC building in Aoba ward, Sendai city, as shown in Photo 6.3-27. The link beams have two openings at the center of them, and were damaged around these parts (Photo 6.3-28).

Photo 6.3-27 Appearance of damaged building (Aoba ward, Sendai city)

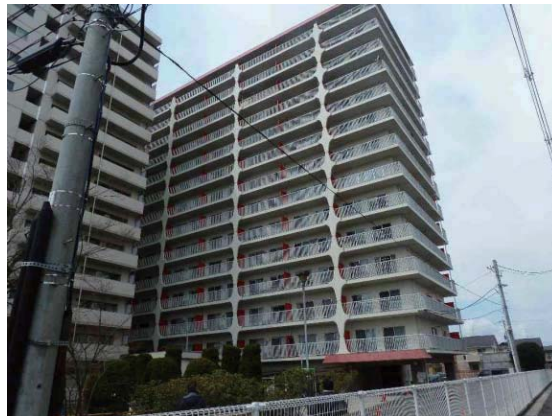
A fourteen-story RC building shown in Photo 6.3-29 was settled down and was tilted about  $1/70$  radian. The building is one of two residential buildings located in L-shape with expansion joint in Miyagino ward, Sendai city. The shear cracks on the nonstructural walls over every story and some parts of mullions occurred in both buildings as shown in Photos 6.3-30 and 6.3-31, which damage was classified as B-2). Though the other building without inclination had same shear cracks on the nonstructural walls from first to sixth story in the Miyagiken-oki Earthquake in 1978 and had been repaired with concrete replacement, almost same damage was happened on the similar part.

Photo 6.3-29 Appearance of tilted building (Miyagino ward, Sendai city)

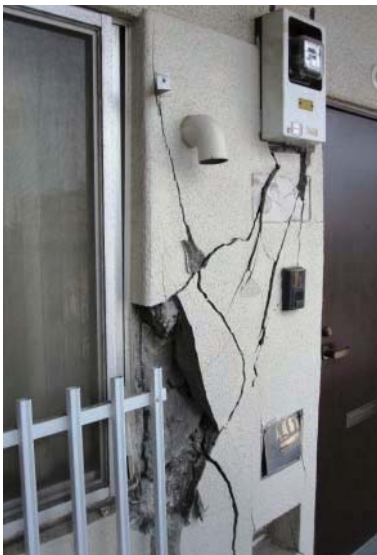
Photo 6.3-30 Shear cracks on nonstructural wall

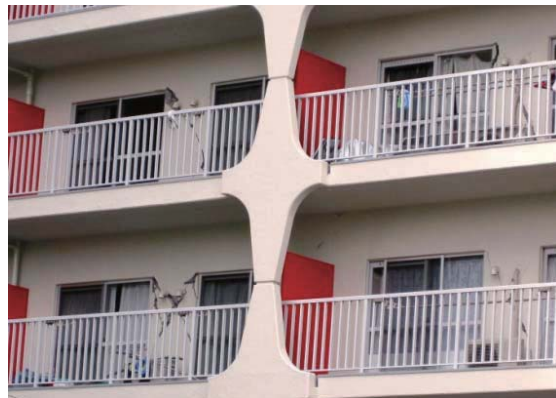
Photo 6.3-31 Shear cracks on mullion

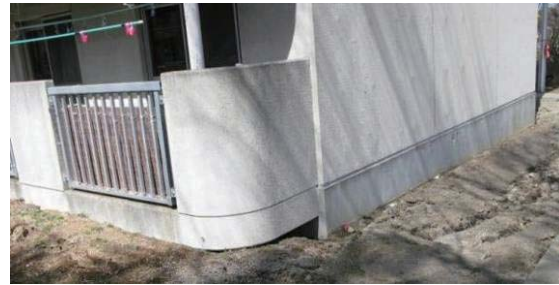
Photo 6.3-32 shows a residential building that sank and leaned in the longitudinal direction in Shirakawa city. The balcony, of which height above ground level was about 77cm, went down to ground surface in the gable side, as shown in Photo 6.3-33.

Photo 6.3-33 Sunken balcony

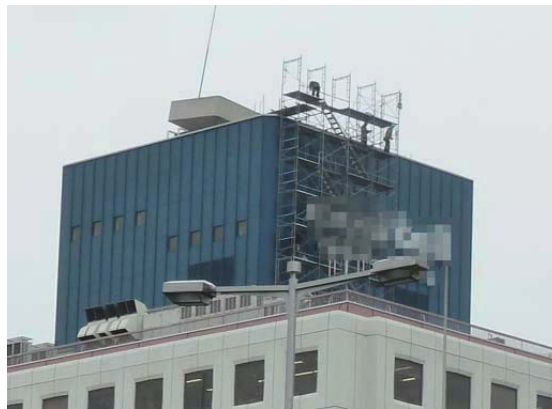
The damage on penthouses was observed everywhere, like tilting of it in Aoba ward, Sendai city, as shown in Photo 6.3-34. The clock tower attached to a five-story RC building constructed in 1954 was destroyed at the bottom of it, despite the building was heavily damaged in Fukushima city (Photos 6.3-35 and 6.3-36).

Photo 6.3-34 Damaged penthouse (Aoba ward, Sendai city)

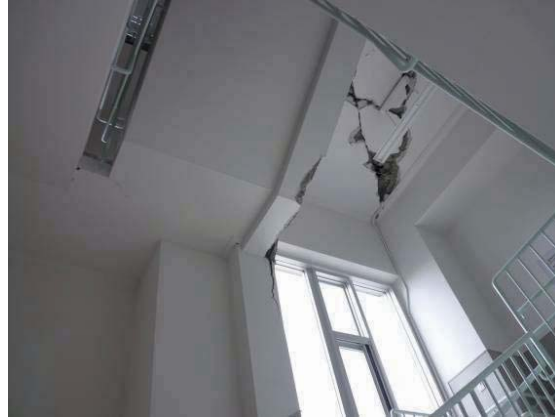
Photo 6.3-36 Bottom of the tower

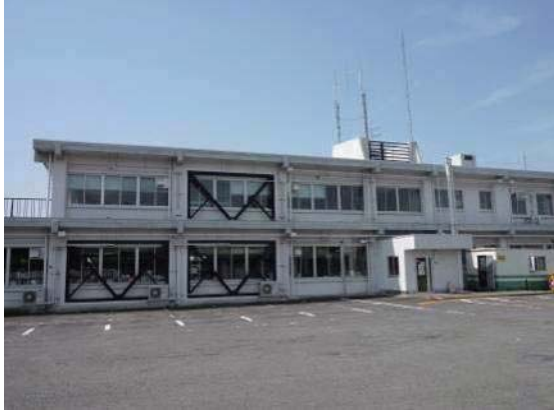
Photo 6.3-37 shows a two-story RC office building constructed in 1969 in Hitachiomiya city of Ibaraki prefecture. The building had been retrofitted with framed steel braces in the longitudinal direction in 2003, because the seismic index of structure,  $I_S$  on the first story of the building was below the seismic demand index of structure,  $I_{S0}$  by the seismic evaluation method <sup>6.3-1)</sup>. Meanwhile, the building in the span direction was not retrofitted, as a consequence the seismic index of structure in the direction satisfied the seismic demand index of structure. The steel braces had been eccentrically installed to the center axis of the beams and columns.

Photo 6.3-37 Appearance of damaged building (Hitachiomiya city)

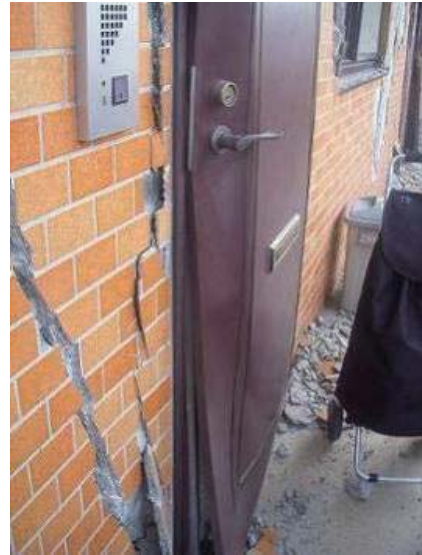
cracks occurred on the nonstructural wall in the longitudinal direction. For this reason, the front door was deformed out-of-plane as shown in Photo 6.3-44, and could not be opened and closed. The shear cracks on the mullion walls also occurred in a eight-story RC hotel building in Sukagawa city (Photos 6.3-45 and 6.3-46).

Photo 6.3-44 Damage of nonstructural wall and deformed door in same building shown in Photo 6.3-22

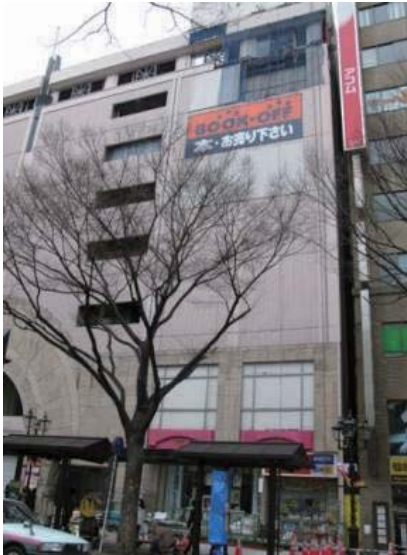
Photos 6.3-47 and 6.3-48 show the case where the AAC (Autoclaved lightweight Aerated Concrete, the abbreviated term ‘ALC’ is commonly used in Japan.) panel on the

Photo 6.3-47 Damaged building with AAC panels (Aoba ward, Sendai city)

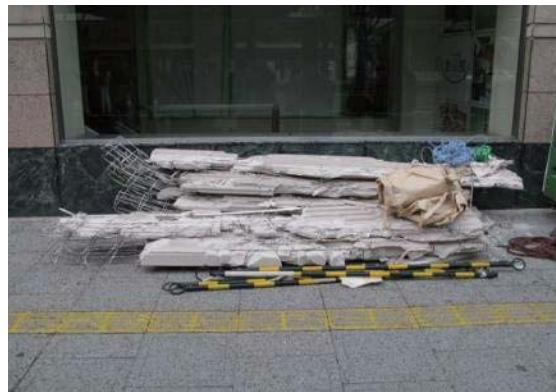
Photo 6.3-48 Dropped AAC panels

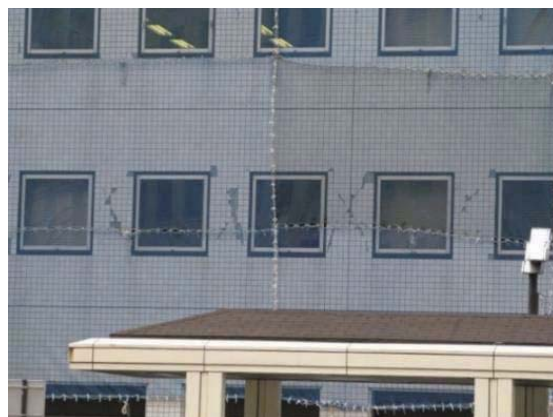
upper floor in a eight-story building fell down, and Photo 6.3-49 is the case where the tile on exterior wall was dropped, in Aoba ward, Sendai city.

Photo 6.3-49 Damage of tile on exterior wall

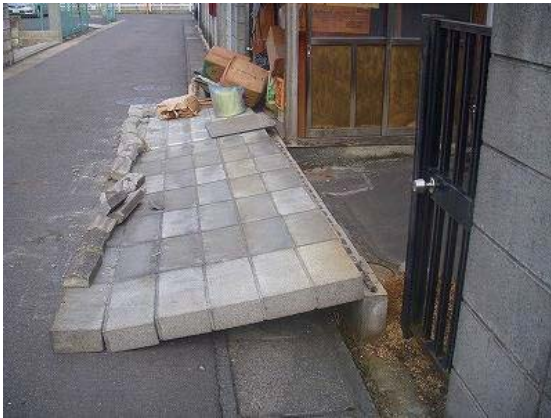
Photo 6.3-50 Collapse of concrete block wall (Koriyama city)

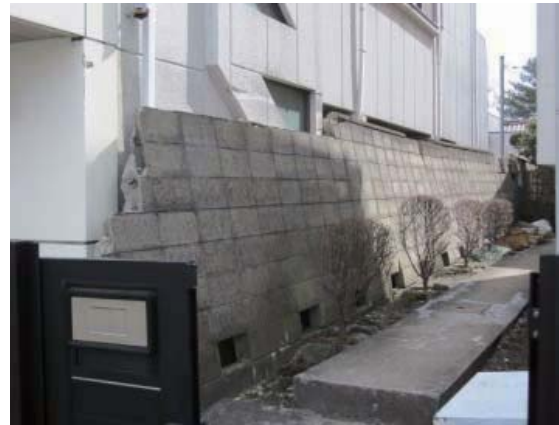
Photo 6.3-51 Collapse of concrete block wall (Sukagawa city)

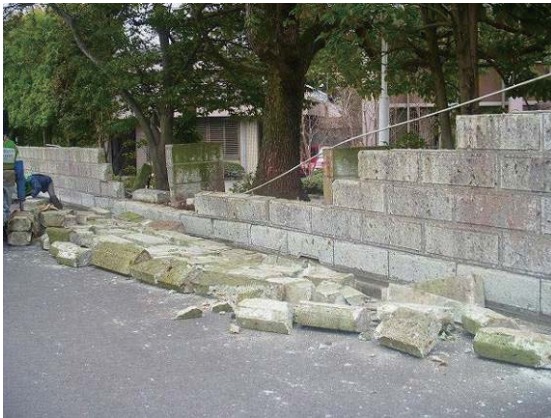
Photo 6.3-52 Collapse of stone masonry wall (Fukushima city)

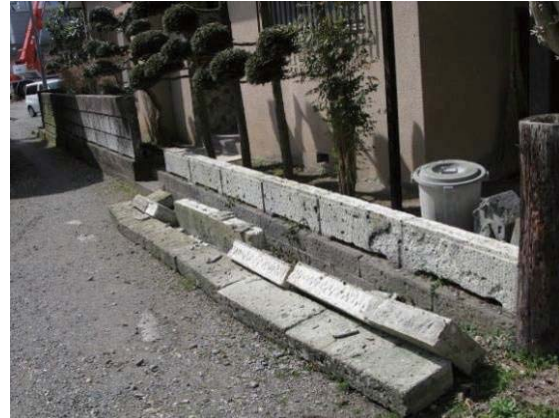
Photo 6.3-53 Collapse of stone masonry wall (Shirakawa city)
