6.6 Damage to Nonstructural Components

6.6.1 Introduction

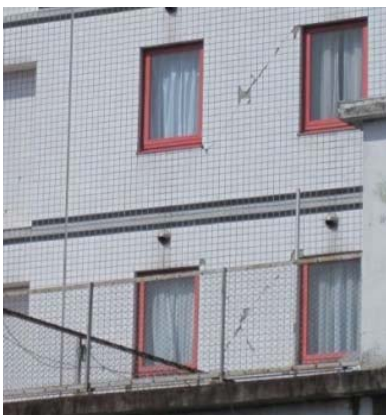
Detachment of ceramic wall tiles was often observed at buildings of RC nonstructural exterior walls. Types of the detachment were classified according to existence or nonexistence of crack on the damaged RC wall.^{6.6-1) 6.6-2)} In Photo 6.6-1, ceramic wall tile detached from RC exterior wall. Cracks were observed on the damaged RC wall. Photo 6.6-2 shows detachment of ceramic wall tiles installed on a cylindrical RC wall above the building entrance (within a circle). No crack was externally observed on the undersurface RC wall. A net was placed over the damaged area to catch falling tiles.

Photo 6.6-1 Detachment of ceramic wall tiles from damaged RC exterior wall

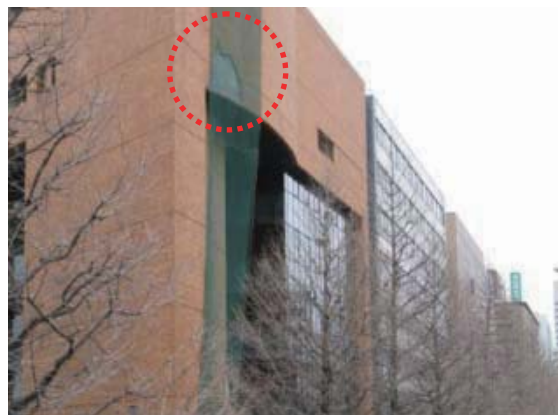
Photo 6.6-2 Detachment of ceramic wall tiles from RC wall

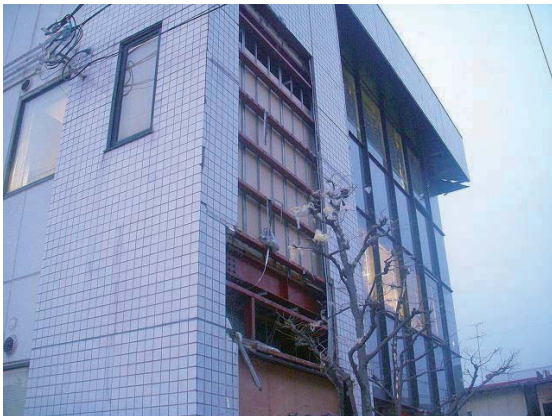
Damage to cement mortar and metal lath exterior walls was often observed in steel buildings. Photo 6.6-3 shows detachment of cement mortar and metal lath exterior wall in a 3-story building. Damage to the window glass was not observed, but cement mortar and metal lath fell from the exterior wall (shown in Photo 6.6-3) and from the parapet on another side. Photo 6.6-4 shows a one-story steel building in which cement mortar and metal lath detached from an exterior wall and from an eaves soffit. Photo 6.6-5 shows a damaged gable end wall of a gymnasium. This wall consisted of two layers. The undersurface wall was cement mortar and metal lath exterior wall. The surface one was exterior boards nailed to furring installed on the undersurface wall. Both were damaged and fell by the earthquake.

Photo 6.6-3 Falling of cement mortar and metal lath wall

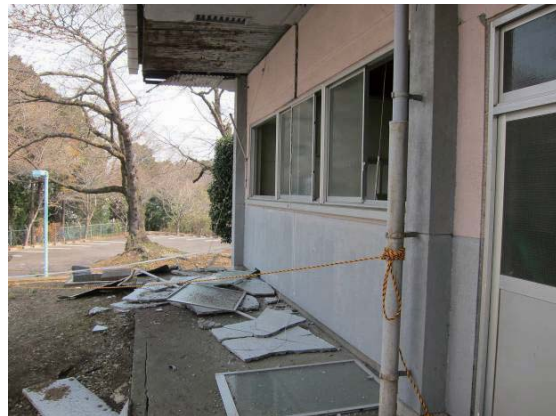
Photo 6.6-4 Falling of cement mortar and metal lath from eaves soffit

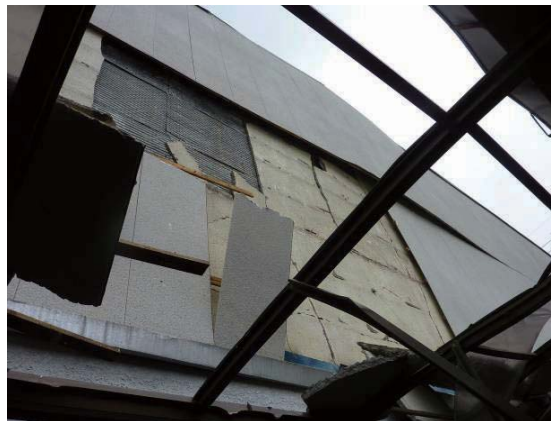
Photo 6.6-5 Damage to gymnasium gable end wall

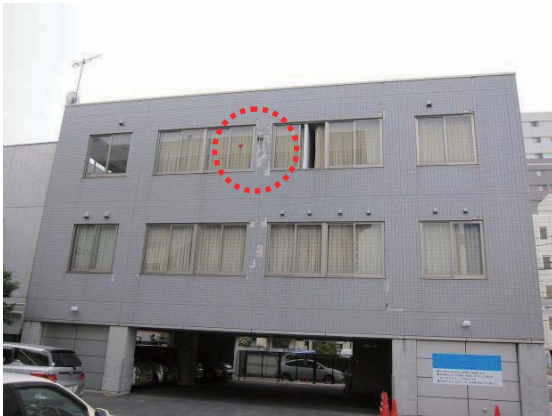
Photo from 6.6-6 to 6.6-7 shows damage to AAC panel exterior walls. Photo 6.6-6 shows falling of finishing ceramic wall tiles on AAC panels and broken light-weight aerated concrete in a 3-story building. Ceramic wall tiles on all faces of the exterior walls detached and the corners of the AAC panels were chipped. AAC panel was broken and internal iron wires were exposed at the circular broken line in the photo. AAC panels fell from another side. The construction method of the AAC panel exterior wall was not

Photo 6.6-6 Falling of ceramic wall tiles and breakage of AAC panels

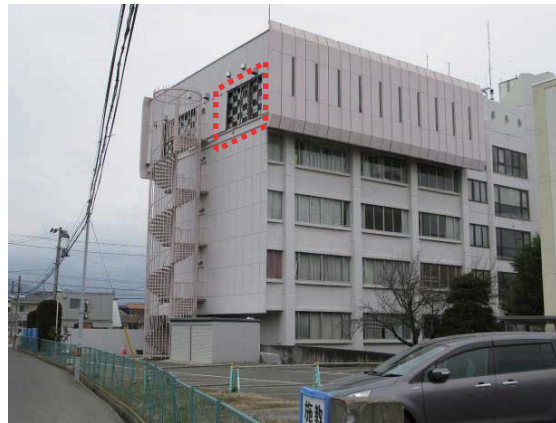
observed in the external survey. Photo 6.6-7 shows falling of AAC panels from the top-floor of a 5-story building. The damaged AAC panels were observed to be installed to the support metal with cement mortar and steel bar. This AAC construction method appeared in 3rd edition of Japanese Architectural Specification Standard JASS 12 as one of standard construction methods for AAC panel exterior wall but not included in its 4th edition. ^{6.6-3)} ^{6.6-4)} AAC panels installed with this AAC construction method were frequently observed to be damaged.

Photo 6.6-7 Detachment of AAC panels

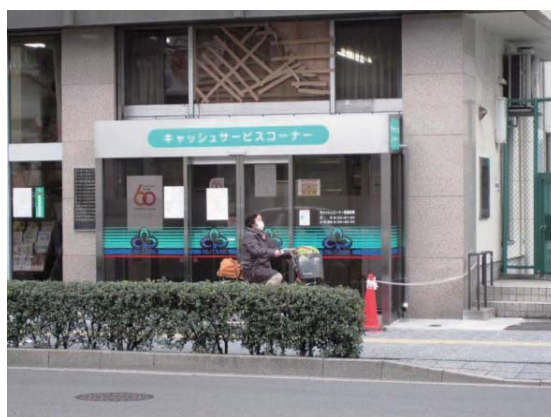
Photo 6.6-8 shows broken window glasses in the upper area of a windbreak room on the ground level of a 5-story building. Exterior ceramic wall tiles fell from another side.

Photo 6.6-8 Broken window glass

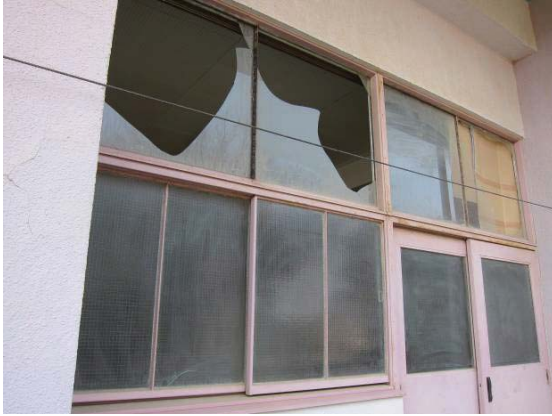
Photo 6.6-9 shows damaged window glasses installed to the upper fixed window with hardening putty at a gymnasium gable end wall. Cracked wired window glasses

were also observed at the lower double sliding window with hardening putty. Flaking of paints was observed on the center of an arch beam of the gymnasium. Photo 6.6-10 shows breakage of window glasses in a gymnasium. The window glasses were installed to fixed window frames with glazing bead and twelve window glasses were broken at three exterior surfaces. Flaking of concrete at the roof bearing support part, deformation of almost all roof horizontal braces and fracture of one roof horizontal brace in the gymnasium were observed.

Photo 6.6-9 Breakage of window glasses installed to fixed window frame with hardening putty

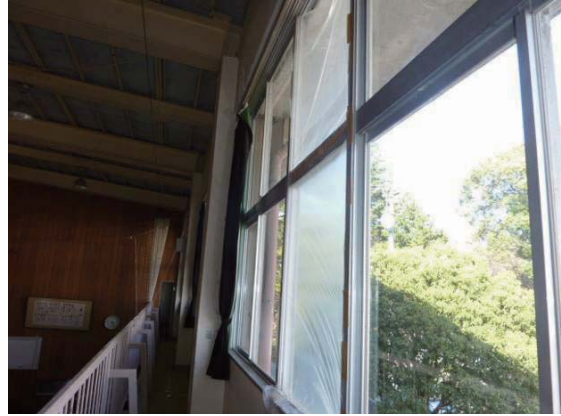
Photo 6.6-10 Breakage of window glasses installed to fixed window frame with glazing bead

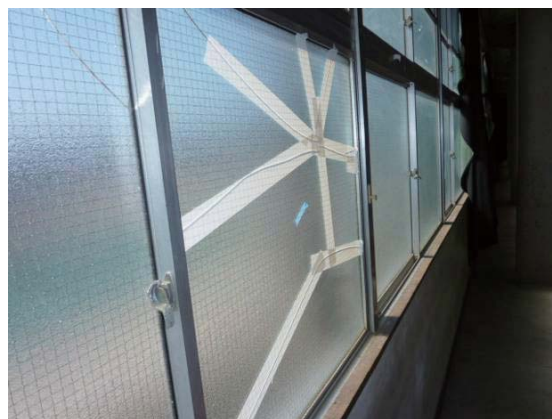
Photo 6.6-11 shows broken window glasses on the longitudinal surface in a gymnasium. Twenty-six wired window glasses were broken, which were installed to double sliding window frames with glazing bead. On the windows of opposite side, there were no damage to the frosted window glasses and a detachment of a mullion cover of a window. No damage was observed in the structure.

Photo 6.6-11 Breakage of wired window glass installed to double sliding window frame with glazing bead

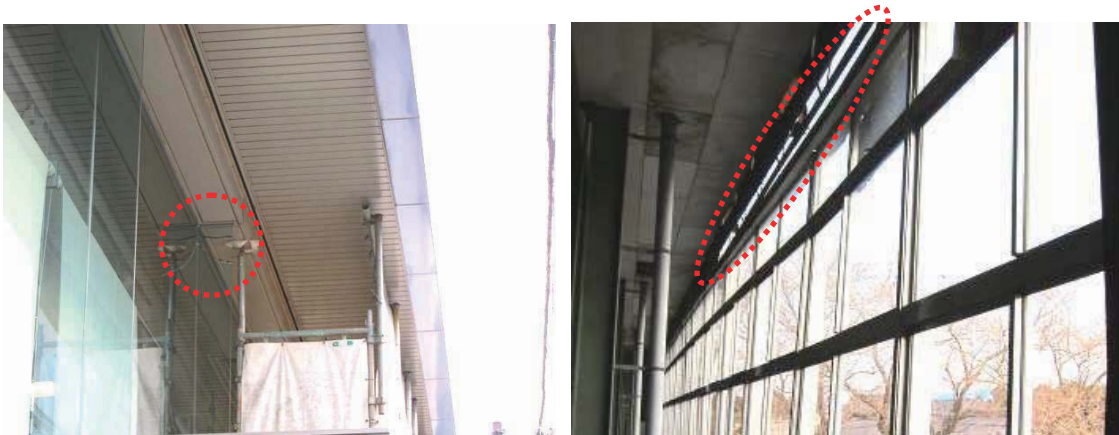
Photo 6.6-12 shows a damaged glass wall system at the 1st floor of a 6-story building. A glass mullion was broken in an area circled by a broken line (steel pipe adjacent to the broken glass were installed after the earthquake for the repair work).

Photo 6.6-13 shows damage to window frame in a gymnasium. The photo shows the window frames near the center of the longitudinal surface of the gymnasiums. The upper part of the window frame was dislocated and leaned to the outside. The same damage was observed also at the opposite side. Fracture or buckling was observed in most of the section loss parts by bolt holes on longitudinal direction frame braces. Braces were fractured in three of four frames.

Photo 6.6-12 Breakage of glass mullion of glass wall system Photo 6.6-13 Dislocation of window frame

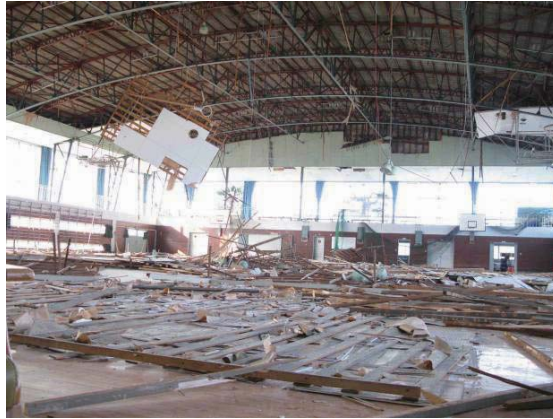
Photo 6.6-14 shows a damaged wooden suspended ceiling in a gymnasium. The ceiling almost fell with light fittings except at perimeter. Partial falling of an eaves soffit, dislocation of a window frame and 33 broken window glasses were also observed.

Photo 6.6-14 Falling of wooden suspended ceiling

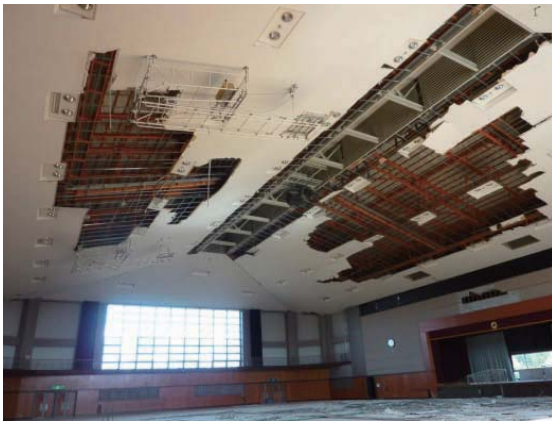
Photo 6.6-15 shows a metal furring suspended ceiling broken at the center of a pitched ceiling. Damage was also observed at interior walls above the stage. No damage was observed to the steel roof and supporting RC columns. Photo 6.6-16 shows damage to a high ceiling above the lobby of an airport passenger terminal building. There were five metal furring suspended ceilings of 3m x 11m. The metal-sheet clips hanging the metal furring channels were damaged by the earthquake and one of the ceilings fell. In the ceiling plenum, vertical diagonal members were unevenly installed and the members were complicatedly installed near the connection with the surrounding wall. No damage to the structure was observed.

Photo 6.6-15 Falling of metal furring suspended ceiling

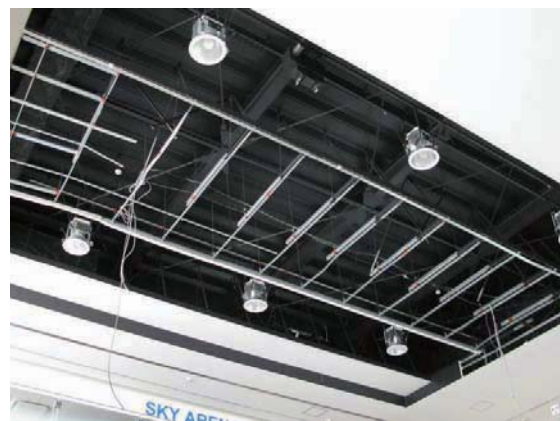
Photo 6.6-16 Falling of metal furring suspended ceiling

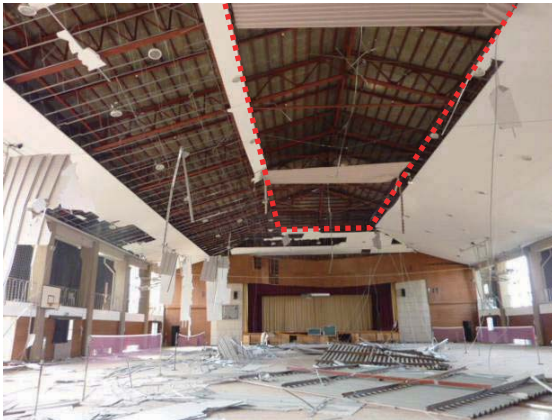
Photo 6.6-17 shows damaged ceilings in a gymnasium. The horizontal ceiling marked with red dotted lines was composed of corrugated steel plates and steel members and the pitched ones were composed of metal furring channels and other steel members faced with gypsum board. Both ceilings fell. The broken window glasses and the leaned interior wall above the stage were also observed. Many roof horizontal braces were fractured.

Photo 6.6-17 Falling of metal furring suspended ceiling and corrugated steel plates

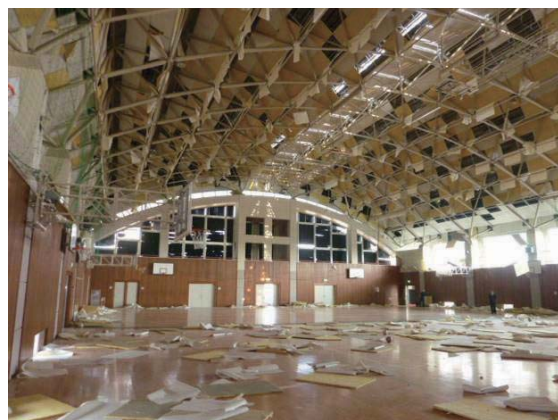
In the gymnasium shown in Photo 6.6-18, many glass wool boards on exposed T system fell. Flaking of concrete was observed in the structure.

Photo 6.6-18 Falling of glass wool board of T system ceiling

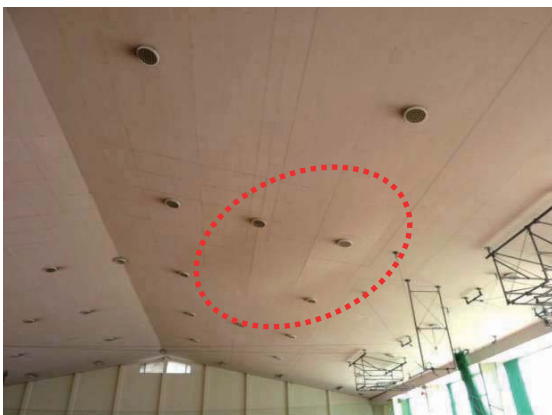
Photo 6.6-19 shows a damaged metal furring suspended ceiling in a gymnasium. Significant visual damage was not observed, but the ceiling board sagged near the center of pitched ceiling marked with a red dotted oval line in the photo. This was possibly due to the displacement of ceiling members in the plenum. Cement mortar finish of interior wall above the stage was flaked as shown in Photo 6.6-23, and the exterior boards were broken at the gable end wall. No damage to the structure was observed.

Photo 6.6-19 Sagging of metal furring suspended ceiling

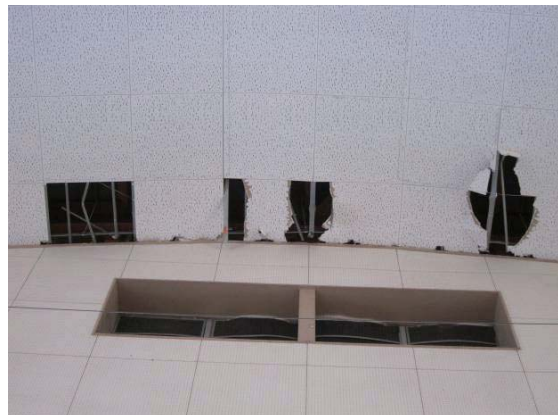
Photo 6.6-20 shows damaged ceiling at the connection with surrounding wall in a gymnasium. Bending of the metal furring channels and detachment of ceiling boards were observed. In the corner of the ceiling, the sheet-metal clips were damaged and the ceiling sagged in several meters long. The gymnasium is composed of lower RC frame and upper steel frame.

Photo 6.6-20 Damage to metal furring ceiling at the connection wall

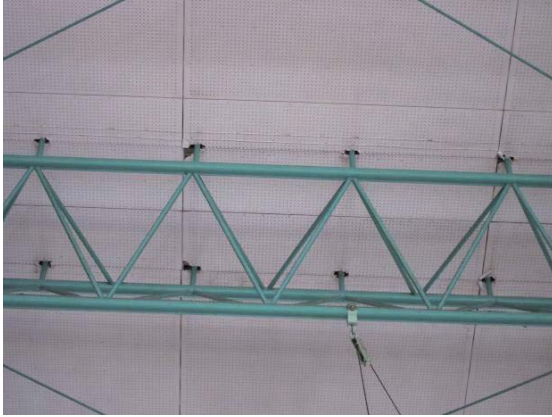
Photo 6.6-21 shows damaged ceiling boards at the connection with the structure of a gymnasium. It was reported that one window glass was broken. No damage to the structure was observed.

Photo 6.6-21 Damage to metal furring suspended ceiling at the connection

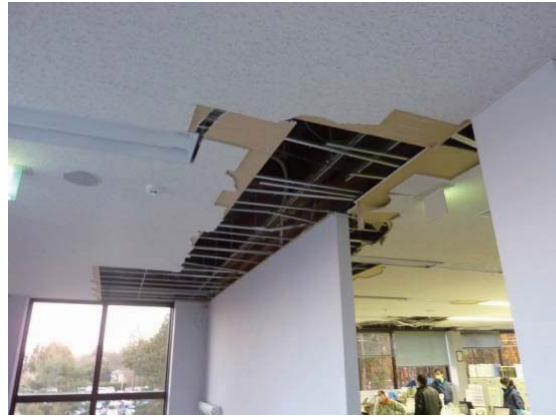
Photo 6.6-22 shows damaged ceilings at an office building. The ceiling was damaged at the connection with the partition. Bending of a metal furring channels and falling of ceiling boards were observed.

Photo 6.6-22 Damage to metal furring suspended ceiling at the connection

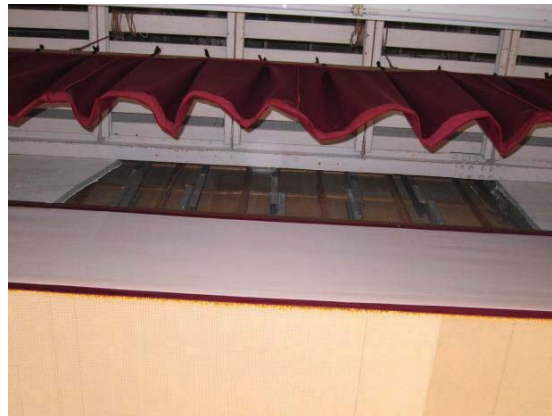
Photo 6.6-23 shows damaged walls above the stage in the gymnasium shown in Photo 6.6-19. Cement mortar finishes on the studs were broken and fell. Damage to the walls above the stage was observed also in some gymnasiums such as shown in Photo 6.6-15 or Photo 6.6-17.

Photo 6.6-23 Falling of cement mortar finish above stage

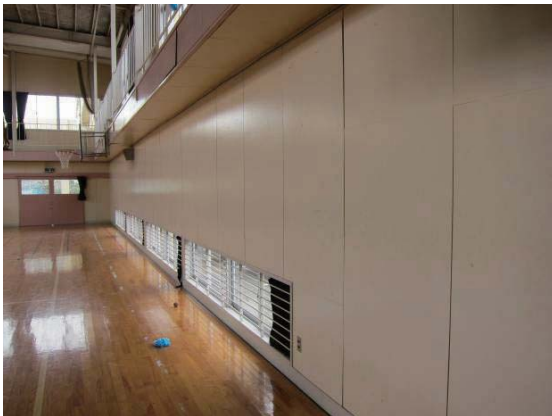
Photo 6.6-24 shows a lift of the nail fixing interior wall boards to the studs in the arena of gymnasium.

Photo 6.6-24 Loosen nails fixing board

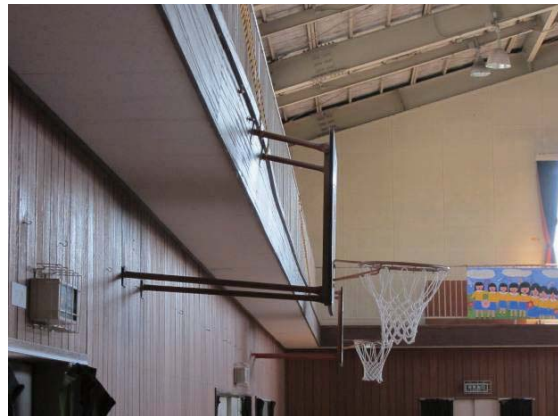
Photo 6.6-25 shows damaged interior walls in a gymnasium. Interior walls around

the supports leaned at two of three basketball hoops. The damaged hoops were temporarily supported with ropes.

Photo 6.6-25 Damaged interior wall
