7. Damage to Buildings in Inundation Areas Induced by Tsunami

7.1 Introduction

8. Damage of Buildings, etc. due to Fire

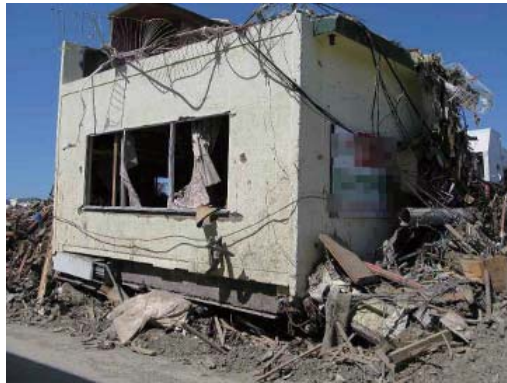
A case that column capitals and bases on the first floor in a building were subject to bending failure and subsequently to story collapse was seen in a 2-story building (Photo 7.2-1).

The building had column-to-beam frames. The first floor had relatively small number of walls, but many concrete block walls were placed on the second floor. The first and second floors of the building in Photo 7.2-1 were used as shop and dwelling, respectively. The relevant building was estimated to have structural characteristics of low strength and stiffness on the first floor. As an opening on the second floor was not large, it is assumed that the second floor suffered a large tsunami wave pressure and the shear force acting on the first floor exceeded the lateral load-bearing capacity, resulting in the collapse of the building. Story collapse of the first floor has not been observed in 3-story or higher buildings in the investigations. In 3-story buildings, in general, reinforced concrete walls are often used in the first floor. Therefore, the strength of the first floor of 3-story buildings is considered to have been larger than that of 2-story buildings.

Photo 7.2-1 Story collapse of a 2-story reinforced concreted building

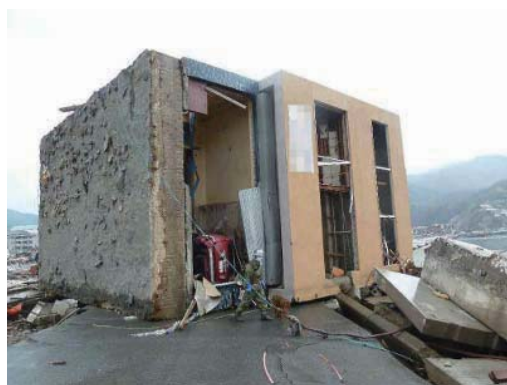
Overturning was observed in 4-story or lower buildings. In all overturned buildings, the maximum inundation depth exceeded their height. Overturning types include buildings that fell sidelong (Photo 7.2-2) and buildings that turned upside down. Most of the overturned buildings were of mat foundation. In some overturned buildings on pile foundation, piles were pulled out.

Photo 7.2-2 Overturning of a 3-story reinforced concrete building

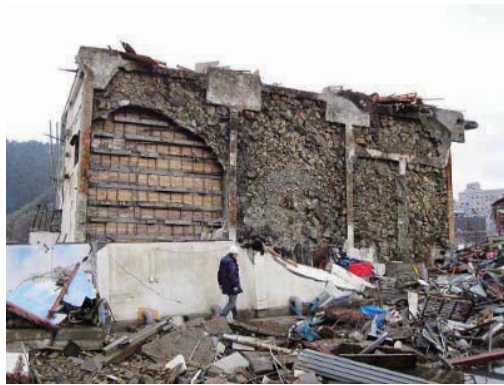
Photo 7.2-3 A 2-story reinforced concrete building that moved over the fence and overturned

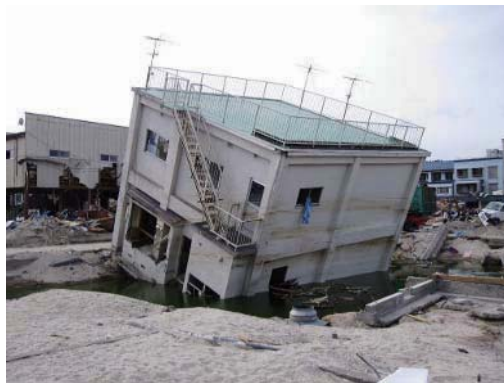
When tsunami acted on a building, a strong stream was generated around the corner of the building, resulting in many large holes on the ground that were bored by scouring. In one case, a building on mat foundation fell into a hole bored by scouring (Photo 7.2-4).

Photo 7.2-4 A 2-story reinforced concrete building that was tilted by scouring

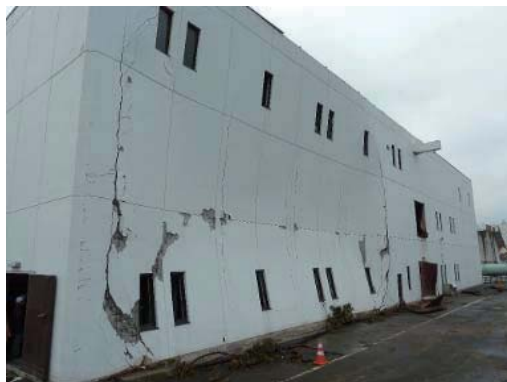
Cases that such wall reinforcement was fractured were often seen in wall members with single layer bar arrangement. In one damaged building (Photo 7.2-5), a 300 mm-thick shear wall with double layer bar arrangement and a support span of more than 10 m and without the second and third floor slabs was bent inside by tsunami wave pressure. However, a shear wall in an area (Photo 7.2-5 Back of the building, right-hand side), where there was a floor on the second story and a support span was not long in the same building, was not bent.

Photo 7.2-5 Out-of-plane fracture of reinforced concrete shear wall without floor

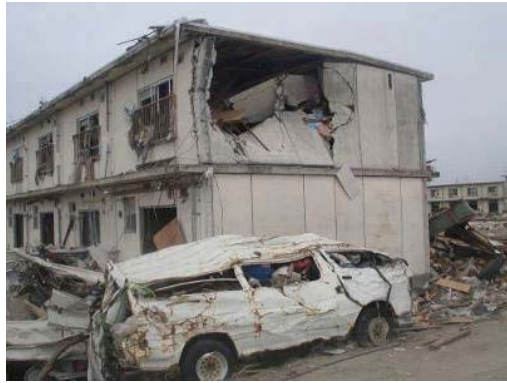
Debris impact was seen in most of the non-structural members such as window and ceiling materials. The number of cases of clear damage to skeletons was not large, but in one observed case, a multi-story wall in an apartment house was probably bored by debris impact (Photo 7.2-6).

Photo 7.2-6 Wall opening probably generated by debris impact

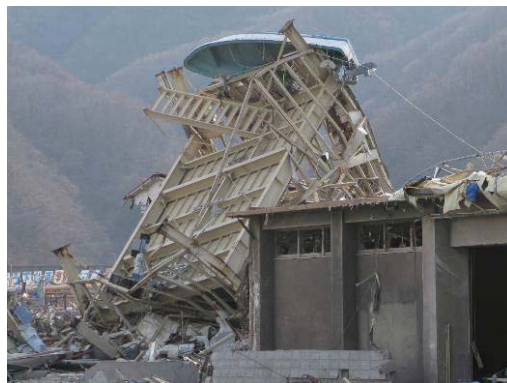
A typical case of building movement and washout was that a building moved and flew due to the fracture of anchor bolts and/or base plates at steel exposed column bases and the fracture of a weld between the column and the base plate (Photo 7.2-7). In most cases, foundation and some column bases were left in the site, but the upper structure of the building was moved beyond the site or missing.

Photo 7.2-7 Steel building overturned by fracture of column base anchor bolts

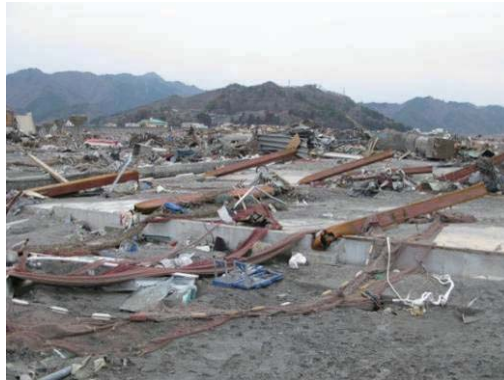
In most cases, welds between diaphragms with lower flanges and the first-floor columns were fractured and the sections of the columns were exposed. In one building, flanges of the second-floor H-shaped beams were torn. Based on the deformation states

near the column bases, it is estimated that a tensile force acted on the first-floor columns, and then the first-floor capital connections were fractured after the first floor was greatly tilted to the same extent as the inclination of the remaining columns.

Photo 7.2-8 First-floor columns falling in the same direction

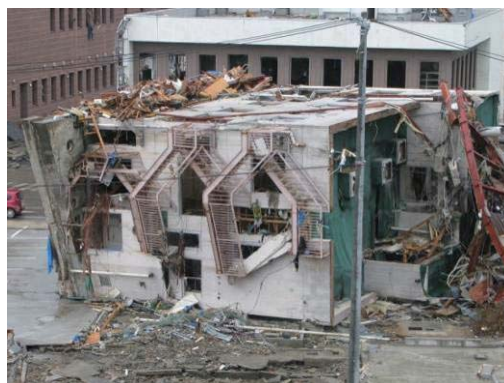
One case that a whole building including foundation was overturned, was confirmed. Most of the AAC panels of claddings were left (Photo 7.2-9).

Photo 7.2-9 Overturning of a 3-story steel building

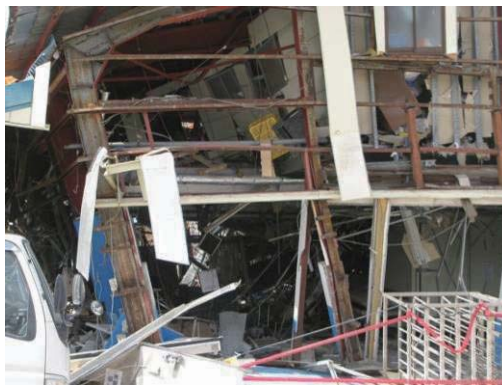
Slight tilting was often observed with remaining their skeletons in steel buildings. In one case (Photo 7.2-11), a gabled roof frame building did not collapsed despite large residual deformation.

Photo 7.2-11 Tilted gabled roof frame

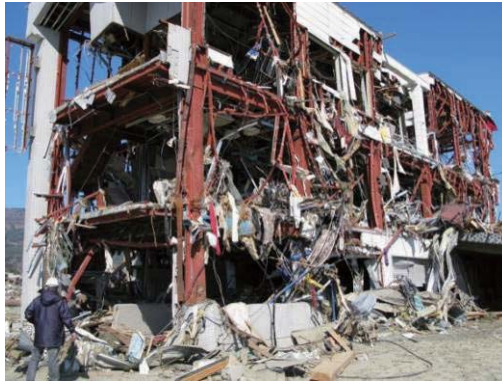
Cladding materials such as AAC panel were almost fully fractured and washed away, and then a steel frame as a skeleton was remaining. This case was often observed (Photo 7.2-12). It is considered that an external force that acted on the skeleton became small due to early washout of the cladding materials. In the remaining building, slight tilting of the skeleton, member deformation on the face affected by tsunami, and members locally damaged possibly by debris impact, were observed.

Photo 7.2-12 A remaining 3-story steel building

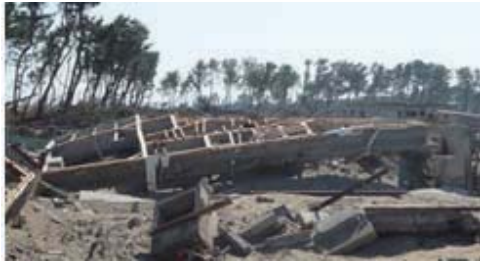
Photo.7.4-1. Foundations washed away.

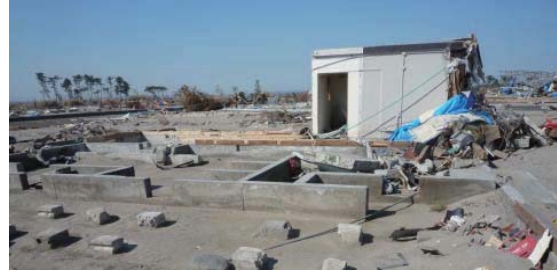
Photo.7.4-2. Only foundation remained.

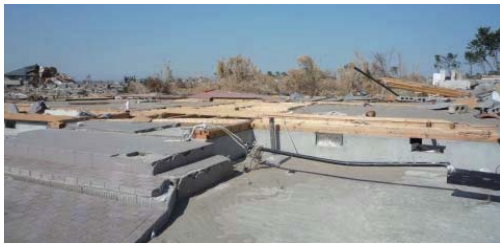
Photo.7.4-3. Foundation and sills remained.

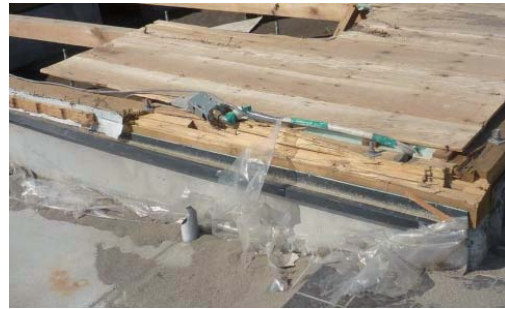
Photo.7.4-4. Sills, foundation and floor boards remained.

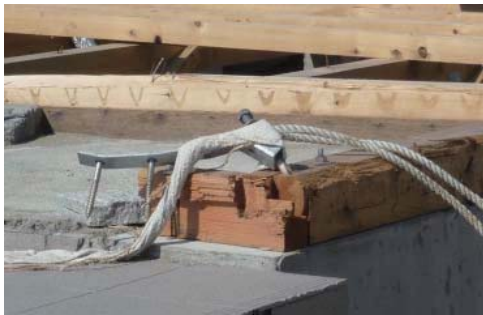
Photo.7.4-5. Failed hold down fastener.

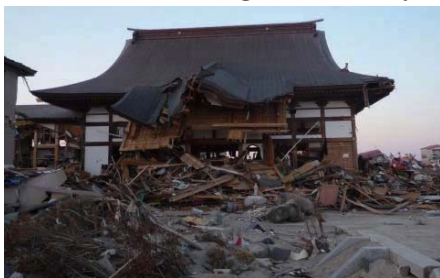
Photo 7.4-12. Heavily damaged temple (³) building in Yuriage, Natori city.

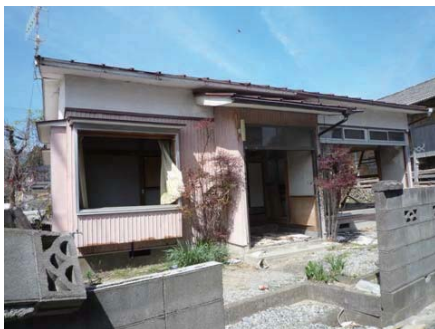
At the location where we went up the slope land from these houses, a light steel-frame house (9) remained in under the about 5 m water depth. In the next of this house, the 1-story old wood house (Photo 7.4-31:10) whose structural specification was not so good, but the anchor bolts were installed remained. In addition, a warehouse with mud walls (Photo 7.4-32:11) was remained and an old wood house without anchors (Photo 7.4-33:12) turned and moved horizontally. Because the wood house under about 5 m water depth were almost washed away in plain areas, it might be possible for the slope land to make lateral force caused by tsunami a little smaller.

Photo 7.4-31. Survived house (9) which seemed to have comparatively slight structural specifications in Akasaki-cho, Oofunato city.

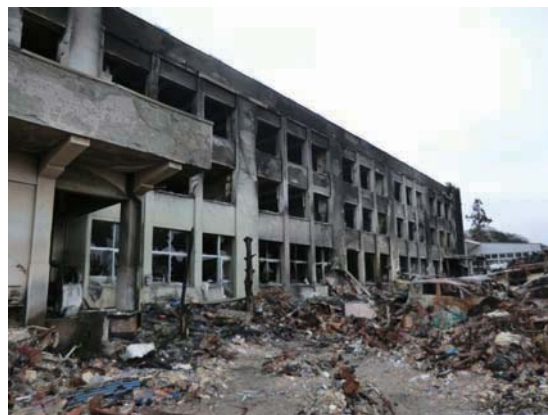
Photo 8.2-1 Tsunami fire at an elementary school (Ishinomaki city, Miyagi prefecture)

Photo 8.2-1 shows a fire scene of an elementary school building located at about 1 km from the coast. Almost all of the 3-story school building had been burnt by the flame flared up from cars, combustible debris and oil and so forth that drifted and accumulated by tsunami in the schoolyard in front of the building.

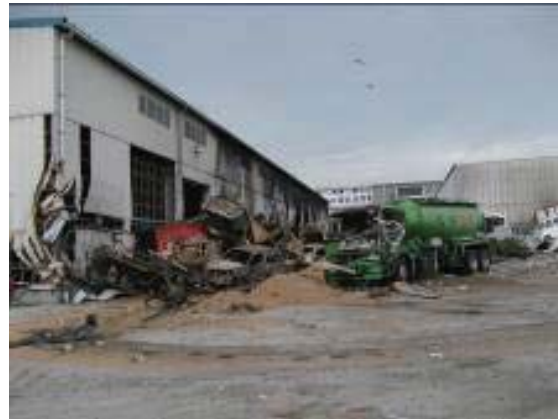
Building at a port was one of the most damaged buildings by tsunami with not only tidal wave but also debris, cars and ships and so forth drifted by tsunami (Photo 8.2-2 and 8.2-3). Several hundred automobiles which have been parked in a parking zone, being drifted to a port warehouse by the tsunami, caused fire at the place where it accumulated.

The cause of the fire is unclear, but it is assumed that the car collided severely each other, the gasoline tank of the cars were damaged, and sparked by malfunction of the electrical system by the seawater. There was no spread of fire in the interior of the building, only the external wall has been damaged by fire.

Photo 8.2-2 Tsunami fire at a port warehouse (Sendai city, Miyagi prefecture)

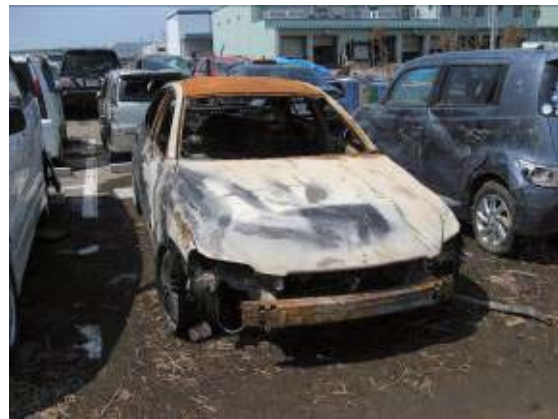
Photo 8.2-3 Vehicle fire due to tsunami at a parking lot (Iwanuma city, Miyagi prefecture)

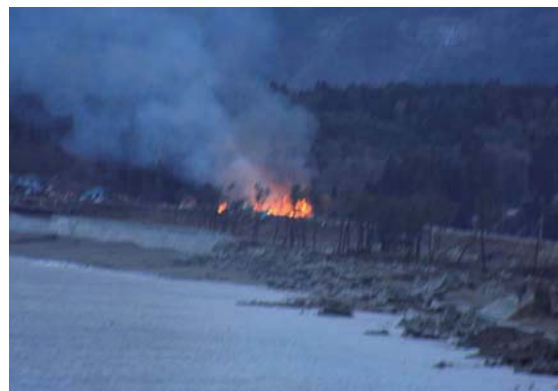
Photo 8.2-4 Fire at a site of 8 buildings due to tsunami (Noda-village, Iwate prefecture), Courtesy of Noda-village

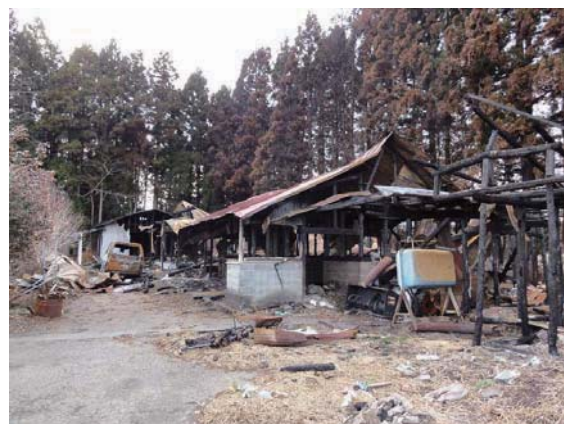
Photo 8.3-1 Fire scene of a house (Oushu city, Iwate prefecture)

district. The fire broke out not soon after the mainshock but at 10 pm of the same day. The cause of the fire has not been identified clearly, but, it is thought to be by the spark or hot exhaust gas leaked from the gap of smoke duct of a boiler for heating and bathing, due to earthquake motions.

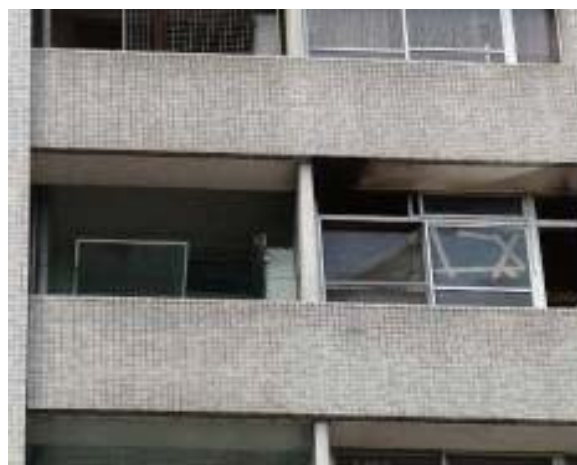
For a condominium fire, one case has been investigated: the fire broke out when electricity supply has been recovered at the night of the next day of the mainshock. The fire broke out on the 7th floor of a 17-story medium scale condominium. The residents of the room of fire origin were absent at the time, but some neighbors were aware of the fire and informed the fire station. Because of early suppression by firefighters, there was no spread of fire to the upper floor and the next rooms (Photo 8.3-4).

Photo 8.3-4 Fire scene at a condominium (Sendai city, Miyagi prefecture)

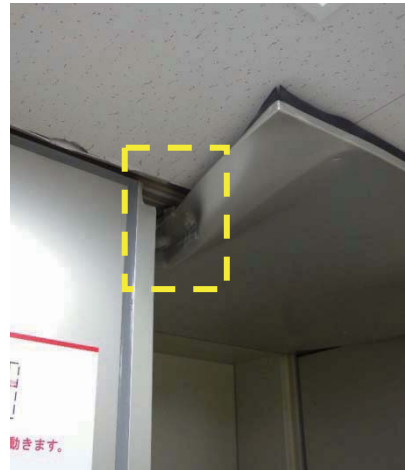
(b) Damage to the expansion joint

Photo 9.2-2 Damage near the boundary between isolated and non-isolated floors

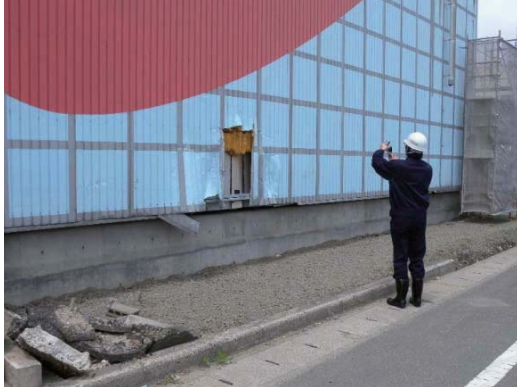
Photo 9.2-6 Damage due to debris

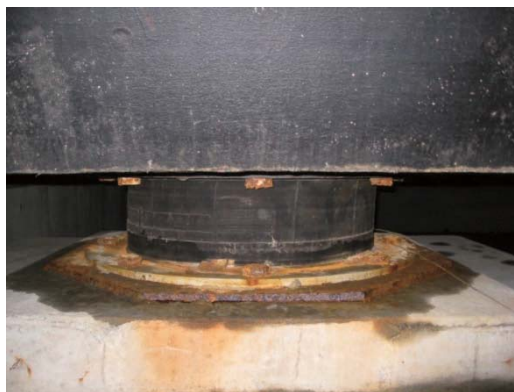
- d) From visual inspection, there was no harmful scratch or inflation of the rubber of HRB, however, severe rust was observed at the steel plates and bolts (Photo 9.2-10).

Photo 9.2-10 Rust of High-damping rubber bearing

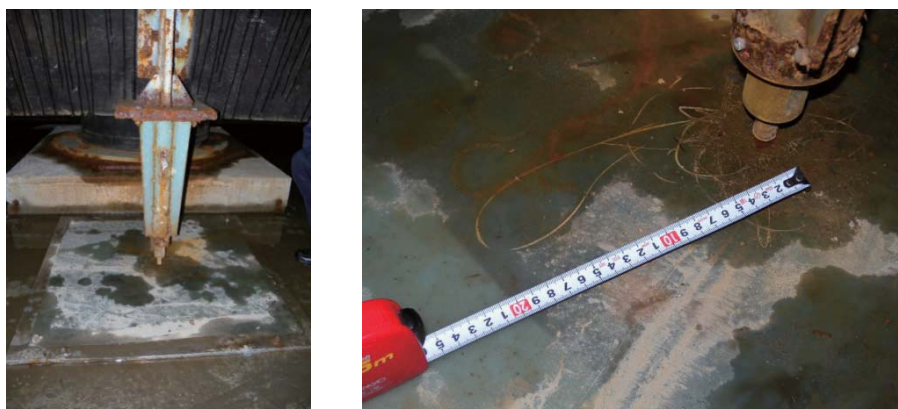
was estimated as around 21 cm at the mainshock (Photo 9.2-11).

Photo 9.2-11 Trace of displacement of the SI floor on the scratch board
