2.9. Report on Monitoring of Construction Practices of Confined Masonry Structure in Indonesia
(Keiko SAKODA)

**Monitoring activity report
on
housing reconstruction
in Yogyakarta, Indonesia**

12.Mar.2008

NPO EVAA
(Ex-volunteers association for Architects)
Keiko Sakoda

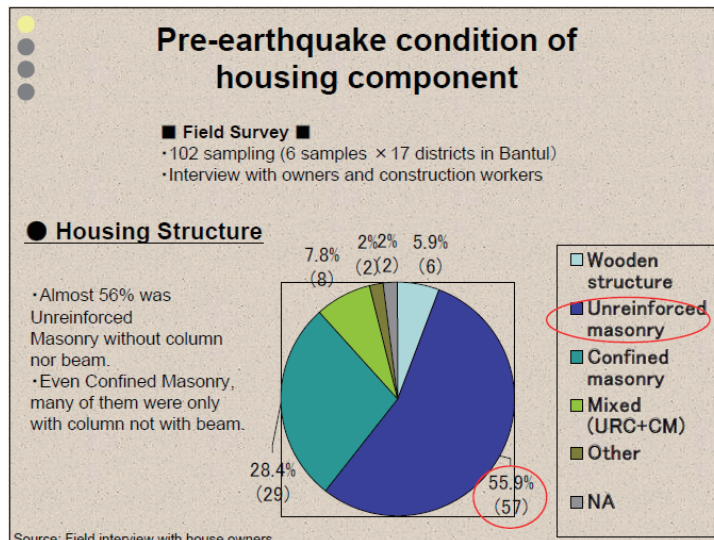
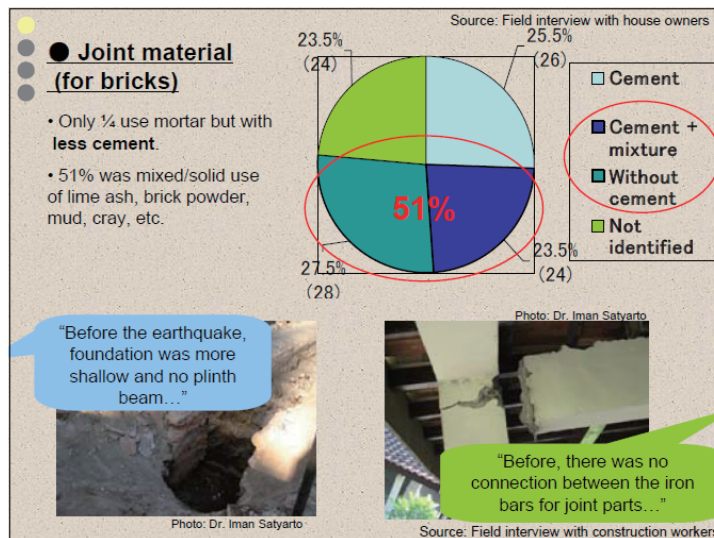
Brick house

- Unreinforced Masonry
(Majority in pre-quake period)
- Confined Masonry
(Majority in post-quake period)
