Non-Engineered Construction and its Earthquake Damage

Yuji Ishiyama
Professor Emeritus
Hokkaido University

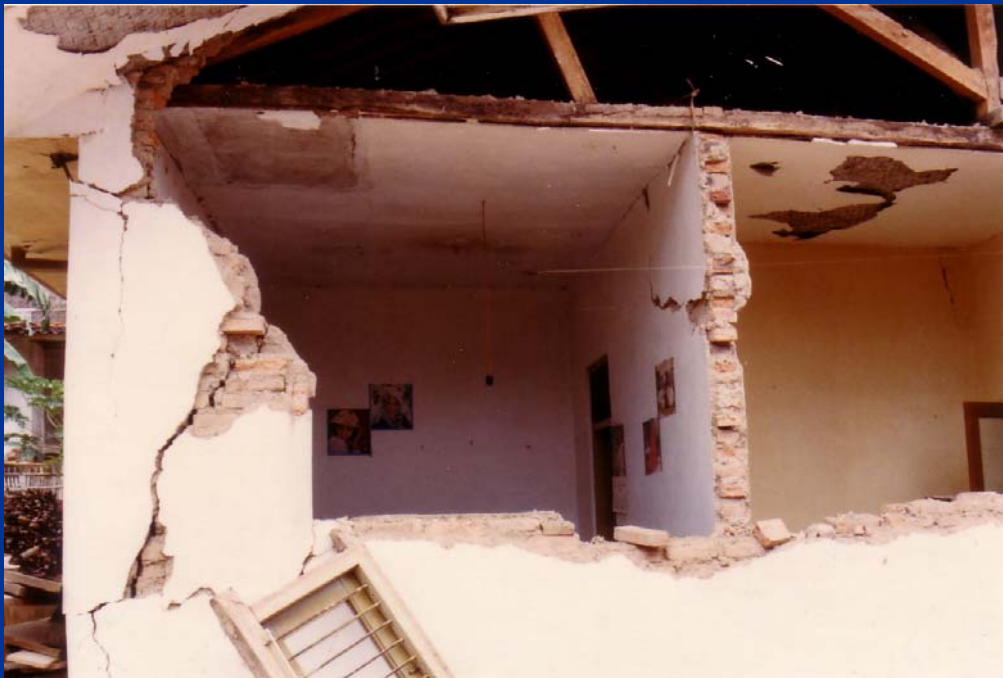
Damage to brick masonry, most of them have no reinforcement.

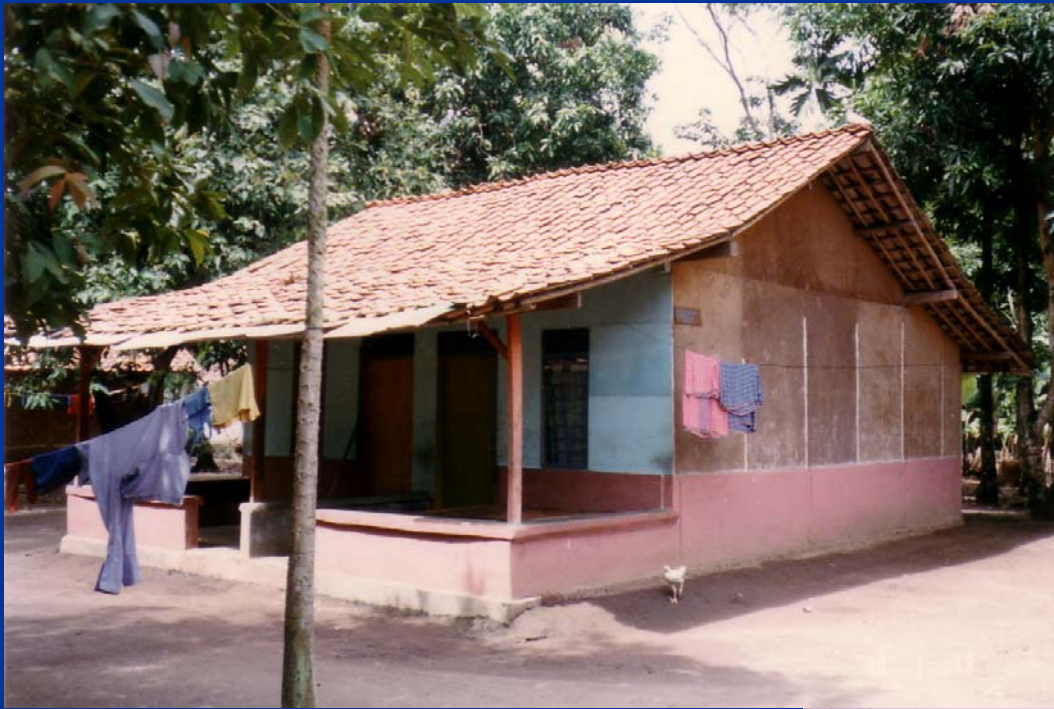
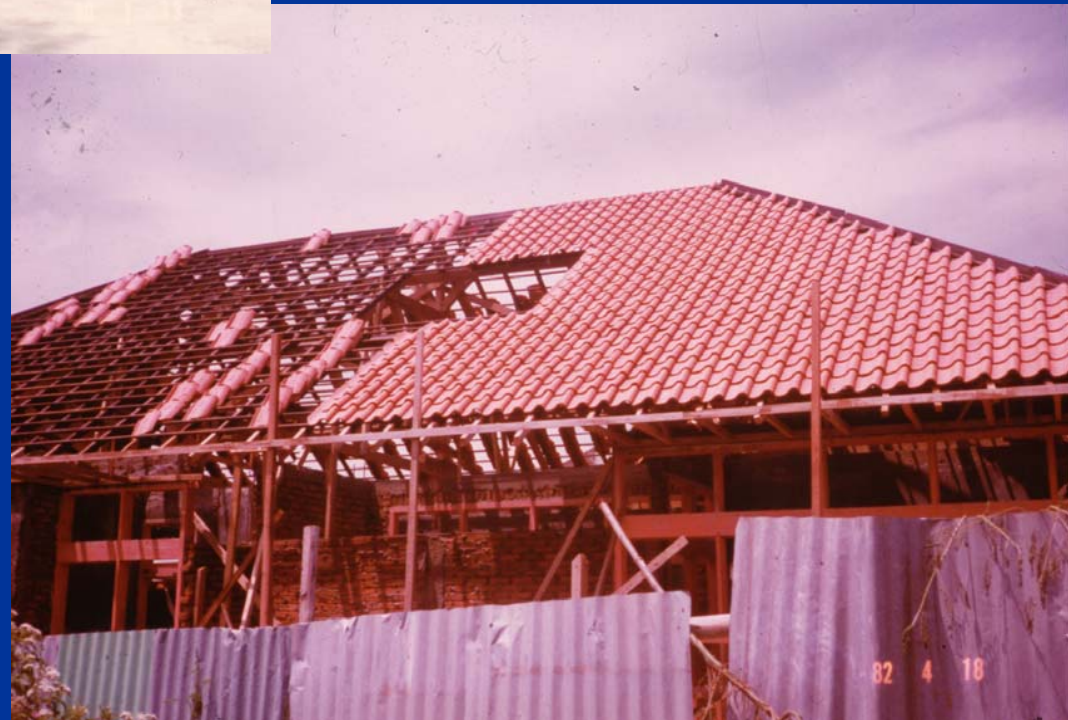
Wooden houses
have better
performance
against EQ's.

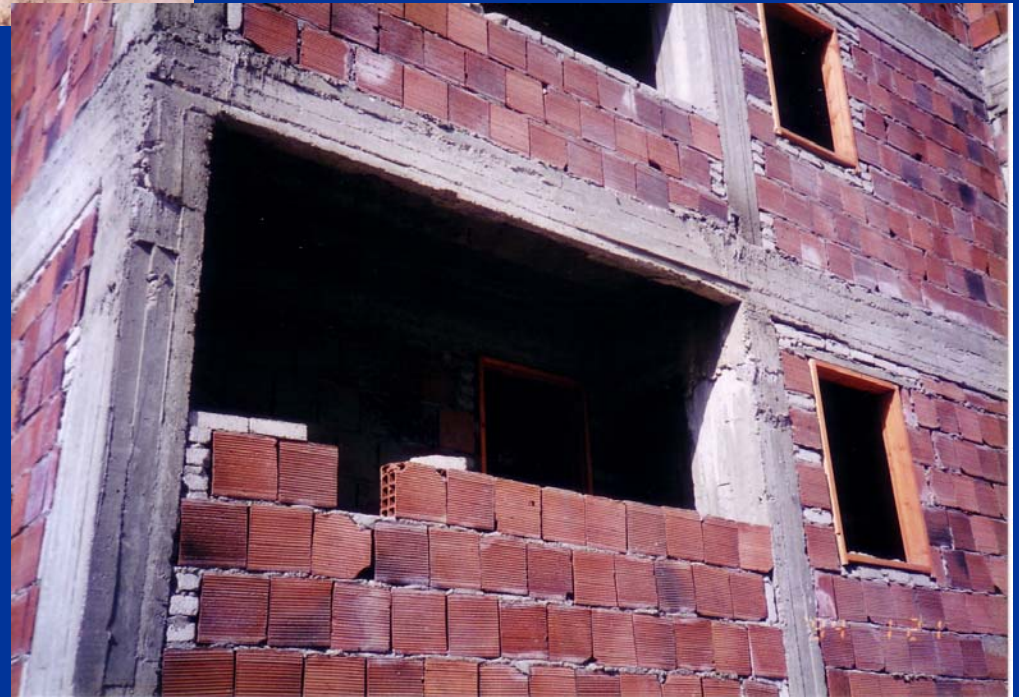
Brick infill wall in Egypt

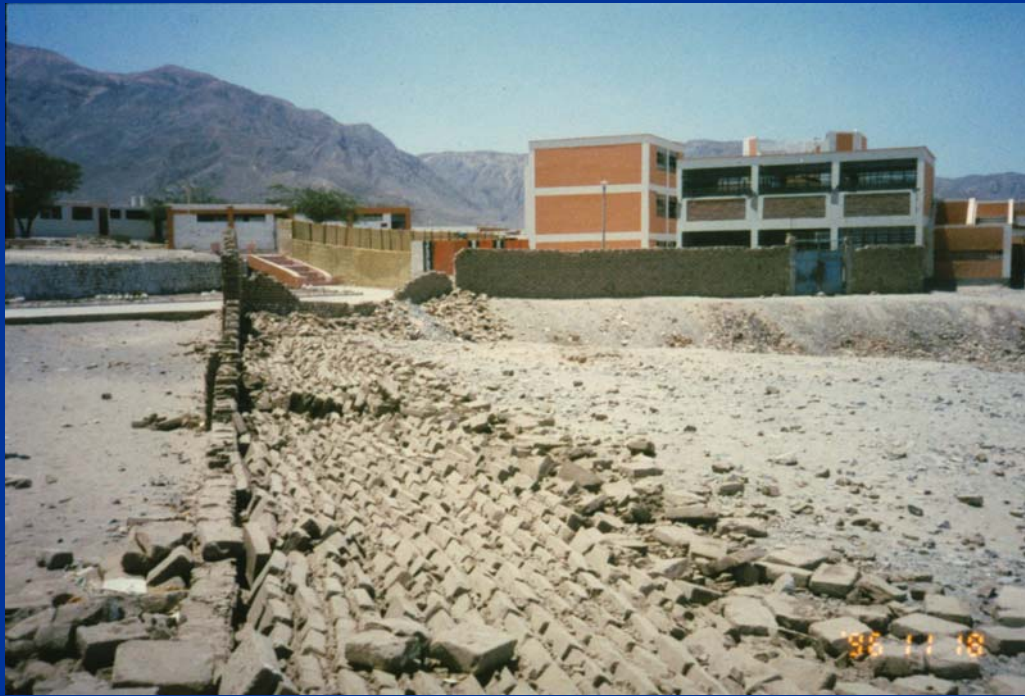
Damage to Adobe
(sundried mud block)
construction (1996
Nazca, Peru EQ)

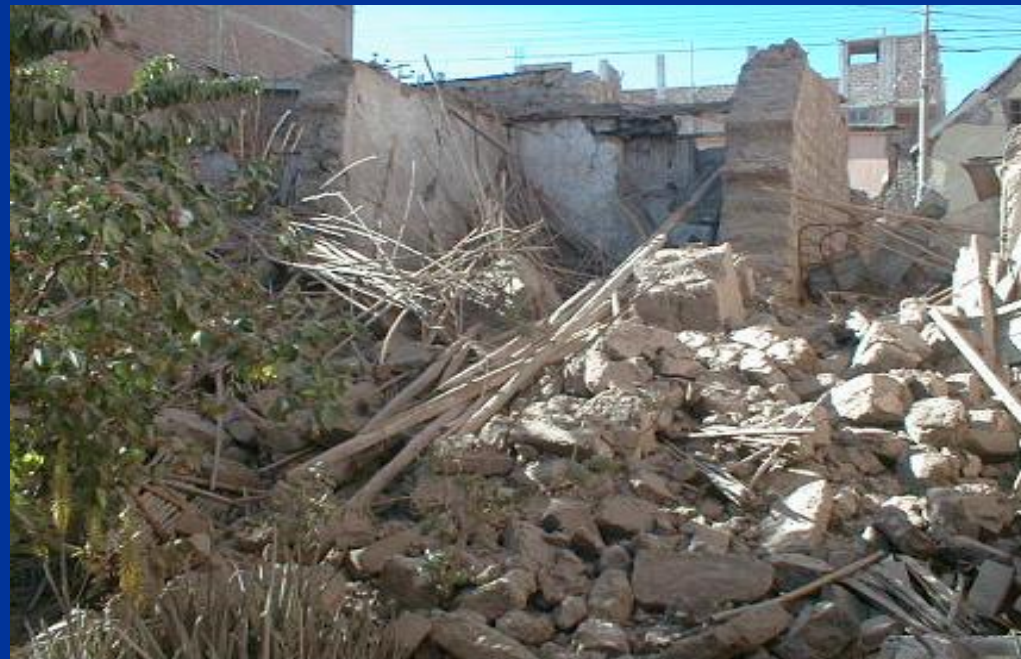
Damage to Adobe
(2001 Atico, Peru EQ)

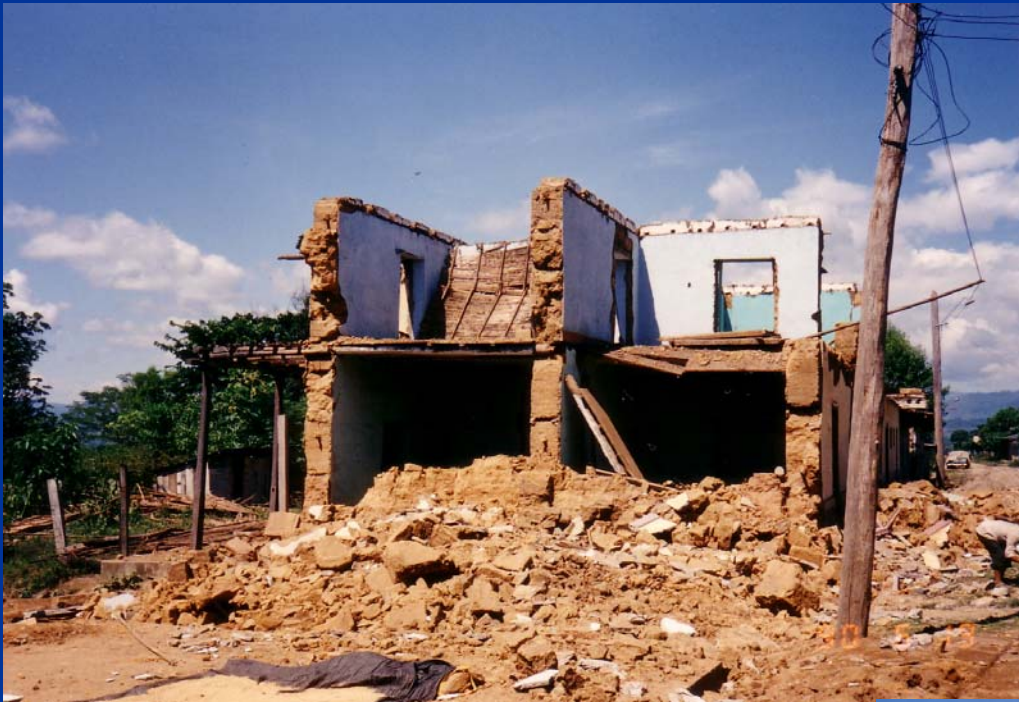
Damage to Tapial construction (1990 Peru EQ)

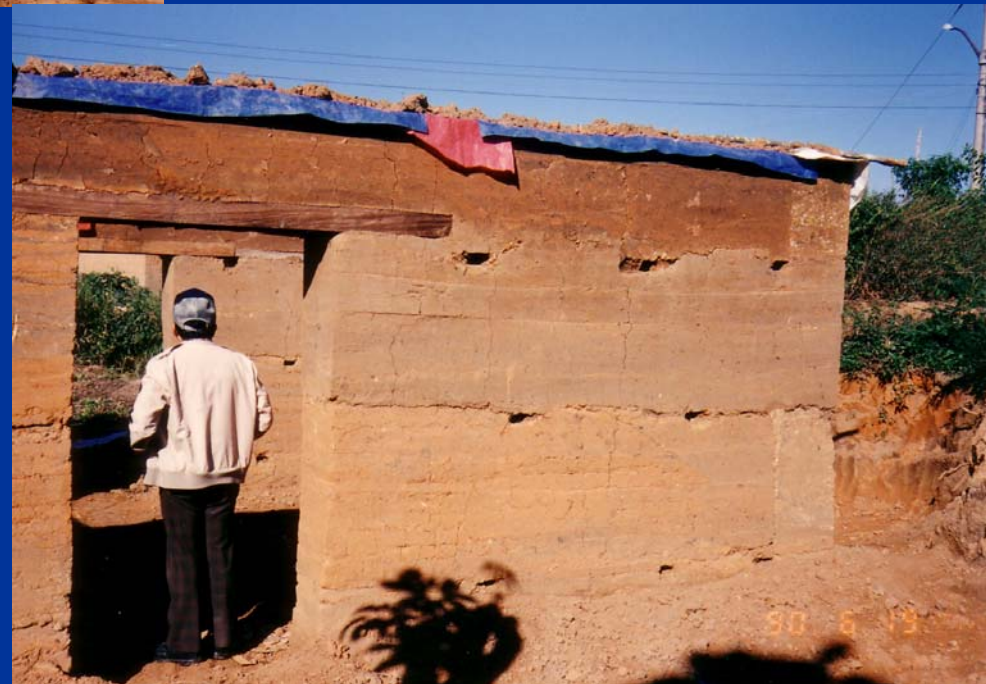
Tapial is cast-in-place mud construction (1990 Peru EQ)

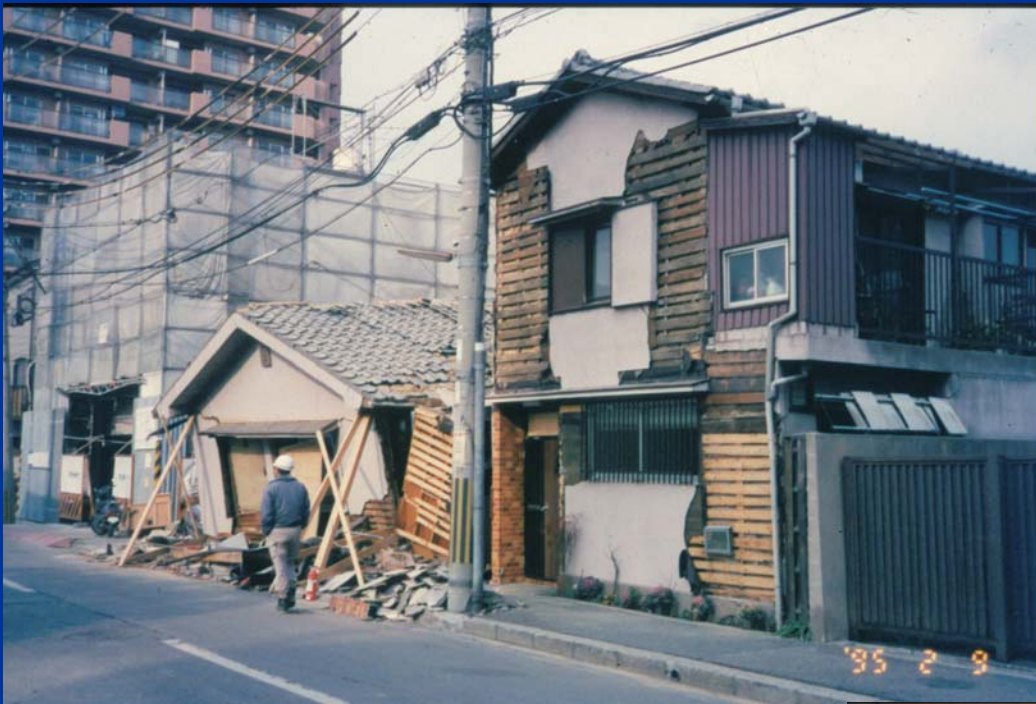
Damage to Japanese wooden houses (1995 Kobe EQ)

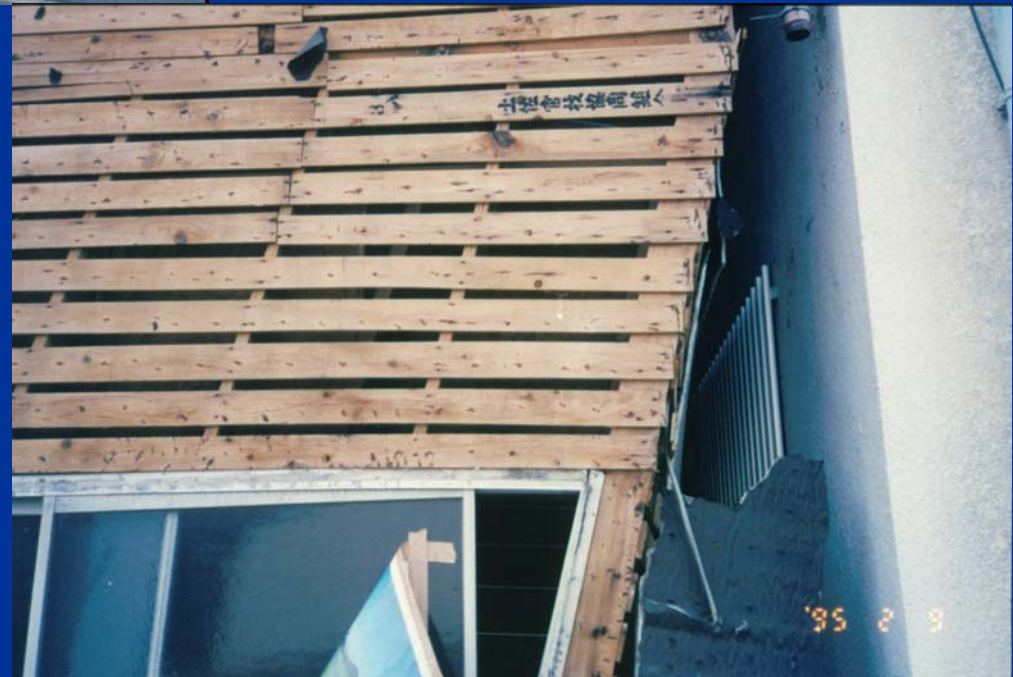
Narrow boards nailed to frame cannot resist lateral forces (1995 Kobe EQ)

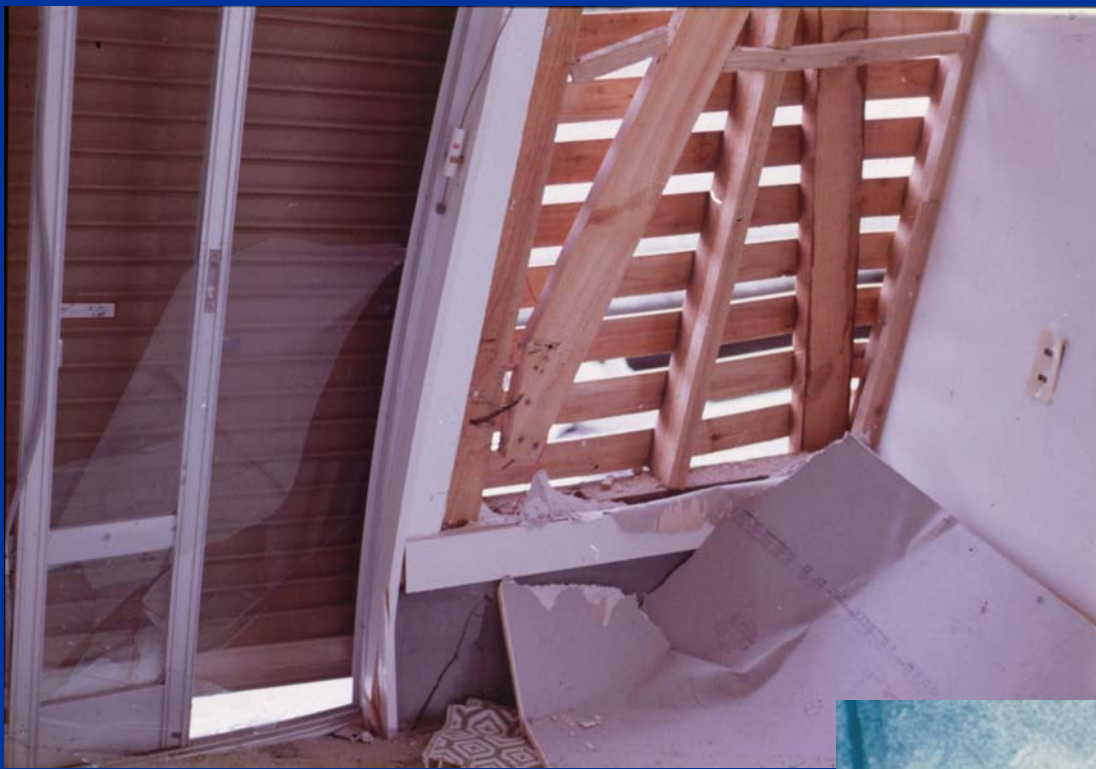
Braces are effective to resist lateral forces (1995 Kobe EQ)

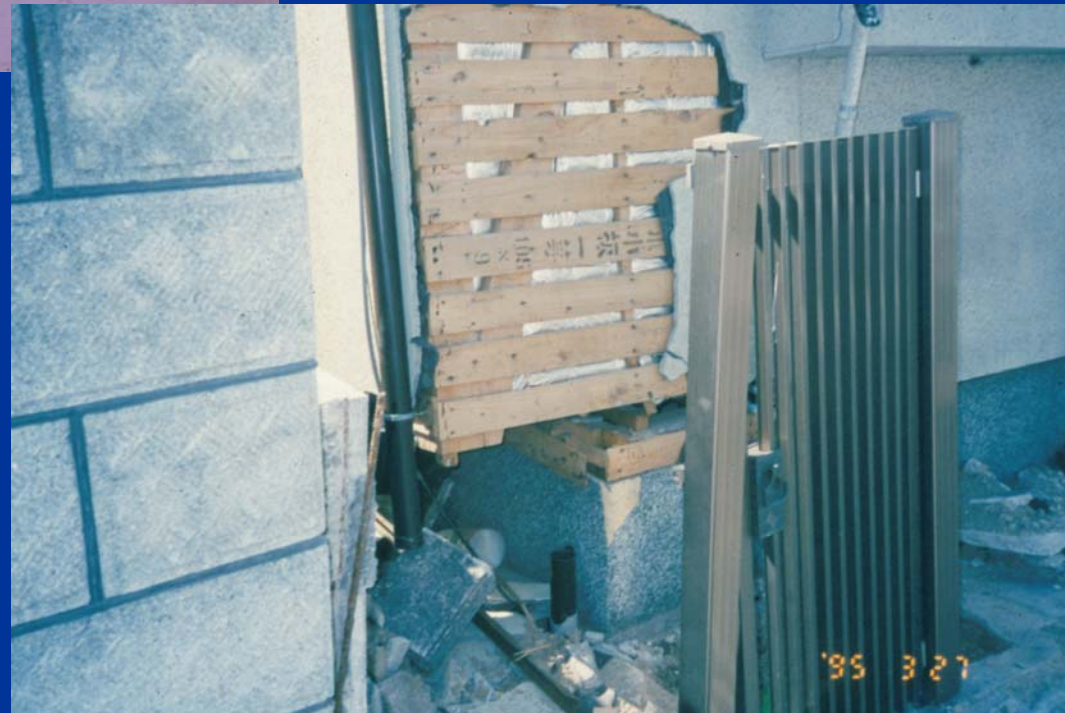
Connections of braces and frames should be sound (1995 Kobe EQ)
