September 2011

**Summary of the Field Survey and Research on  
“The 2011 off the Pacific coast of Tohoku Earthquake”  
(the Great East Japan Earthquake)**

National Institute for Land and Infrastructure Management (NILIM)  
Ministry of Land, Infrastructure, Transport and Tourism, Japan

Building Research Institute (BRI)  
Incorporated Administrative Agency, Japan

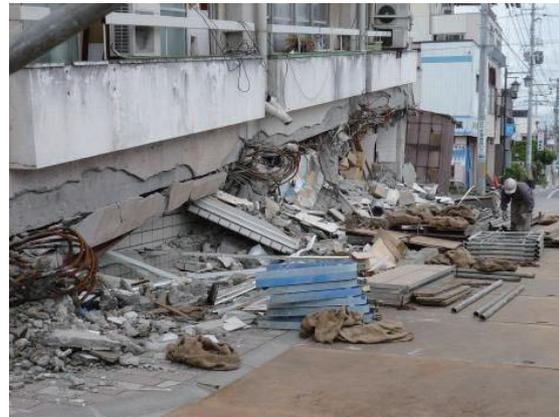
Photo 6.3-3 Close-up view of the fallen story

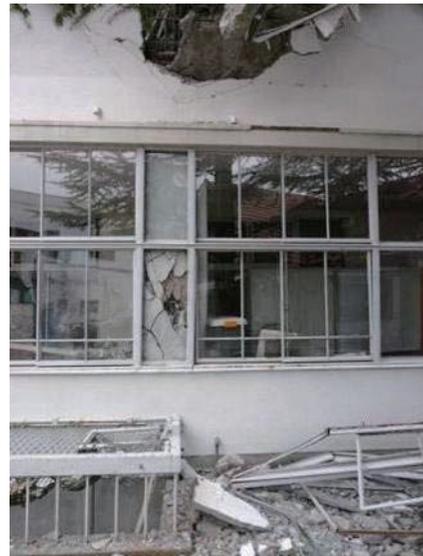
Photo 6.3-8 Shear failure of the first-story column

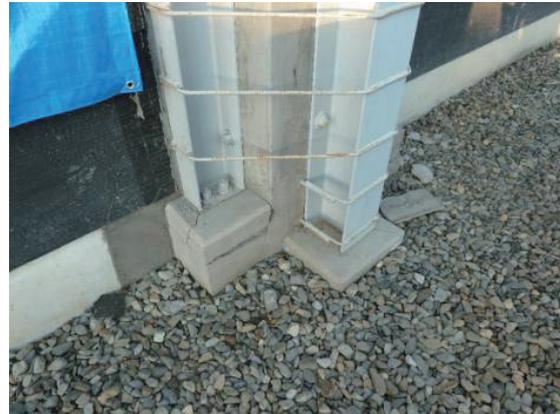
Photo 6.3-11 Column strengthened with H-shaped steel

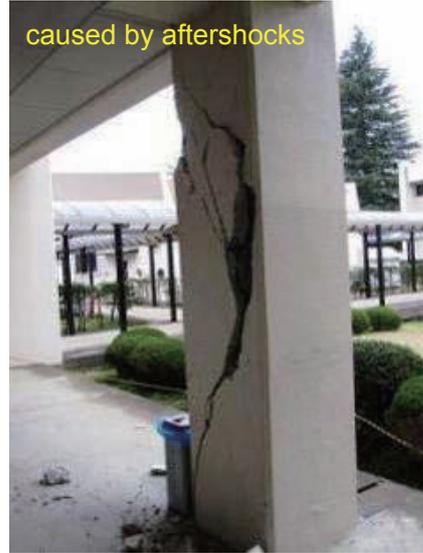
Photo 6.3-13 Shear cracks of first-story columns

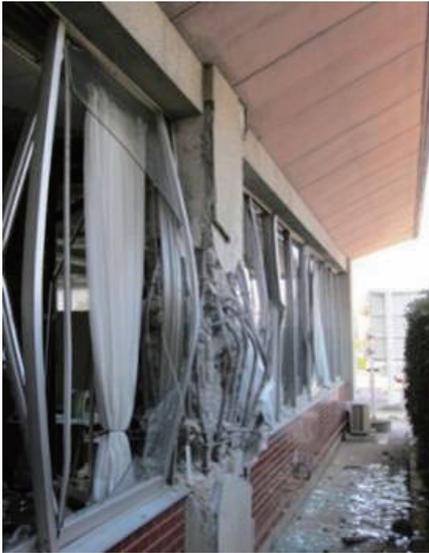
Photo 6.3-15 Shear failure of short column

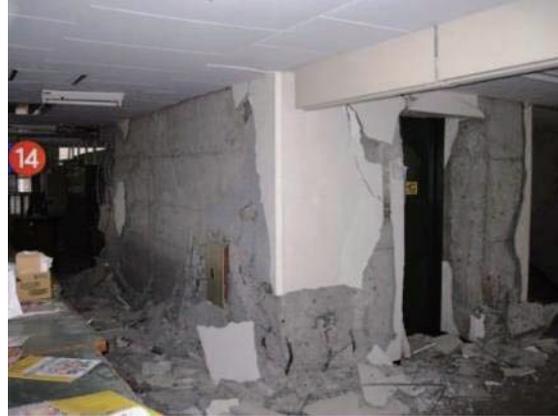
Photo 6.3-16 Failure of shear wall

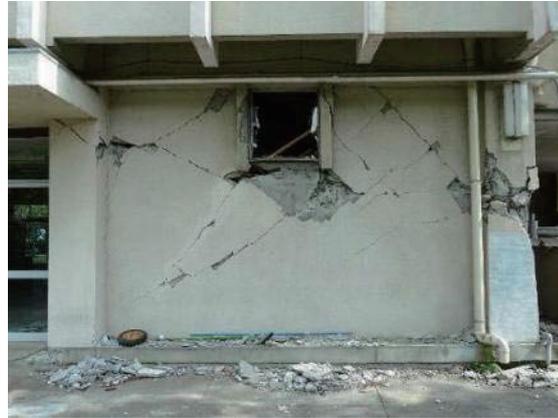
Photo 6.3-19 Shear failure of wall with opening

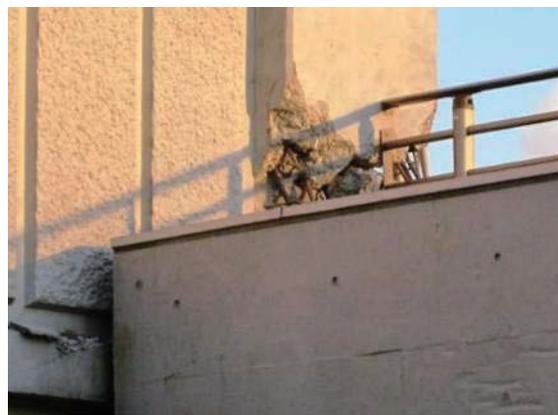
Photo 6.3-21 Crushing at the bottom of column of the multi-story shear wall

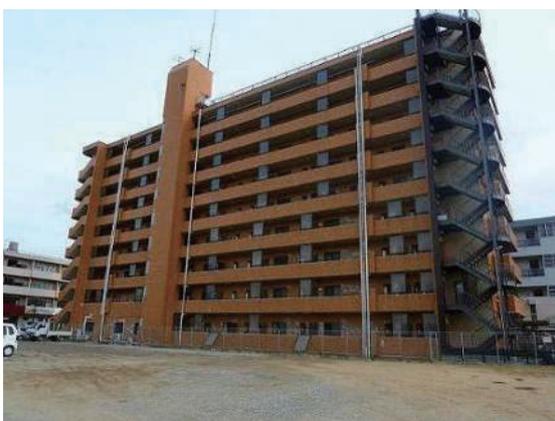
Photo 6.3-22 shows the appearance of a damaged building, which is the nine-story SRC residential building constructed in 1991 in Koriyama city of Fukushima prefecture. Pullout of anchor bolts, buckling of reinforcing bars and compressive failure of concrete occurred at the corner column and the bottom of multi-story shear wall in the first story, as shown in Photo 6.3-23, and shear cracks and bond splitting cracks were observed on the first story columns.

Photo 6.3-22 Appearance of damaged building (Koriyama city)

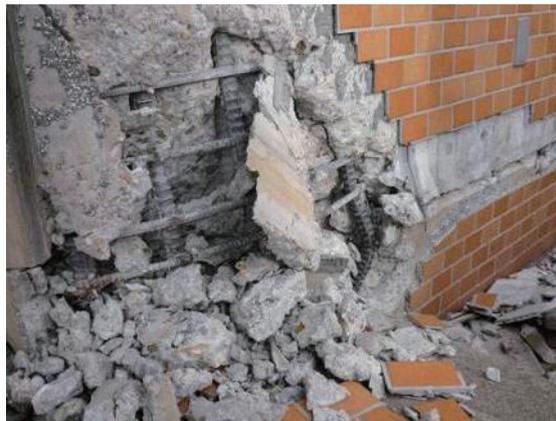
Photo 6.3-23 Damage at the bottom of SRC column

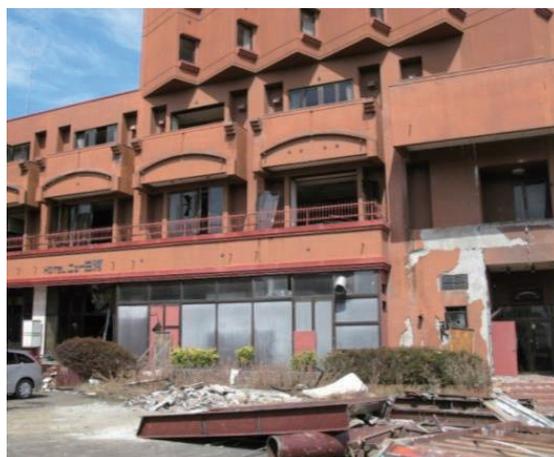
The damage at the bottom of SRC column and shear wall was also observed on a building in Shirakawa city shown in Photos 6.3-24 and 6.3-25, which was composed of RC and SRC structures. Pullout of anchor bolts of the exposed-type column base occurred. In consequence, the reinforcing bars were forced to stretch large and the buckling of them occurred around the base plate, as shown in Photo 6.3-26.

Photo 6.3-24 Appearance of damaged building (Shirakawa city, Fukushima pref.)

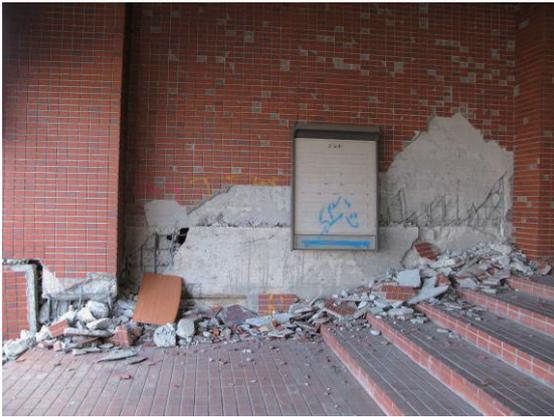
Photo 6.3-25 Damage of the bottom of SRC column and shear wall

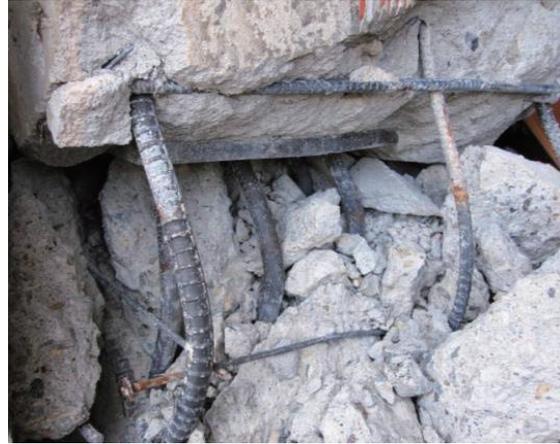
Photo 6.3-26 Close-up view of the bottom of SRC column

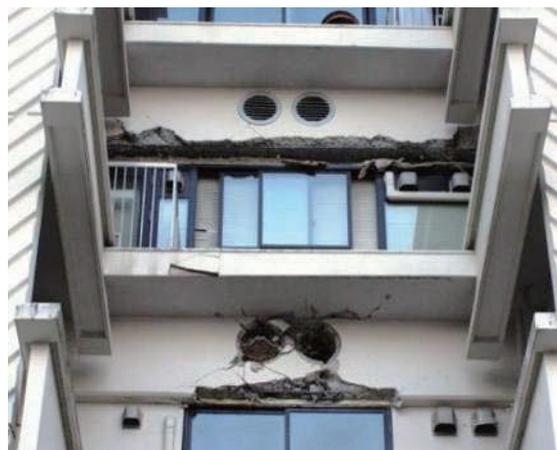
Photo 6.3-28 Damage of boundary beam with opening

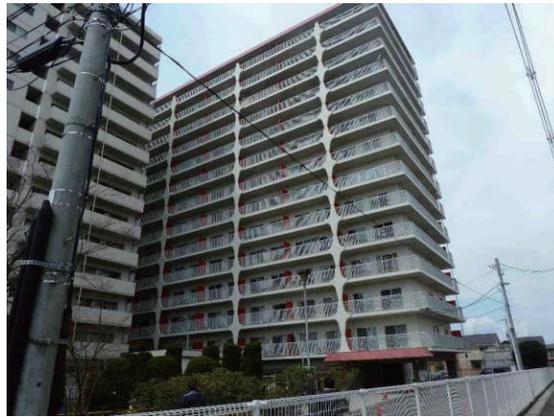
A fourteen-story RC building shown in Photo 6.3-29 was settled down and was tilted about 1/70 radian. The building is one of two residential buildings located in L-shape with expansion joint in Miyagino ward, Sendai city. The shear cracks on the nonstructural walls over every story and some parts of mullions occurred in both buildings as shown in Photos 6.3-30 and 6.3-31, which damage was classified as B-2). Though the other building without inclination had same shear cracks on the nonstructural walls from first to sixth story in the Miyagiken-oki Earthquake in 1978 and had been repaired with concrete replacement, almost same damage was happened on the similar part.

Photo 6.3-29 Appearance of tilted building (Miyagino ward, Sendai city)

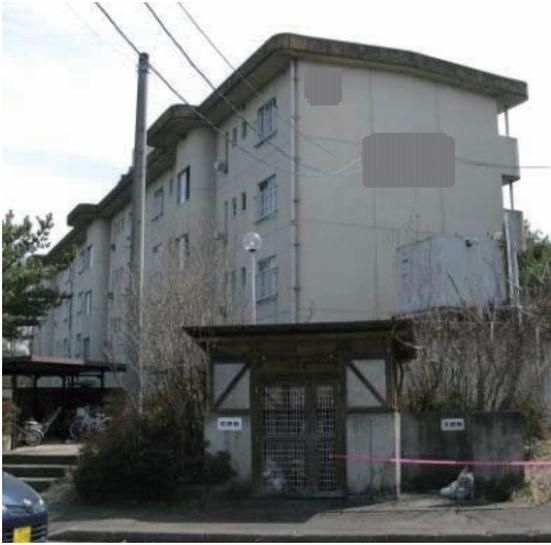
Photo 6.3-32 Appearance of sunken and leaned building (Shirakawa city)

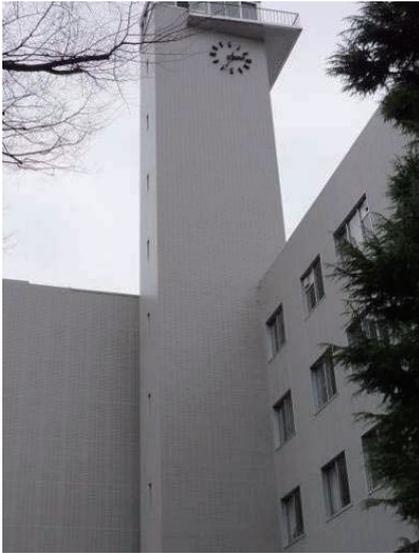
Photo 6.3-35 Damaged clock tower (Fukushima city)

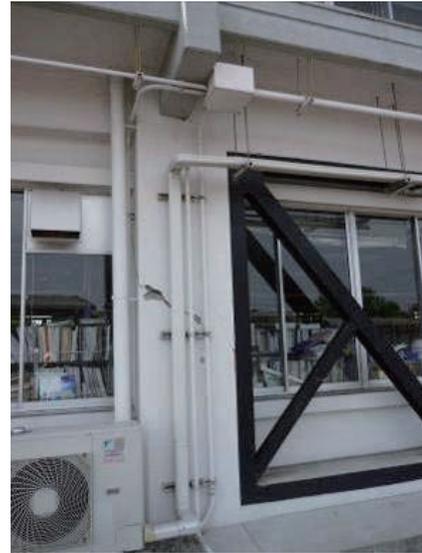
Photo 6.3-38 Shear crack on column with framed steel braces

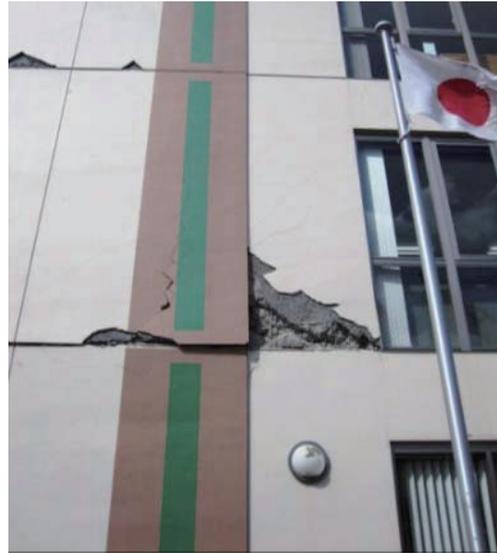
Photo 6.3-40 Separation of concrete of wing wall

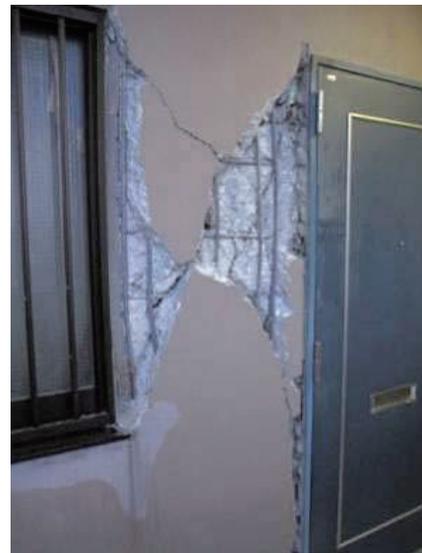
The nonstructural walls around the front doors from lower to top floors were subject to shear failure, while the doors were deformed on a ten-story SRC residential building constructed in Aoba ward, Sendai city in 1996, as shown in Photos 6.3-41 and 6.3-42. In addition, shear cracks were observed on the mullion walls on balconies in some of the lower floors.

Photo 6.3-42 Shear failure of nonstructural wall

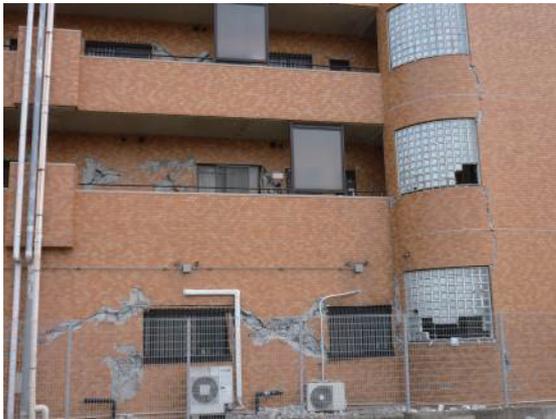
The cases where shear cracks occurred on the nonstructural walls around the front door or on the mullion wall of the balcony were relatively often observed in urban residential buildings, regardless of application of the seismic design codes.

Photo 6.3-43 Damage of nonstructural wall in same building shown in Photo 6.3-22 (Koriyama city, Fukushima pref.)

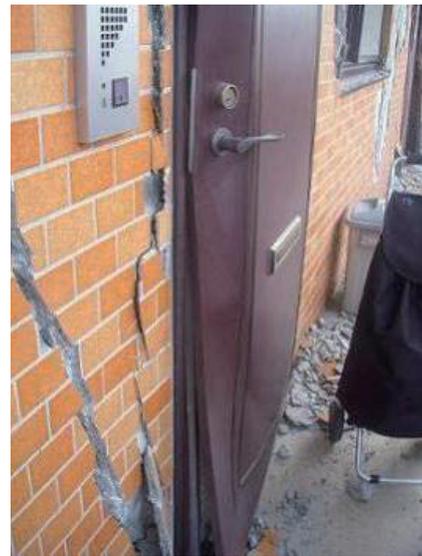
Photo 6.3-44 Damage of nonstructural wall and deformed door in same building shown in Photo 6.3-22

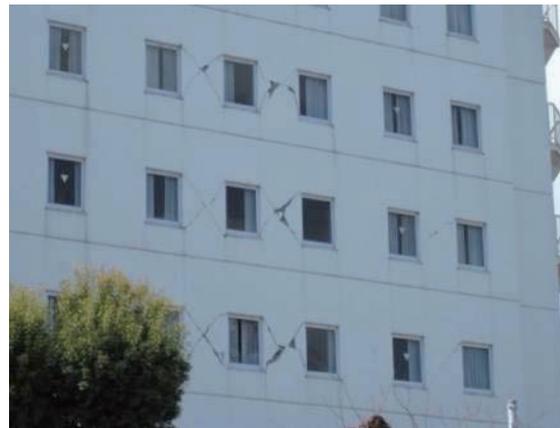
Photo 6.3-46 Shear crack on nonstructural wall

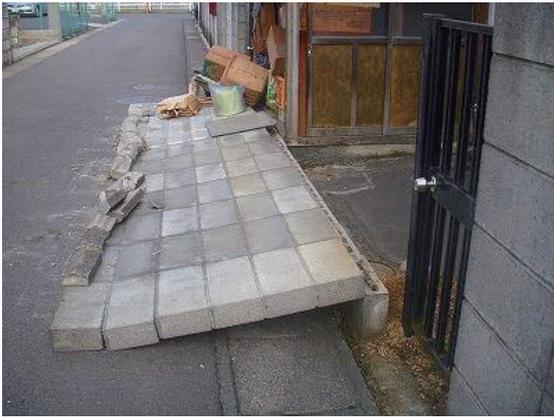
The collapse of concrete block wall and stone masonry wall are well known as earthquake damage caused by strong seismic motion. The damage of that type was often observed in the field investigation, as shown from Photo 6.3-50 to Photo 6.3-53.

Photo 6.3-50 Collapse of concrete block wall (Koriyama city)

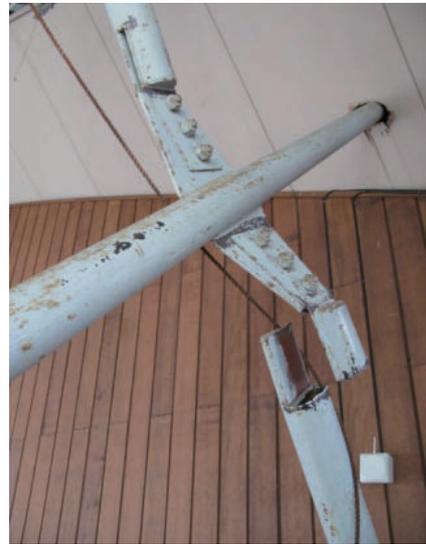
(b) Fracture at brace crossing

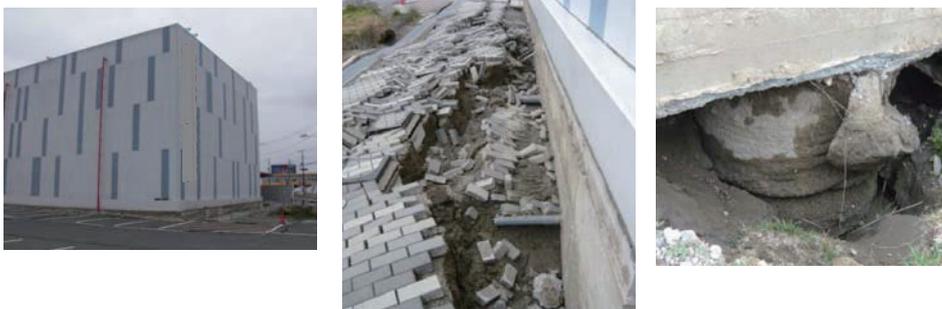
Photo 6.5-1 Situations around the commercial building and state of pile head

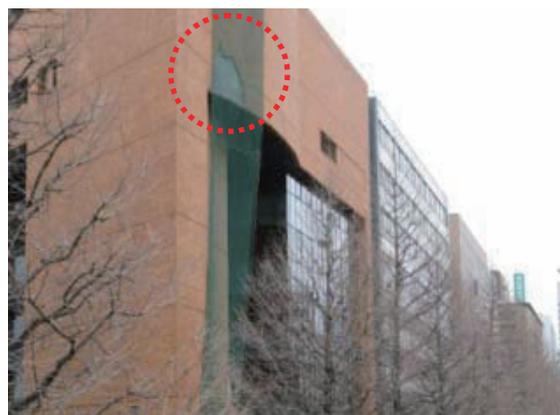
Photo 6.6-2 Detachment of ceramic wall tiles from RC wall

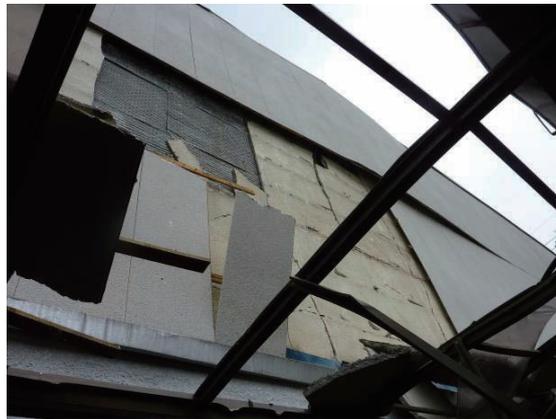
Photo 6.6-5 Damage to gymnasium gable end wall

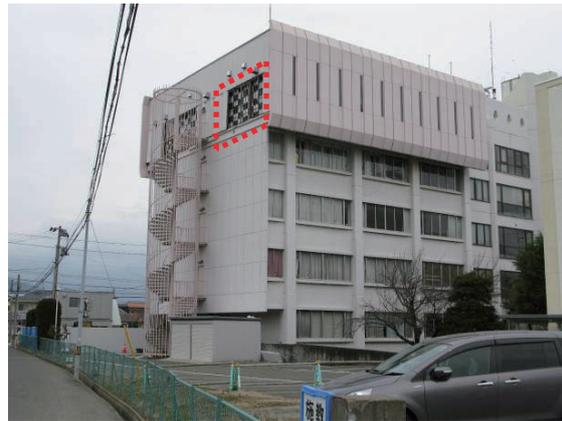
Photo 6.6-7 Detachment of AAC panels

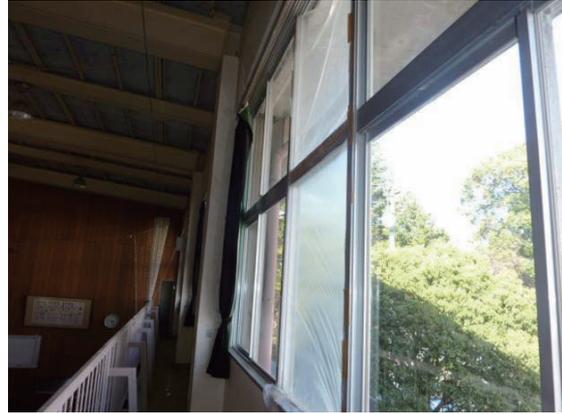
Photo 6.6-10 Breakage of window glasses installed to fixed window frame with glazing bead

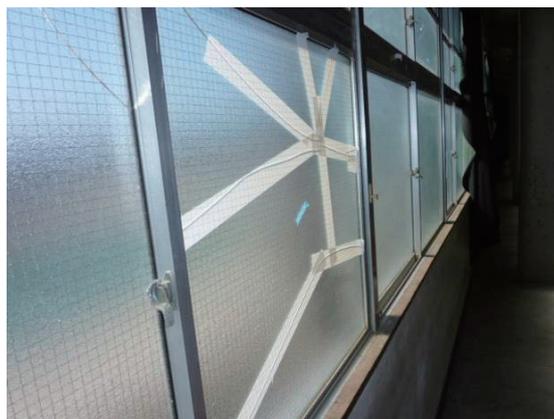
Photo 6.6-11 Breakage of wired window glass installed to double sliding window frame with glazing bead

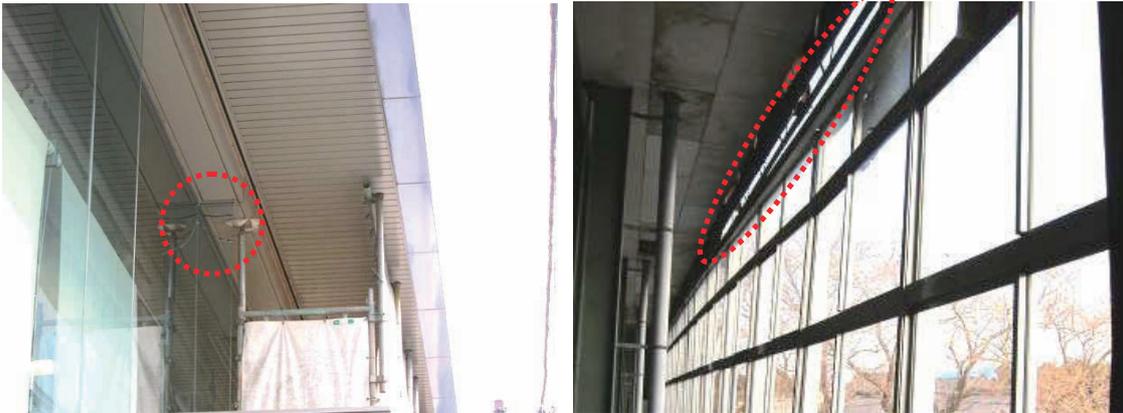
Photo 6.6-12 Breakage of glass mullion of glass wall system      Photo 6.6-13 Dislocation of window frame

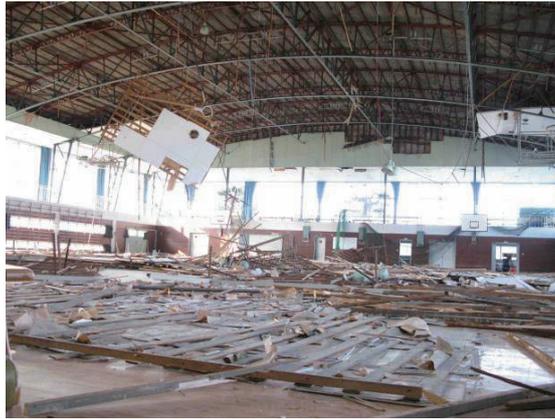
Photo 6.6-14 Falling of wooden suspended ceiling

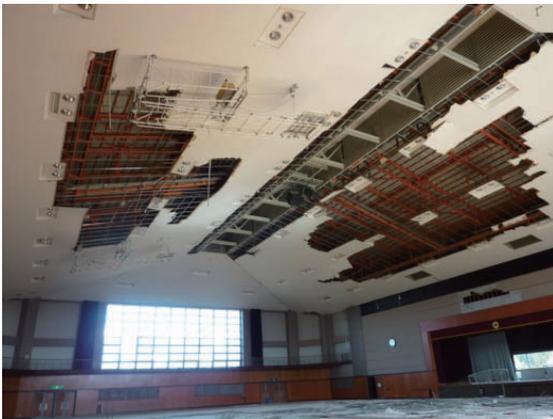
Photo 6.6-15 Falling of metal furring suspended ceiling

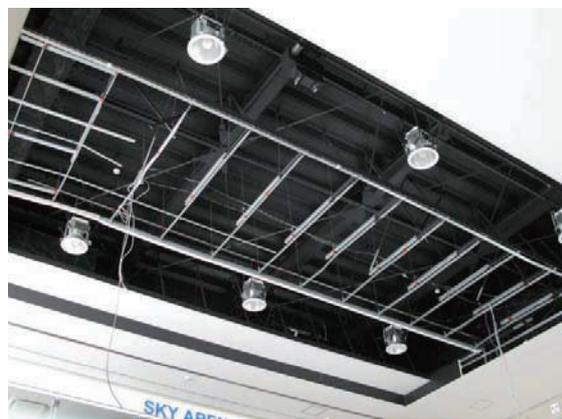
Photo 6.6-16 Falling of metal furring suspended ceiling

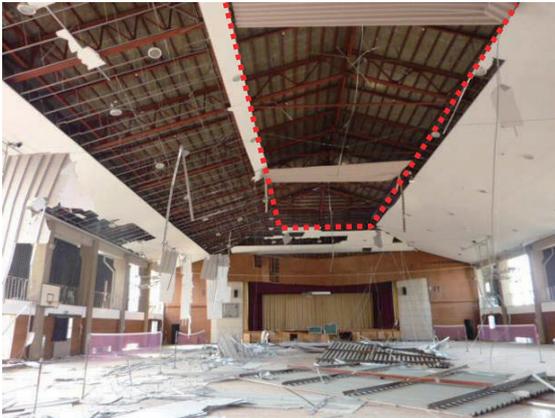
Photo 6.6-17 Falling of metal furring suspended ceiling and corrugated steel plates

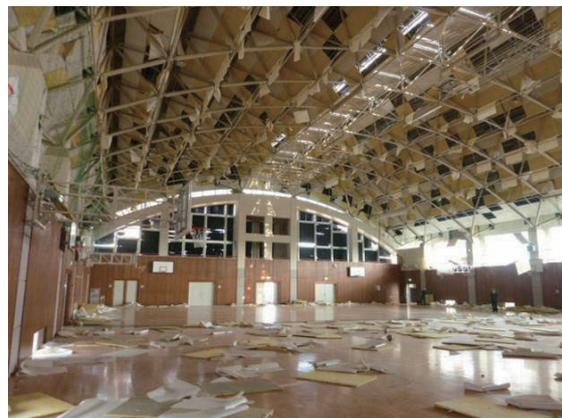
Photo 6.6-18 Falling of glass wool board of T system ceiling

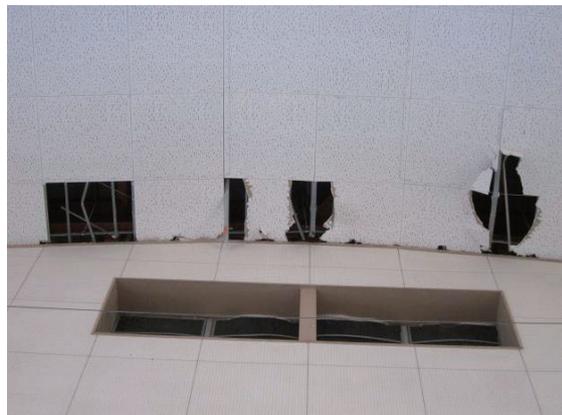
Photo 6.6-20 Damage to metal furring ceiling at the connection wall

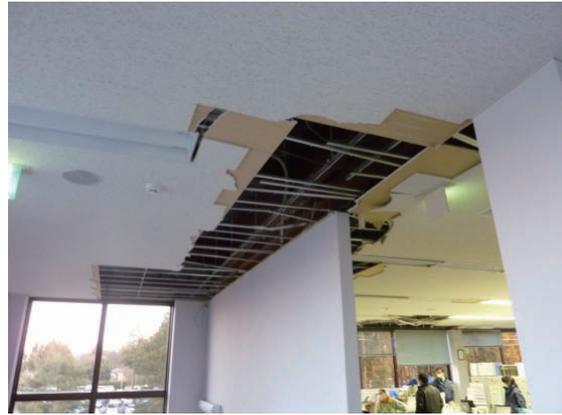
Photo 6.6-22 Damage to metal furring suspended ceiling at the connection

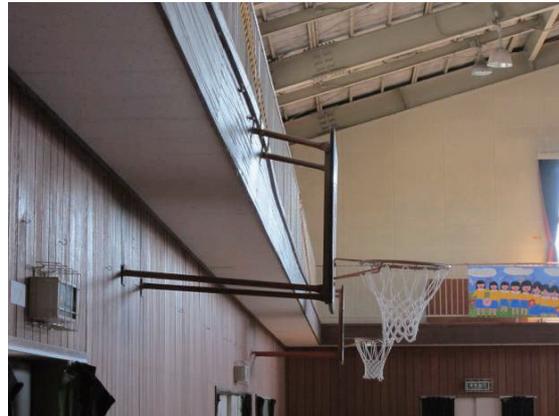
Photo 6.6-25 Damaged interior wall

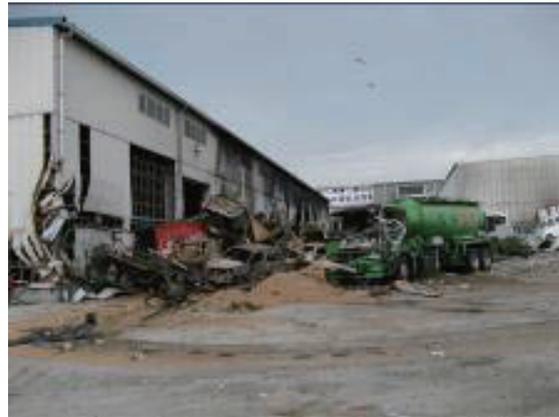
Photo 8.2-2 Tsunami fire at a port warehouse (Sendai city, Miyagi prefecture)

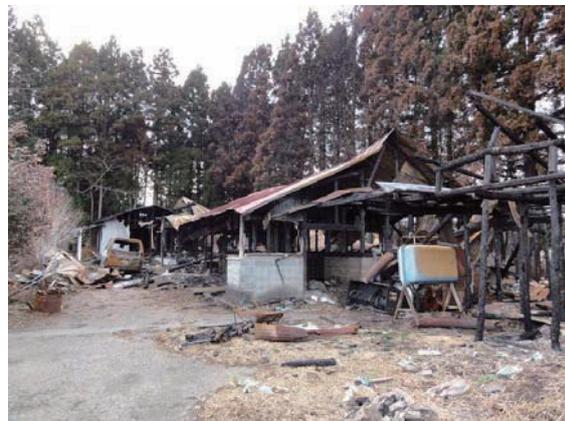
Photo 8.3-1 Fire scene of a house (Oushu city, Iwate prefecture)

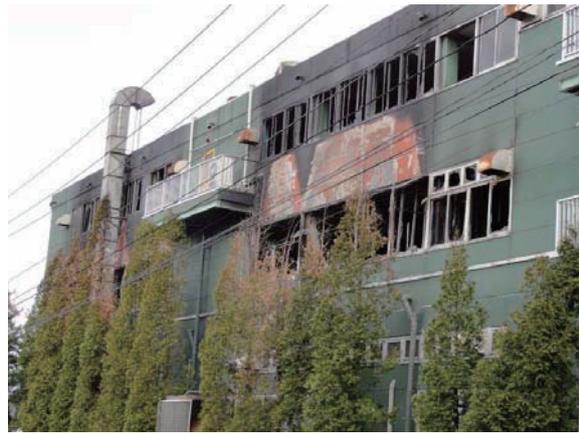
Photo 8.3-2 Fire scene at a factory building (Oushu city, Iwate prefecture)

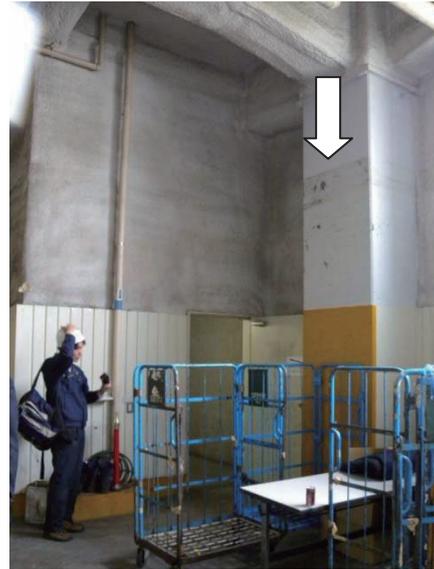
Photo 9.2-7 Trace of tsunami water

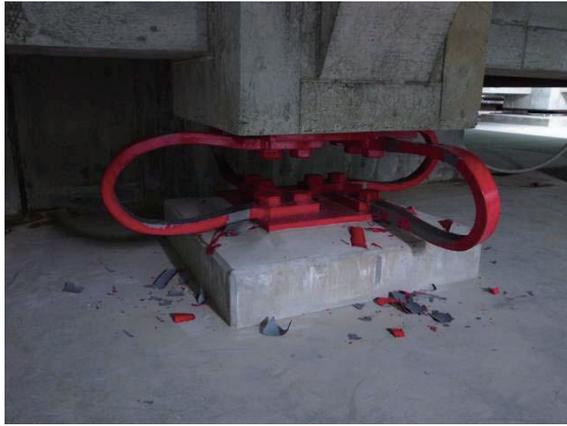
(a) Peeling off of paint
