The Great East Japan Earthquake Damage Report

The Building Research Institute of Japan has conducted an extensive survey of the damage caused to buildings and homes by seismic motion and tsunami waves during the 2011 Great East Japan Earthquake, and offers this report. (Detailed data including damage due to tsunami: <http://www.kenken.go.jp/english/index.html>)

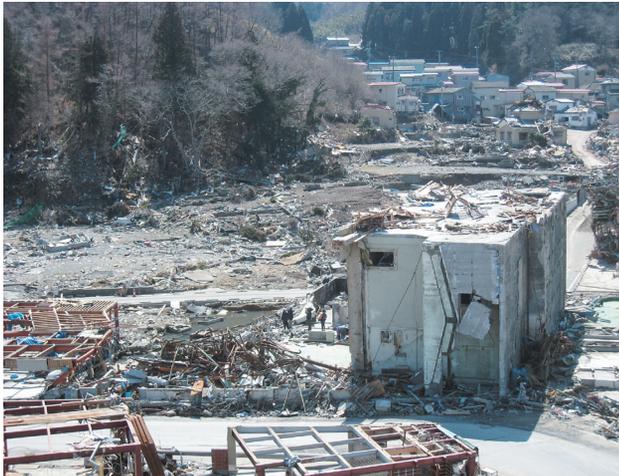
The tsunami swept away all the wooden and low-rise buildings in this coastal area of Onagawa, Miyagi Prefecture, except for a solitary reinforced concrete building.

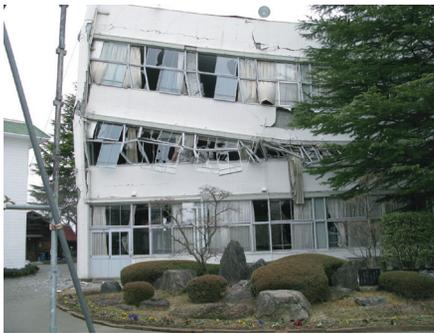
Photo 1: Mid-story collapse in a low-rise building

Most of the structural damage seen in this survey was largely consistent with earthquake damage observed in the past. For instance, major damage such as mid-floor collapses in low-rise buildings (Photo 1), first-floor collapses (Photo 7) of soft first-story piloti structures and column shear failure due to loss of vertical load carrying capacity (Photo 8) also occurred, but most of the structures

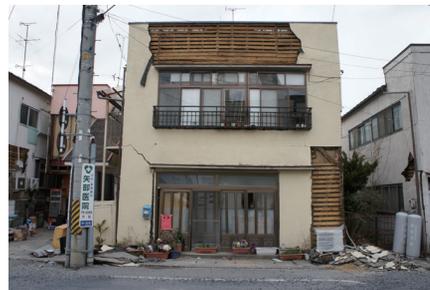
Photo 2: Fallen parts of exterior walls

motion, this includes roofing tile damage such as falling bricks or tiles, damage to interior materials and exterior walls (Photo 2), tilted buildings and story collapses (Photo 3). These forms of damage are largely consistent with the damage seen in past earthquakes.

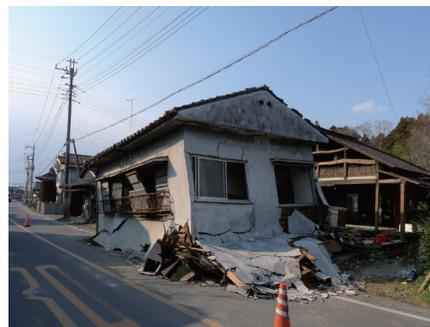
Photo 3: First-floor story collapse

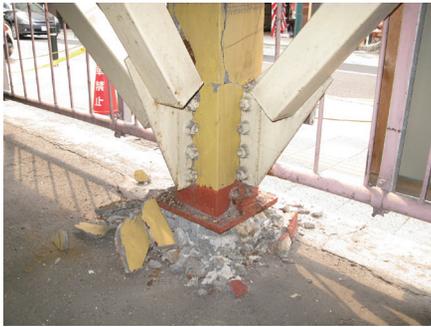
Photo 4: Damage to exposed column bases

In the exterior survey damage to general buildings of steel frame construction, we observed several cases of damage to the bracing structures of buildings such as parking lots, such as buckling of the bracing materials or damage to the bracing joints. Damage to the exposed column bases of parking lots was also observed (Photo 4). In the scope of this survey, no cases of critical damage such as fracture of major structural components like columns and beams were observed.

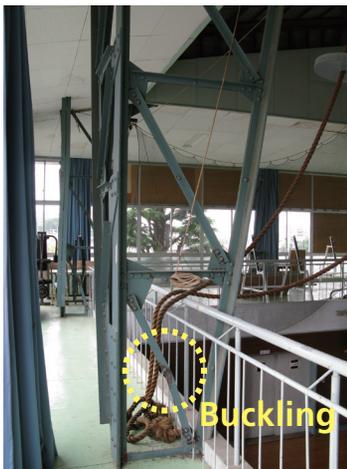
In the damage survey of school gymnasiums, etc. in Ibaraki Prefecture, we observed (i) buckling and fracture of vertical braces and fracture of joints (Photo 5); (ii) buckling in the diagonal bracing of lattice columns (Photo 6); (iii) damage to the joints between reinforced concrete columns and the roof (bearing support parts); (iv) curvature, buckling and frac-

Photo 6: Buckling of diagonal bracing of lattice columns (part shown with yellow dotted line)

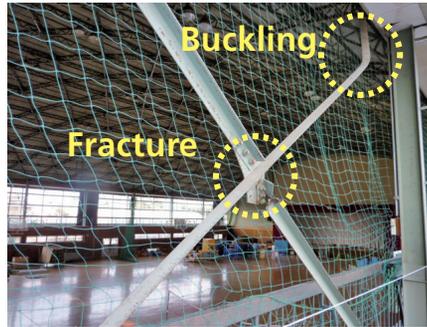
Photo 5: Buckling of bracing materials and joint fracture

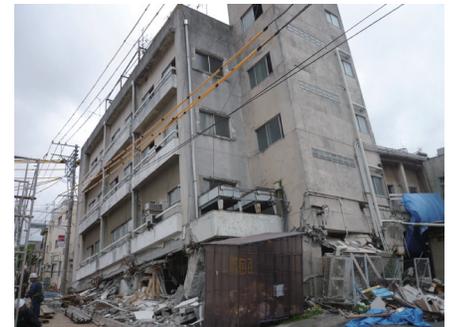
Photo 7: Floor collapse on the first floor of a piloti structure

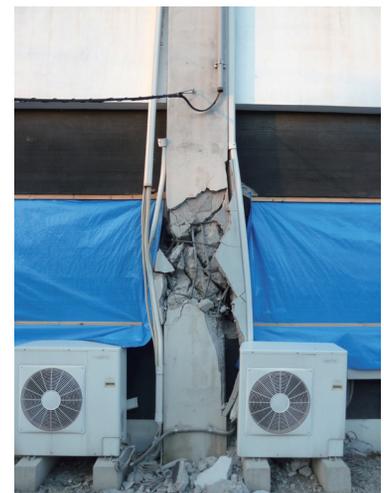
Photo 8: Shear failure

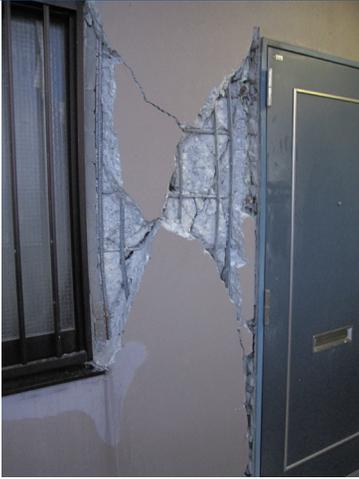
Photo 9: Non-structural shear failure

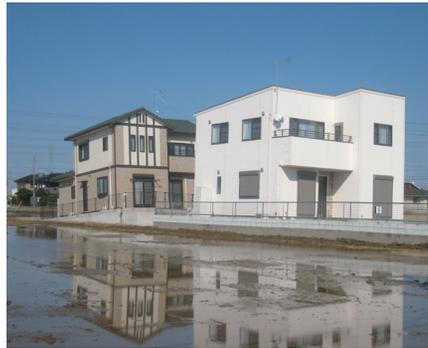
In the 2011 earthquake, building damage due to ground liquefaction occurred mainly in the bay area of the Kanto region. In our survey, we observed the widespread occurrence of damage such as sand boiling and ground deformation associated with liquefaction in the alluvial plain area along the Tone river on the border between Ibaraki and Chiba Prefectures and in the city of Urayasu, Chiba Prefecture. Buildings with severe tilting (Photo 10) were also seen, but within the scope of our survey, we did not observe cracked or damaged foundations from the exterior.

Photo 10: Tilting due to liquefaction

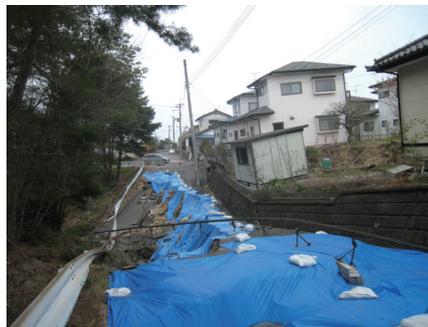
In Miyagi, Fukushima and Tochigi Prefectures, significant damage (Photo 11) associated with sliding of the soil occurred mainly in developed housing areas (at their periphery in particular). In some areas we saw that deformation occurred again on developed land that had been damaged by past earthquakes. There was also a case on residential land which suffered significant damage where the soil under the foundations had slid away, but where the foundations were still holding together.

Photo 11: Damage due to a landslide from a sloped edge

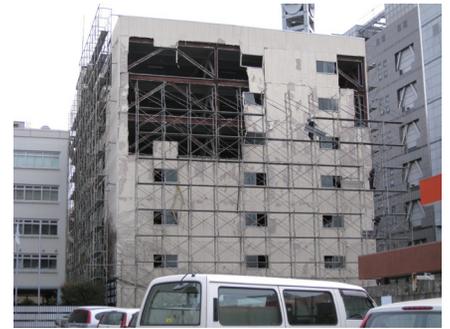
We observed extensive damage associated with exterior walls and curtain wall structures, including the shedding of exterior tiles from RC walls and the dropping of things like outer wall panels (Photo 12). We observed many buildings in which the glass from glass openings had broken. In gymnasiums, interior materials had been damaged or had fallen from the interior walls of the arena, and from the interior materials above the stage. The ceilings of gymnasiums built using a variety of construction techniques were also damaged, with the severity of damage ranging from small-scale damage along the edges to large-scale damage where entire ceilings fell down. At an airport terminal building where the lobby ceiling had fallen down (Photo 13), we observed that the layout of the roof and ground below was uneven and complicated.

Photo 12: Fallen exterior wall panels

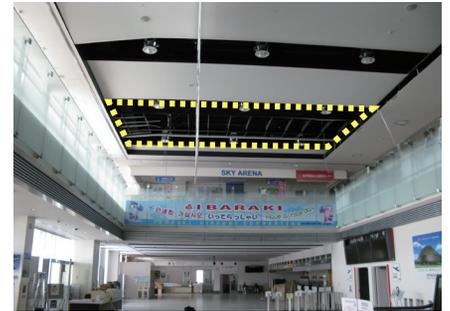
Photo 13: Fallen ceiling at an airport departure lobby (yellow dotted line indicates where the ceiling droppage occurred)
