*Collaborative Research and Development Project for Disaster Mitigation
in Earthquake Prone Areas in Asia*

**STUDY ON SEISMIC PERFORMANCE AND STRUCTURAL
INSPECTION OF RETAINING WALL**

Kosh Nath Adhikari

27 September, 2007

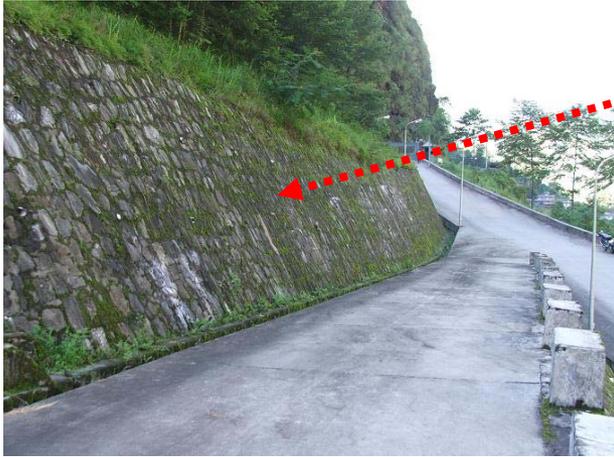
Stone masonry
Retaining wall with
clogged weep holes
due to weeds

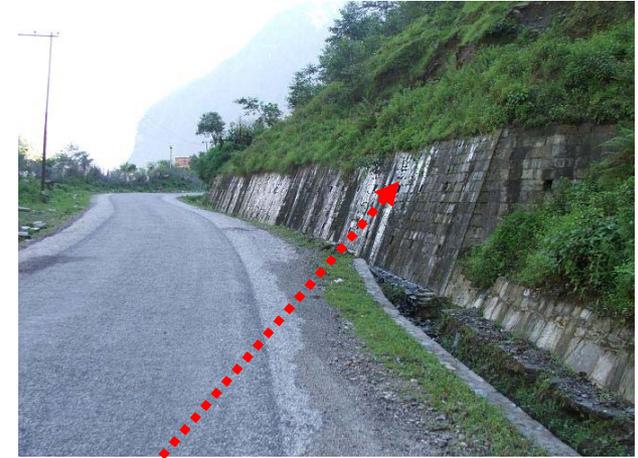
No provision of proper catch
drain in the upstream side of
Retaining wall and water flowing
over the wall

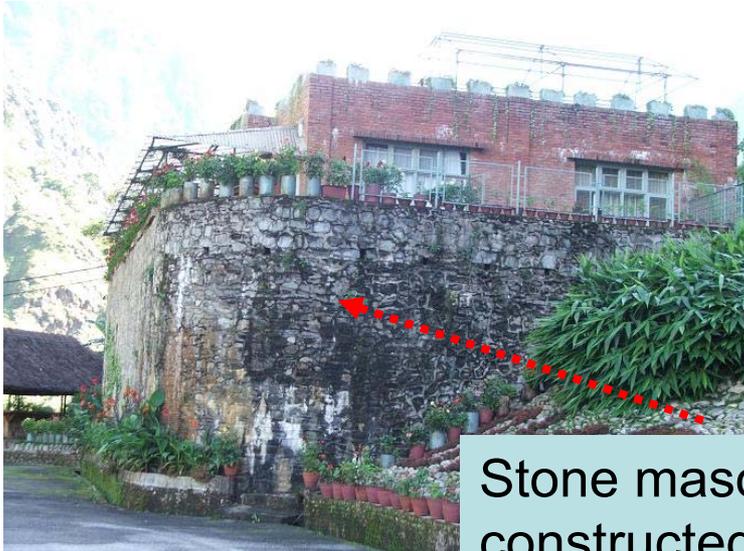
Stone masonry Retaining wall
constructed outer face vertically
to protect building from damage

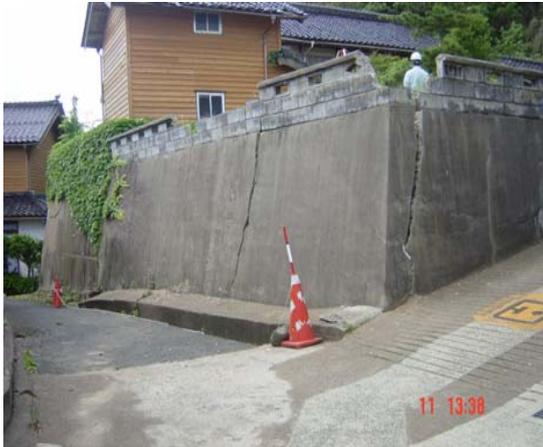
- Magnitude 6.9, 9:42 AM, On 25th March, 2007
- One person was killed, 170 people were injured
- Toge area has a steep slope more than 20° and retaining walls are found to be constructed for the construction of approach roads and houses to maintain the slope stability
- Lateral movement of retaining walls due to increased active earth pressure.

Lateral movement of retaining wall

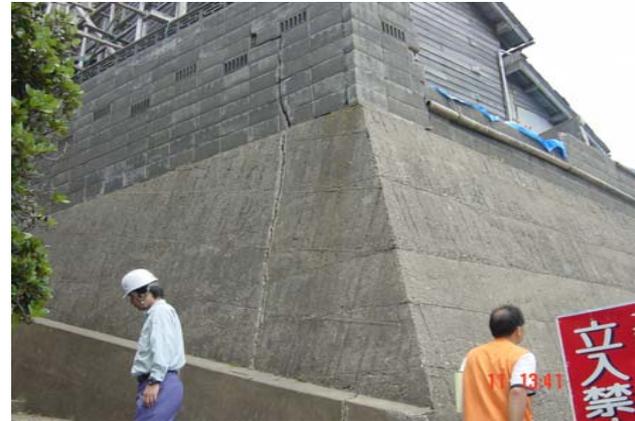
Vertical crack near the corner for vertically extended wall

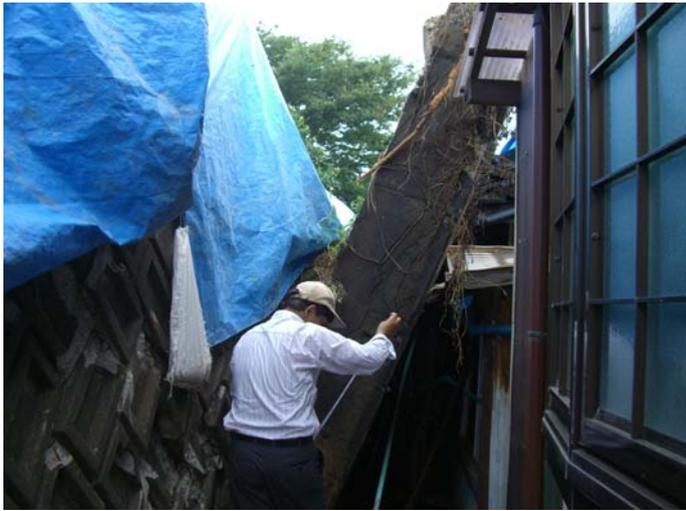
Overturning of retaining wall

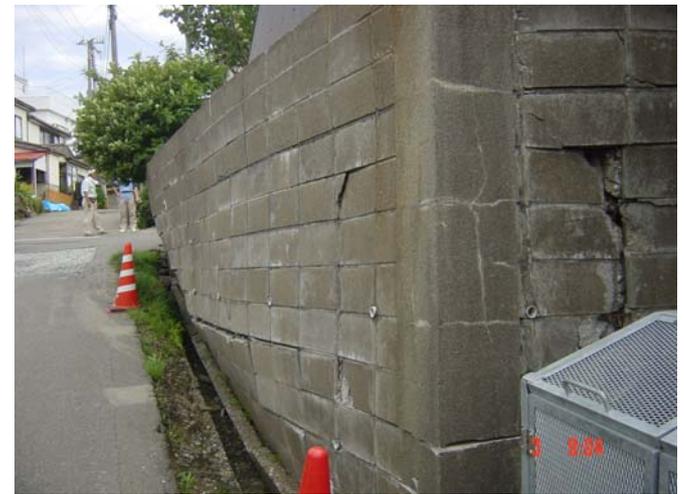
Failure due to insufficient thickness of hollow block wall

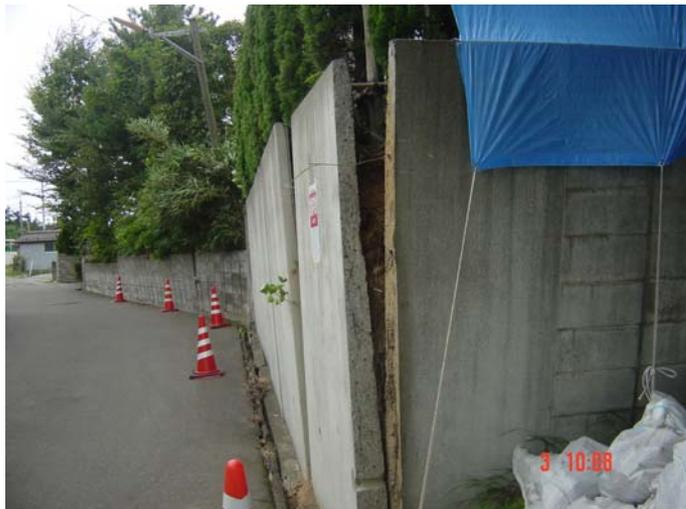
Tilted pre-cast concrete block retaining wall

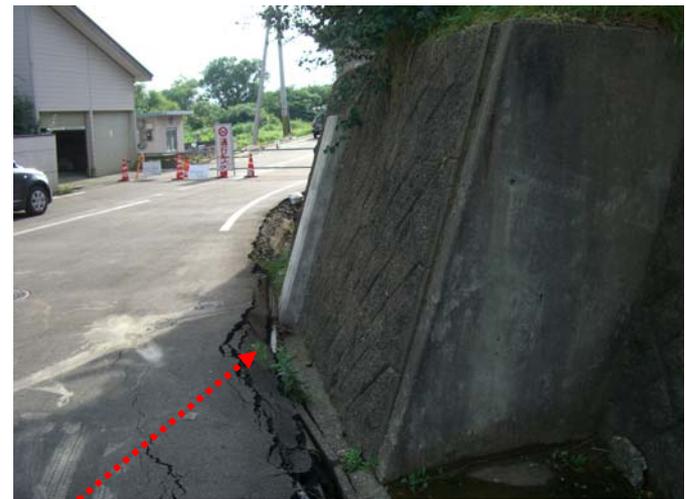
Sliding of retaining wall and crumbling of road side drain

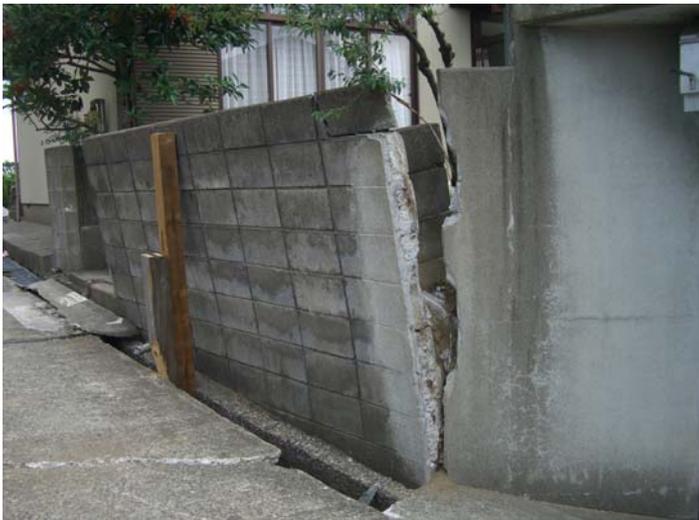
Corner splitting and tilted block compound wall

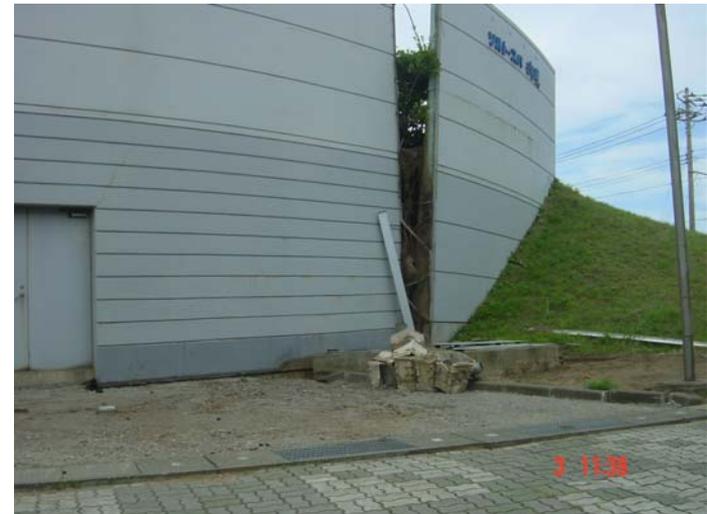
Sliding of RC retaining wall

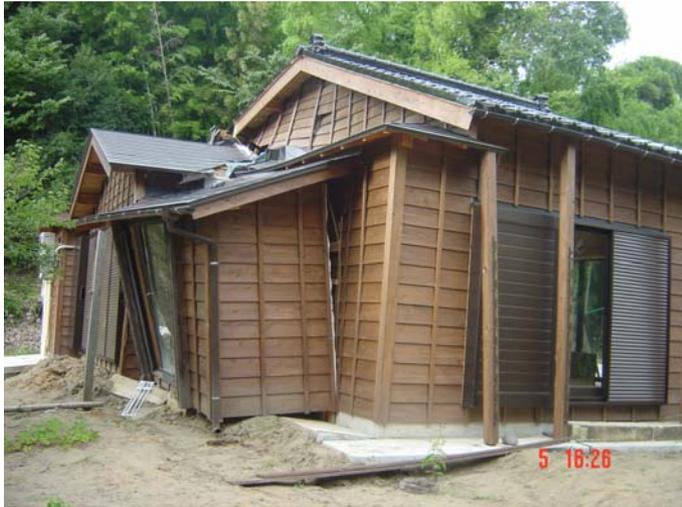
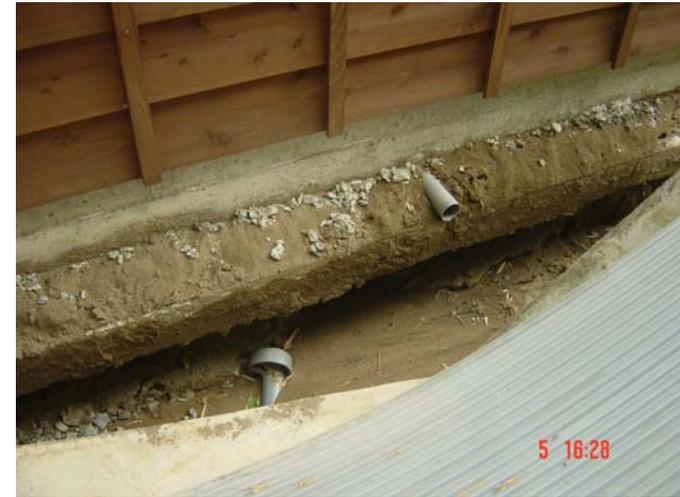
Karihamura area

Failure of newly constructed house at the foot hill due to slip, upheaval of ground and liquefaction

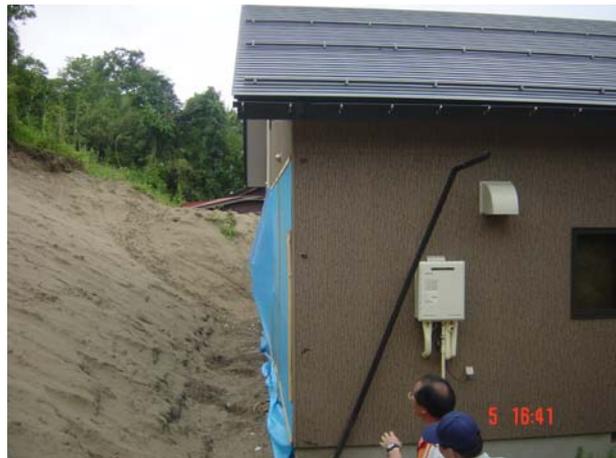
Less or no clearance between slope toe and house

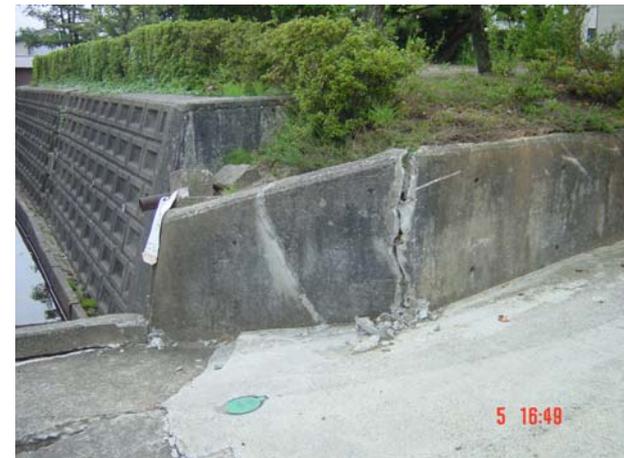
Cracking at corner of wall

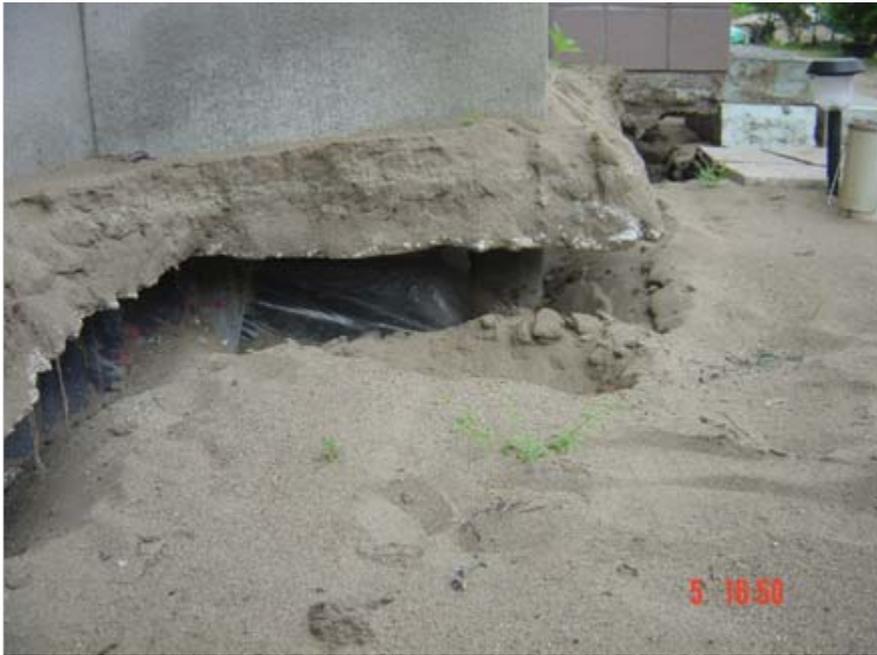
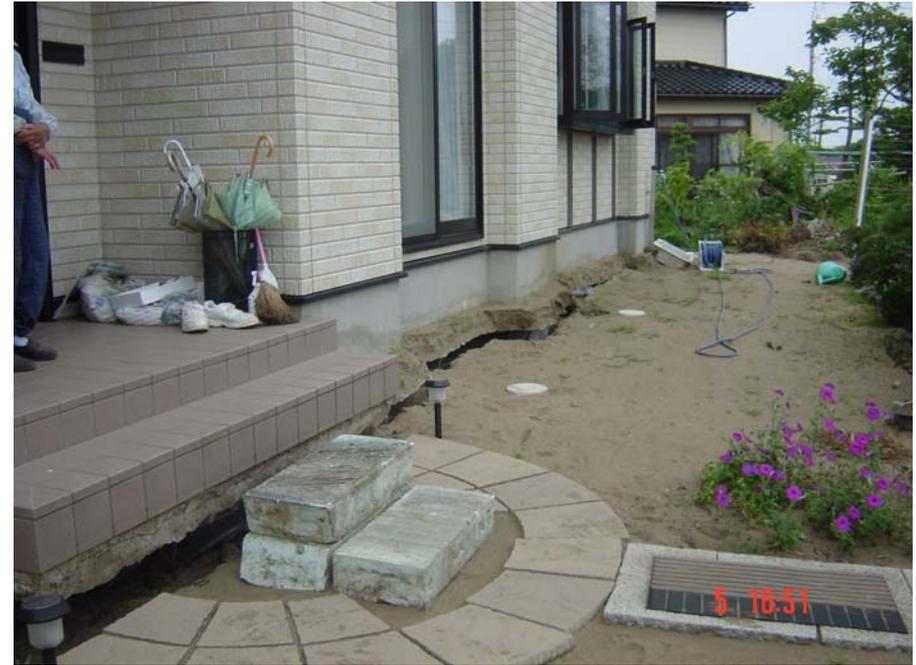
Settlement of ground due to combined effects of sliding and liquefaction

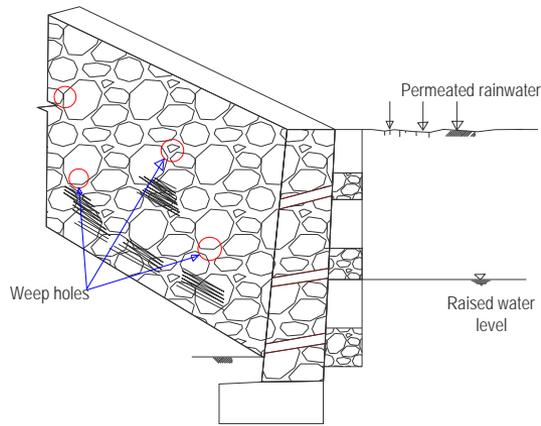
Wetted retaining wall

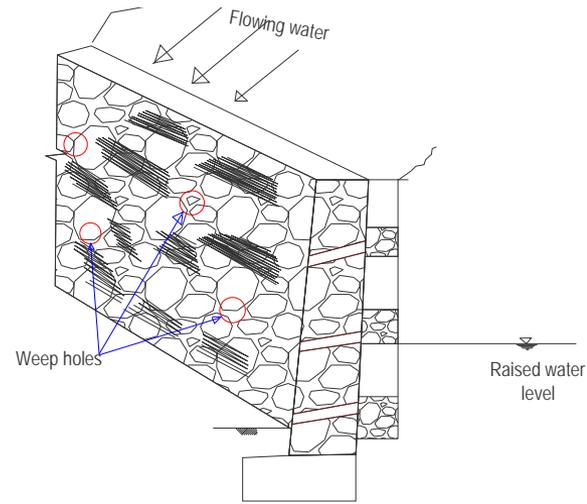
Flowing water over the retaining wall

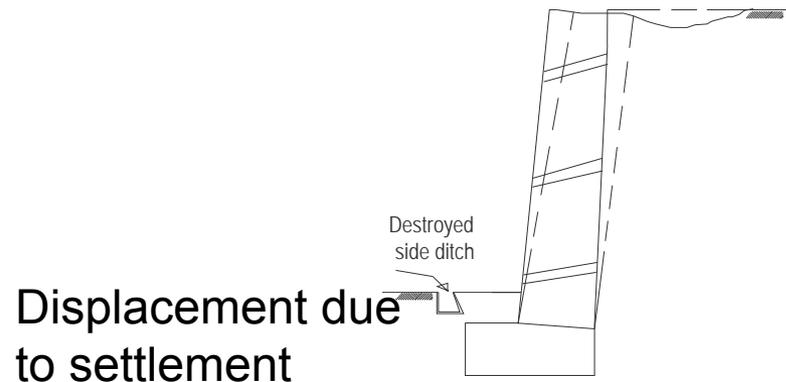
Crumbled side drain and tilted structure
