**Report on Monitoring of Construction Practices
of Confined Masonry Structure in Peru**

NPO EVAA
 (Ex-volunteers association for Architects)
 Shizuko Matsuzaki

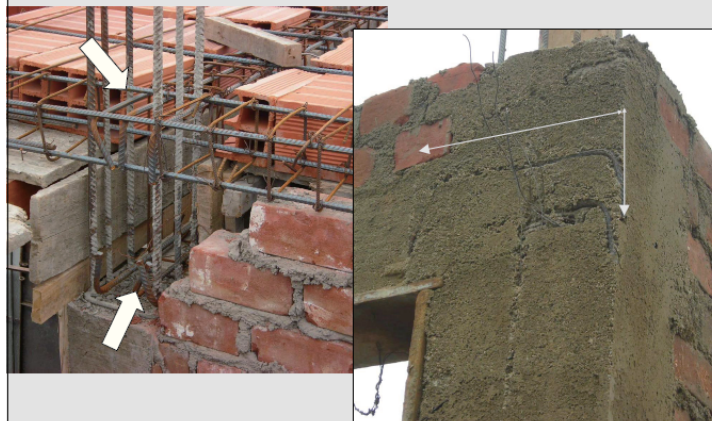
(3) Beams and Columns

Lack of anchorage of beam's reinforcement

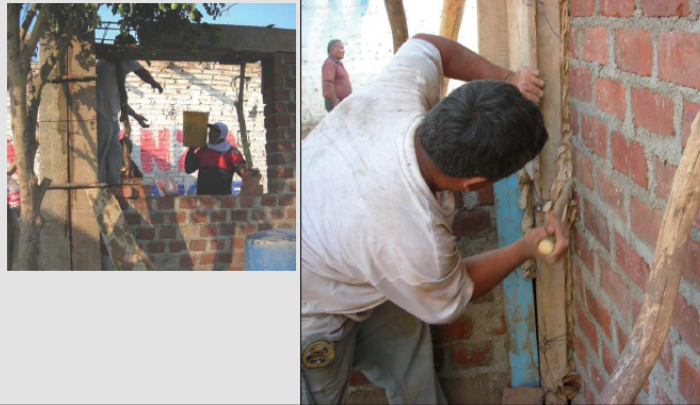
(4) Pouring Columns

Incorporation of foreign object

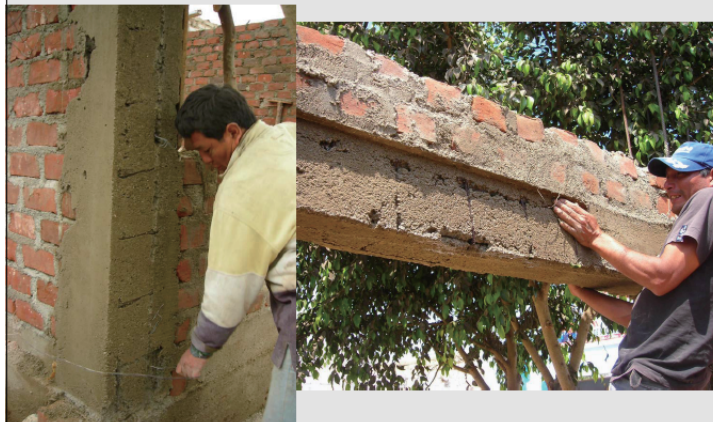
(5) Formwork Removal

Lack of covering for steel reinforcement

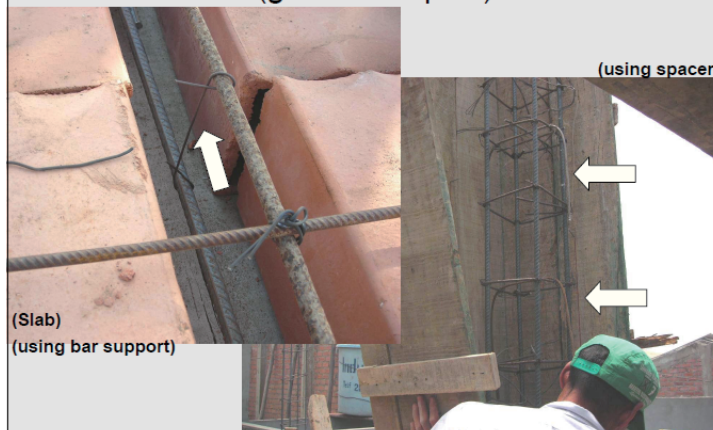
For protective covering of steel reinforcement
(good examples)
