Preliminary Reconnaissance Report of the Chile Earthquake 2010

Hiroto Kato, Seitaro Tajiri**
Department of Structural Engineering, Building Research Institute, Japan

Preface

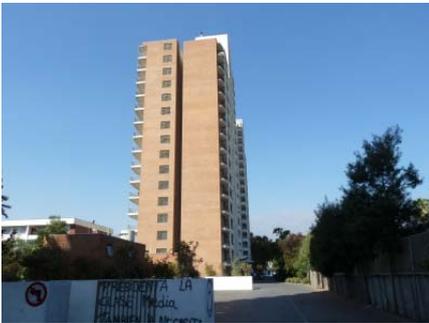
A condominium has 18 floors (2 basements) with RC wall construction. A similar building is in front of Photo 2-1 and the basements for parking garage are between two buildings. Most of RC walls in span direction were smashed at the upper part of walls on the first level basement (Photo 2-2 and Photo2-3). Axial reinforcement is D25 and hoop is D8 ^{#3}. Extensive damage happened on a part of capitals and streamed through the slab at the first floor (Photo 2-4).

Photo 2-1 Appearance

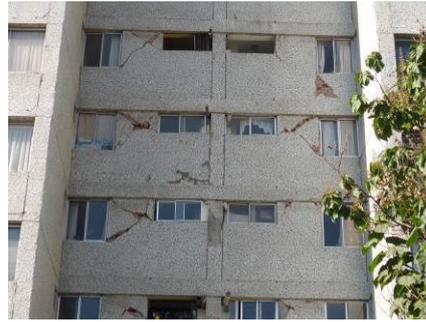
Photo 5-1 shows a high-rise condominium with RC construction and the number of floors is 22 with 38 years after construction. The exterior of nonstructural brick walls were cracked almost all floors as shown in Photo 5-2. Notable damages could not be seen in structural members.

Photo 5-2 Damaged outer wall with bricks

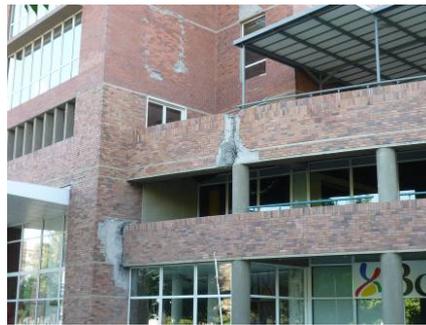
This is an accommodation with 12 floors and only appearance was investigated since access to this building was prohibited (Photo 6-1). The beam-ends of low-rise building, the joint part with high-rise building, and the joint parts of column capital were damaged (Photo 6-2). According to an investigator of this internal building, some crush occurred on RC angle posts at the basement.

Photo 6-2 Damaged wall beam

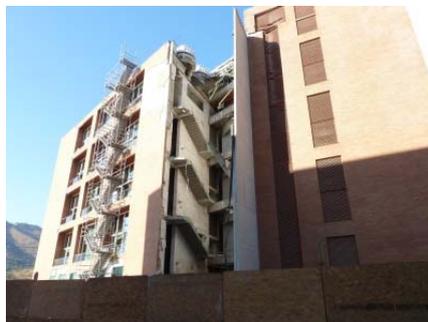
This building group is a commercial establishment with five floors and with other four (Photo7-1). The blindfold wall of external staircase was crumbled. The short spanned wall beams because of nonstructural wall were severely damaged and a part of beam-column joint were broken (Photo 7-2). The penthouse was inclined because of the slab just below was crumbled (Photo 7-3). Earthquake induced ground deformation could be seen on its property (Photo 7-4).

Photo 7-1 Appearance (crumbled external staircase)

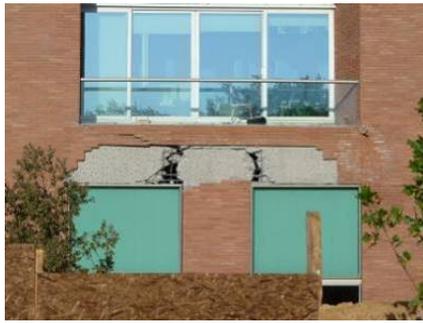
Photo 7-2 Damage on beam and beam-column joint

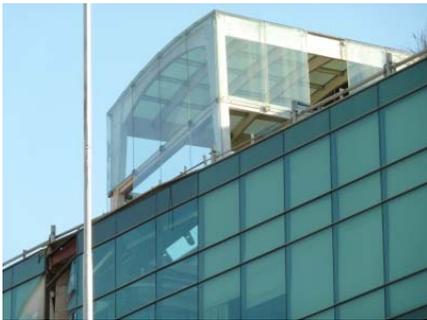
Photo 7-3 Crumbled penthouse

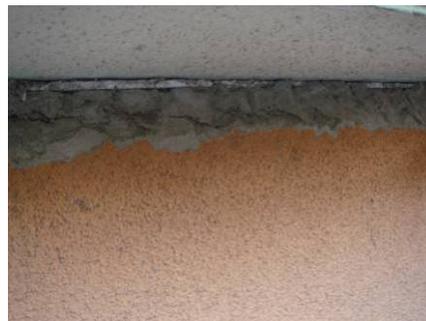
Photo 10-3 Fillers like polystyrenes

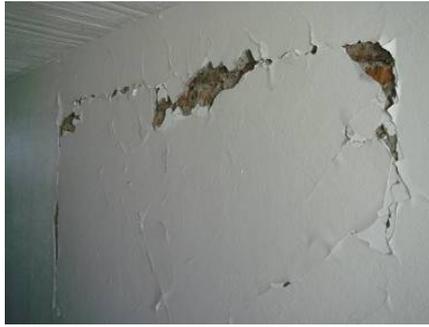
SERVIU requested IDIEM for damage investigation and already completed. A document posted at the entrance shows the inspection results and precaution statement (Photo 12-2). Cracks were appeared on masonry walls in double-loaded corridor and party wall, and some parts were completely fallen off (Photo12-3). This building was kept using through earthquakes happened in Chile in 1960 (Mw9.5) and in 1985 (Mw7.8). Renovation of cracks was found on masonry walls. Meanwhile, some cracks occurred on beam elements, which support the external staircase landing, and vertical deformation with long-term loadings on them were observed (Photo12-4). In other building, a roller supported beam at roof was fallen off because of the earthquake (Photo 12-5), and should be taken measures as a part of reinforcement work.

Photo 12-3 Damages of masonry walls

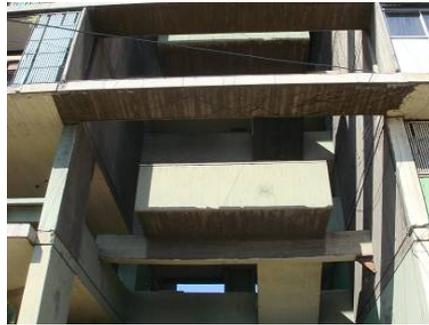
Photo 12-4 Cracks and deflection of beam at external staircase landing

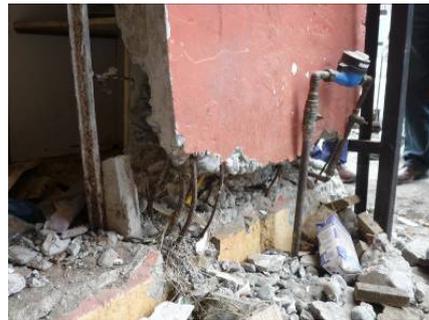
Shear failures of transverse wall were found, and the floor height was down in a building out of four (Photo 15-2). There were rock pockets and rusted reinforcing bars in the broken part. Beam of top of transverse wall came down in another building (Photo 15-3 and Photo 15-4).

Photo 15-2 Shear failure of transverse wall

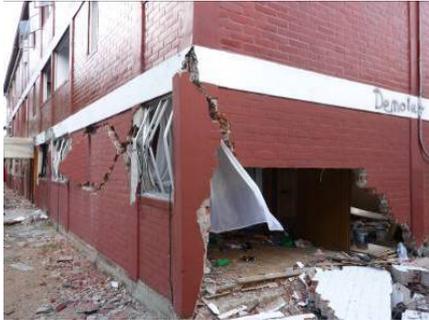
There are four apartment houses of SERVIU with CM structure and three floors constructed 16 years ago on a gentle hillside. Hollow bricks composed the walls, and horizontal reinforcements were arranged in masonry joint every 4-5 layer in longitudinal direction, but nothing in span direction. Walls at the first story suffered from shear failure at the highest building, and almost all columns were severely damaged and smashed (Photo 17-1). Shear cracks were found in one building out of two which separated by Expansion Joint (EXP.J, almost no space), but not so big damage (Photo 17-2).

Photo17-1 Damaged transverse wall and longitudinal direction wall

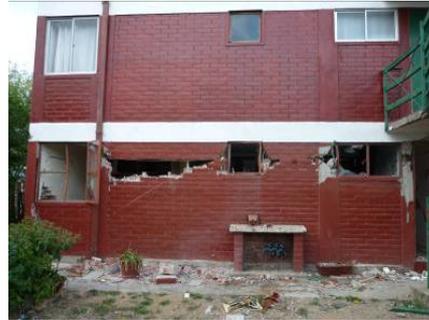
Photo 17-2 Shear cracks of longitudinal direction wall (Another building)

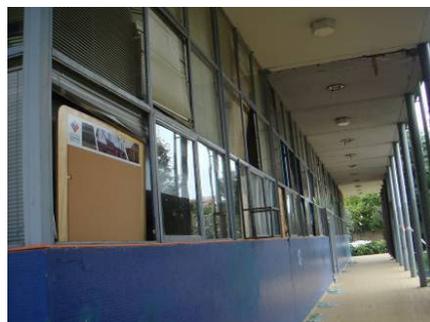
Photo 20-2 Longitudinal direction outer and broken windows

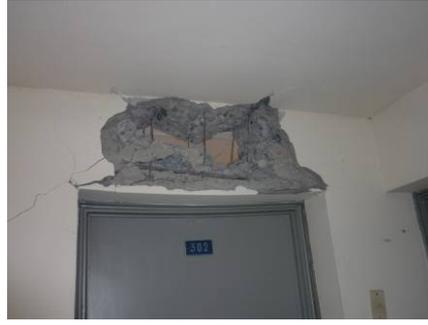
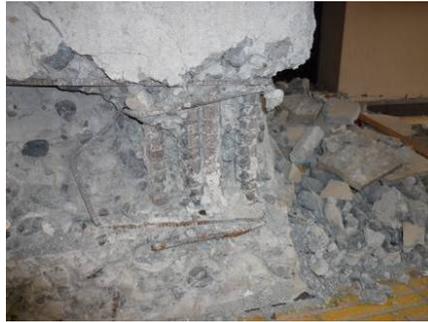
A SERVIU office building of RC structure in Talca with 30 years after construction had six floors (top three floors are apartment), and steel columns composed the outer frames in longitudinal direction (Photo 20-1). Broken windows were scattered on outdoor passage (Photo 20-2). Shear failure of masonry walls at the front, RC bearing walls, and most short span beams of top of the door were observed (Photo 20-3). Four axial reinforcements were arranged in wall edge, but the spacing of reinforcement was narrow (Photo 20-4).

Photo 20-3 Shear failure of bearing walls and short span beam

Photo 20-4 Bar arrangement in wall edge

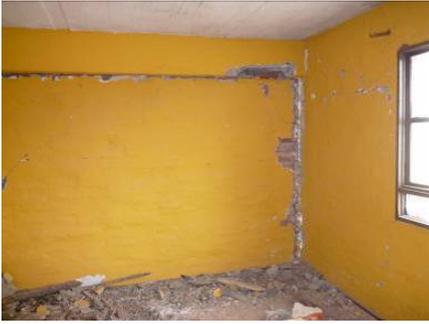
This is a public housing for low-income group with 50 years after construction, and the dimension is long side 47.4m x short side 7.7m and five floors with RC construction (Infilled Wall structure, Photo 21-1). Back of the front wall in Photo 21-2 is an adjacent house, and those were built with EXP.J without any space, so masonry structure walls were damaged because of shock and vibration of the earthquake and almost fallen from the RC structure. Other than above, damages of nonstructural brick walls, and exposure of reinforcing bars of transverse wall edges were found (Photo 21-3). Damages seem moderate, but SERVIU officials told this housing would be demolished.

Photo 21-2 Damaged masonry wall

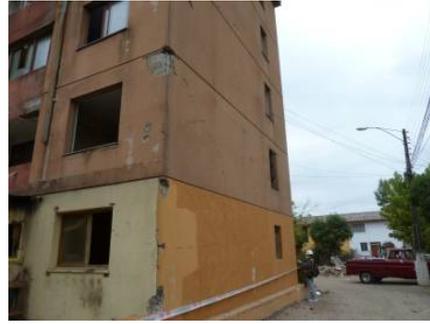
Photo 21-3 Damaged corner columns

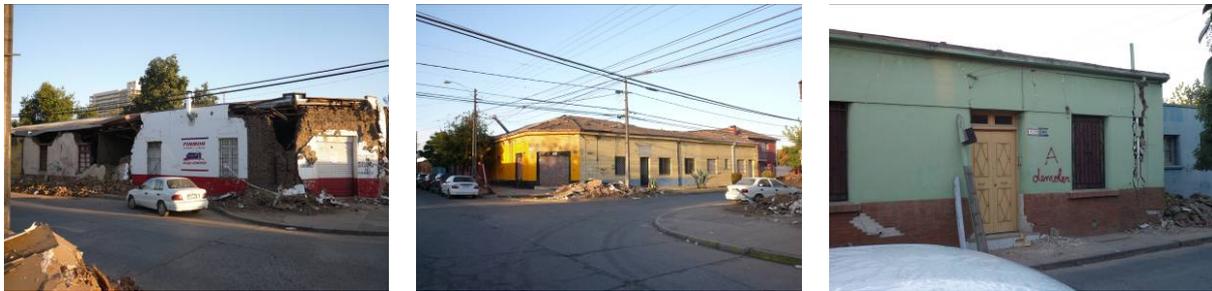
Old brick constructions and Adobe structures everywhere in the city were severely damaged (Photo 22-1). Comparatively new buildings and houses did not receive so much damage (Photo 22-2).

Photo 22-1 Damages of brick and adobe structures

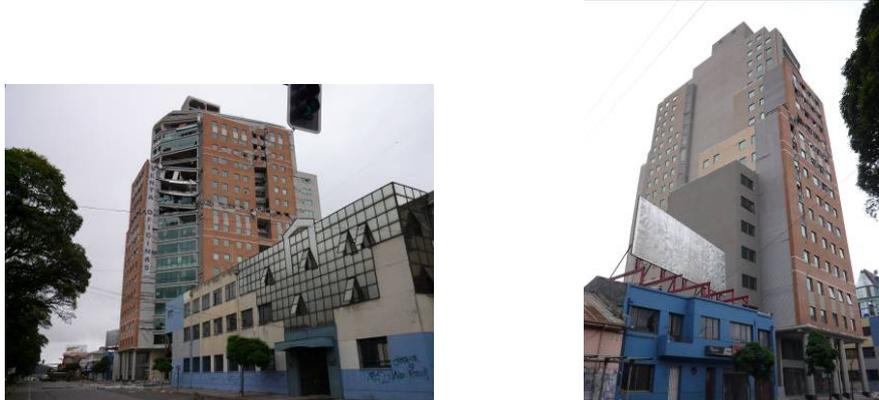
A high-rise office building of 21 floors with RC structure constructed in 2008 was in urban area (Photo 23-1). Story collapse occurred in the middle story near the 12th floor at the front of the building (Photo 23-2). Upper stories were inclined to roadside, and the front street was impassable. Setback was found near the story-collapsed floor. There were multistory bearing walls in backside of the building, and no remarkable damage. According to SERVIU officials, the owner will plan to demolish only the upper stories of the story-collapsed and continue to use the building.

Photo 23-1 Appearance

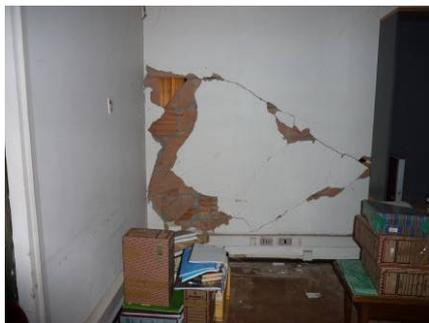
This is an office building constructed by SERVIU and has four floors with RC structure (Photo 24-1). Masonry walls of inside and stairway were smashed (Photo 24-2) and documents were scattered. Bending-shear cracks occurred at regular interval on the capital of circular RC columns of 3rd and 4th floor (Photo 24-3). Nonstructural walls had severe damages, but the building will be able to use after adequate restoration.

Photo 24-2 Damage of masonry e wall

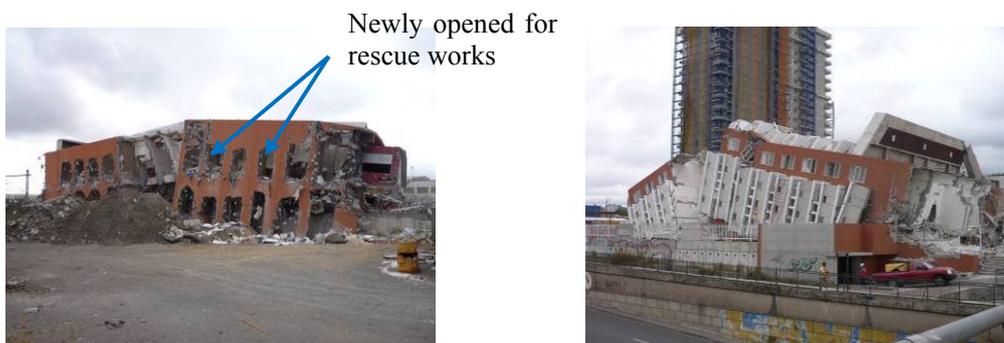
This is a case of a RC condominium collapsed, which had 15 floors (Photo 34-1, reprinted photos shown in Chapter 2). The basements are parking garage (3.3(1) is the similar case) and the length of bearing walls are shorter (smaller) than upper floors, so it seemed the damage at this portion brought on the overturn of the building (refer to Photo 39-1 and Photo 39-2). A schematic illustration of multistory bearing wall that has a large opening at basement is shown in Figure 8. The cause of collapse needs to be considered in detail.

Photo 34-1 Damage of collapse (Photo 25-1 reprinted)

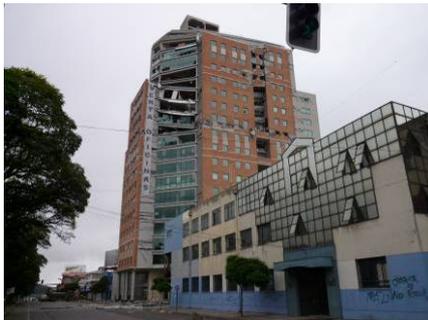
This is an example that the intermediate story in RC high-rise building was collapsed (Photos 35-1 and 35-2). Entire story collapse was observed in the front of the building, but the backside of it was a multistory bearing wall with small opening, and the damage was small. Story collapse occurred at the floor with setback. Information of the building structures and the investigation results did not be obtained yet, so the cause of damages should be considered after time.

Photo 35-1 Collapse of the intermediate story (Photo 23-1 reprinted)

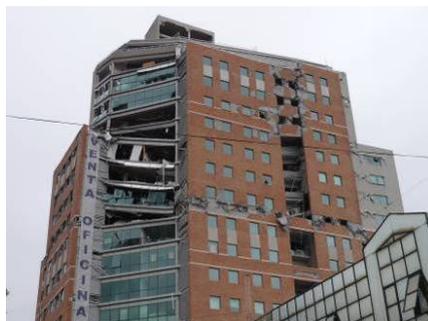
Photo 35-2 12th floor (Photo 23-2 reprinted)

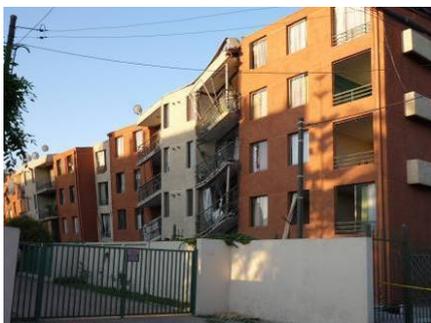
In Japan, after the Great Hanshin-Awaji Earthquake, the provisions for story stiffness ratio, i.e. the evaluation for distribution of stiffness belong to the building height; have been strengthened. Additionally, the points to consider in seismic design of the soft first story structure are published in a technical handbook ^[5], ^[6].

Photo 36-1 Collapse of soft first story
(Photo 8-1 reprinted)

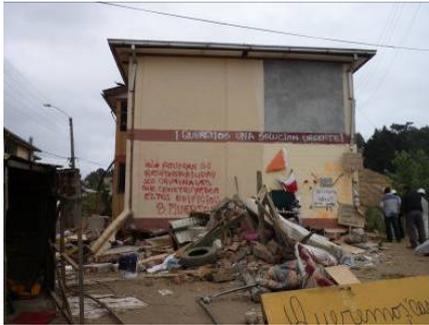
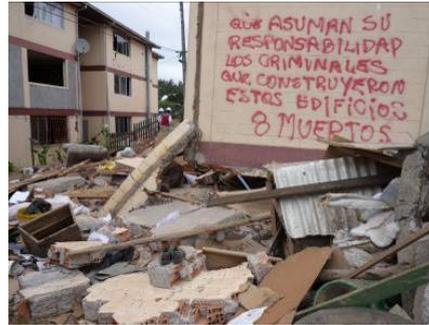
Photo 37-1 indicates a case that an apartment house of CM structure collapsed at the first story, and upper stories fell down. These structures have a tendency to use same member section, bar arrangement, and wall quantity in every story; that causes the shortage of wall at the first story compared to upper, because large opening is set to the entrance. Seismic force against building generally acts on the first story the most, so it leads to the first story relatively breakable. Damages of CM buildings are reported in many earthquakes, and here let me introduce a case in Pisco Earthquake, Peru, 2007 (Photo 37-2).

Photo 37-1 Collapsed first story of CM building (Photo 14-3 reprinted)

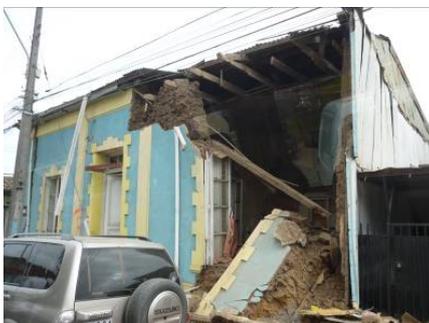
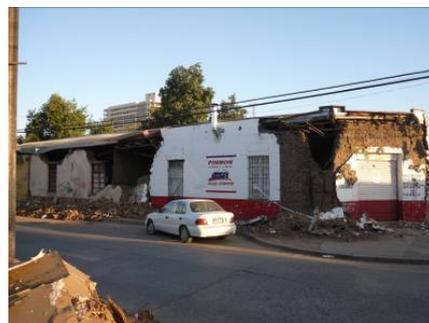
Photos 38-1 and 38-2 show examples of damages of masonry structure buildings as brick constructions and Adobe structures. As cases of recent earthquakes, for example, damage of brick construction buildings in Sichuan Earthquake, China, 2008 (Photo 38-3), and masonry structure buildings in L'Aquila Earthquake, Italy, 2009 (Photo 38-4) are quoted.

Photo 38-1 Damage of Adobe buildings (Photo 16-1, Photo 22-1 reprinted)

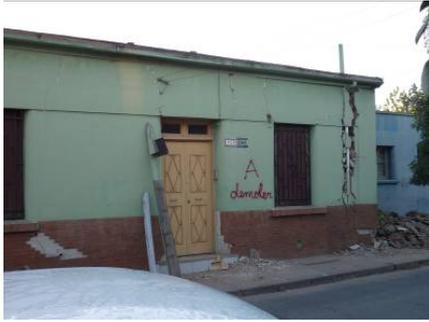
Photo 38-2 Brick construction buildings (Photo 22-1, Photo 26-1 reprinted)

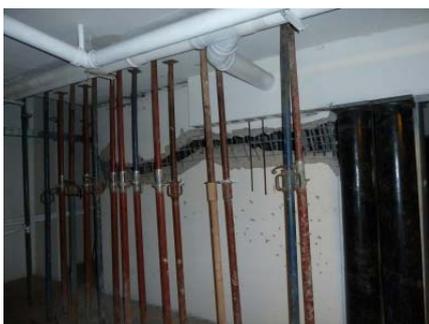
Photo 39-1 shows a case that RC multistory bearing wall of a 12-story building was smashed at the first basement level. Photo 39-2 also shows RC multistory bearing wall was smashed at the first basement level in a building, which has 18 floors and 2 basements. These cases are unknown in past other earthquake, and it might be the specific failure type in this earthquake. In general, the common failure type of RC bearing wall is diagonal shear crack.

Photo 39-1 Smashed RC wall (Photo 1-2 reprinted)

Apartment houses newly-built in urban city area are designed to set up the opening in a part of multistory bearing wall to secure the drive zone at the basement which is used as parking garage (Figure 8). Photo 39-1 is corresponding to the left-side wall underground shown the image in Figure 8. Failure on the Photos occurred because large tensile axial force and shear force were affected on.

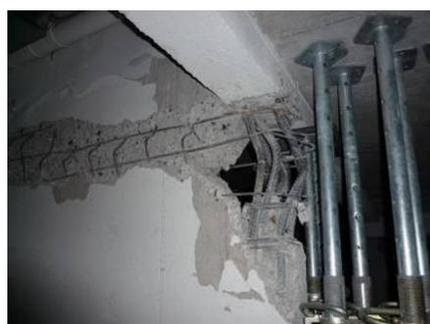
Photo 39-2 Smashed RC wall (Photo 2-3 reprinted)

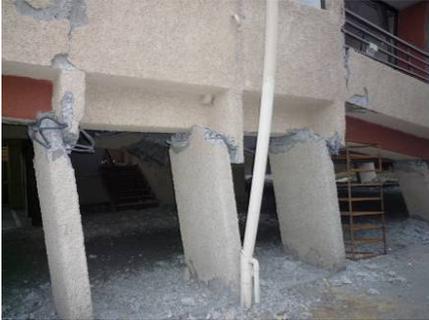
Photo 40-1 shows wall columns (flat shaped columns) of RC mid-rise building, and the big damage

occurred on the capital. These wall columns are imagined that deformation centered to the capital after bending to weak axis direction, and could not support the vertical load with losing the horizontal strength. Similar damages of columns are confirmed in Sichuan Earthquake, China, 2008 (Photo 40-2), but the damage of wall column is presumed the specific failure type in Chile.

Photo 40-1 Flexural hinges on wall columns
(Photo 9-3 reprinted)

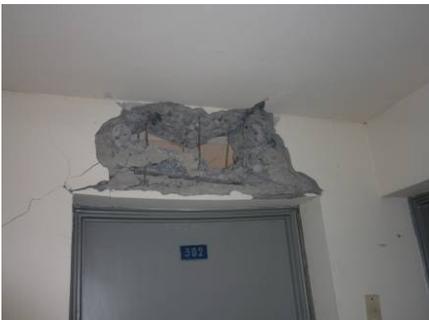
Photo 41-1 shows a example that beams on the top of the door opening in RC mid-rise building failed in shear. The causes of the failure are presumed that stress is easy to be concentrated at short spanned beam in earthquake, and flexural strength of it become strong.

Photo 41-1 Shear failure of short spanned
beam (Photo 9-3 reprinted)

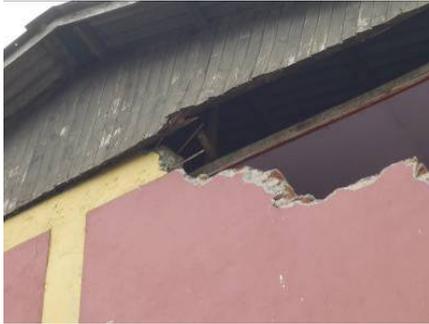
Photo 42-1 shows a beam at the top story of CM building failed around the lap joint of reinforcements and fallen down to out-of-plane. This building was constructed more than 20 years ago and, the standard for design and construction at that time are not recognized. In general, the location and length of the lap joint should be designed so that tensile stresses of which main reinforcements carry can be transmitted. It is imagined that the location and length of lap joint in the fallen beam are not appropriate and the stress transmission is not performed adequately (Photo 42-2).

Photo 42-1 Failed beam at the top of the transverse wall (Photo 15-3 reprinted)

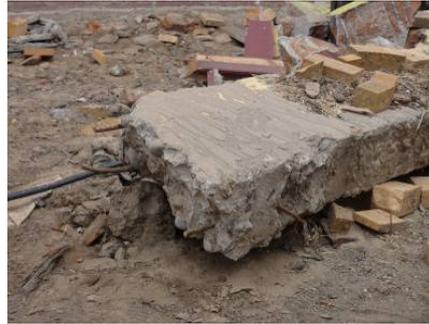
Photo 42-2 Main reinforcement at same joint point (Photo 15-4 reprinted)

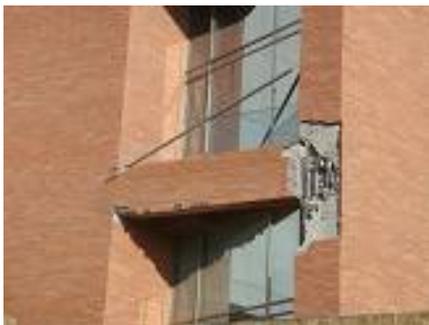
Photo 43-1 shows the failure of beam-column joint in RC mid-rise building, and Photo 43-2 is the same of CM building. In both cases, hoops were not used in the joint, and the section of it was small, then they led to the failure.

Photo 43-1 Failure of beam-column joint (Photo 7-2 reprinted)

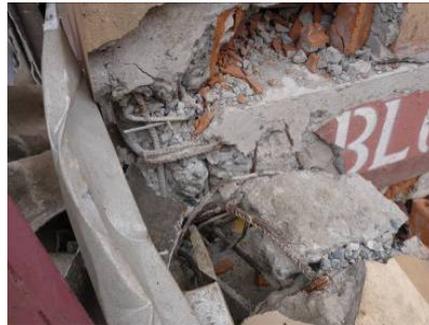
Photo 43-2 Failure of beam-column joint (Photo 14-4 reprinted)

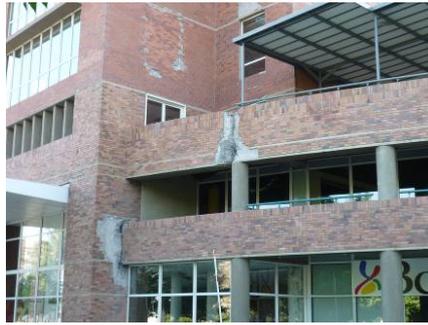
Photo 44-1 Joint among buildings (Photo 6-2 reprinted)

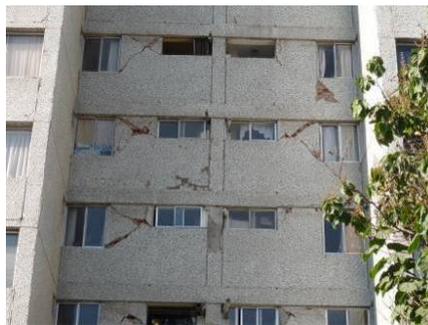
Photo 45-1 Cracks on brick walls (Photo 5-2 reprinted)

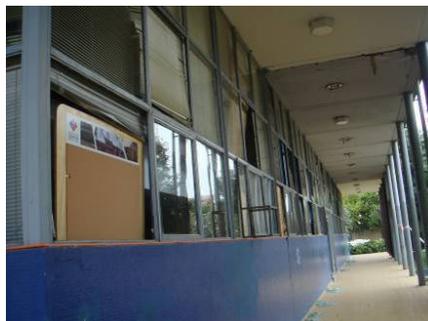
Photo 47-1 shows the situation of broken and scattered windows of outer plane in a mid-rise building.

Photo 47-1 Broken and scattered windows (Photo 20-2 reprinted)

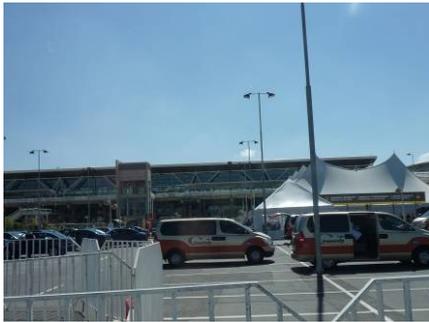
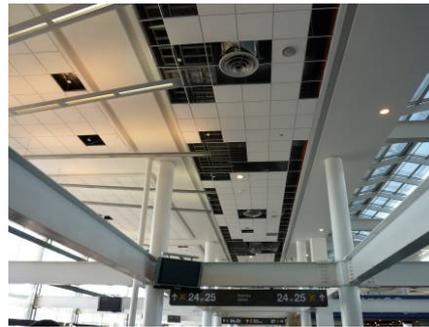
Photo 47-2 Fallen ceiling panels at Santiago international airport
