3 Damage Analysis and Suggestion of Damage Causes

3.1.6 Evaluation of the Current Design Seismic Force for the Building Based on the Damage during the Hyogoken-Nanbu Earthquake

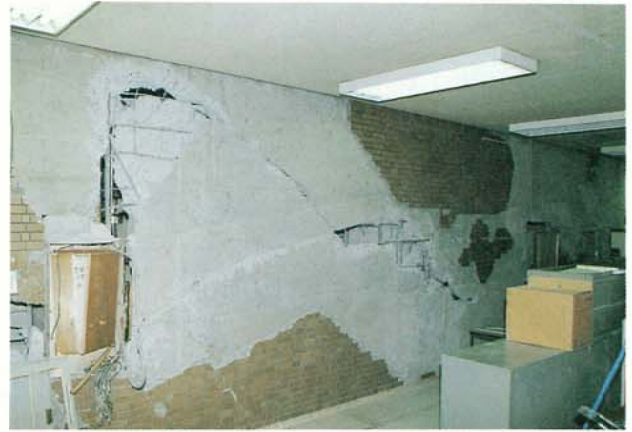
3) Collapse or Severe Damage of the Specified Floors in the Medium Floor of High and Middle Rise Buildings (Photo 3.2.1.3-3.2.1.5).

The middle and high rise buildings with only story collapse at specified floors. Since the buildings based on the old design standard of law are designed by the evenly distributing design shear coefficient along the height, they are inferior in the strength to those built under the present design standard of law especially at the upper floors. According to the fact that the damage cases in the buildings designed under the present standard have not been reported yet, it can be said that the old standard of law contains at least one of the reasons to occur the collapse of the middle floor of buildings. In Japan, for the buildings of more than seven story, many of those are composed of SRC structure in the lower part and of RC structure in the upper part. The damaged buildings with those structures showed the outstanding decrease of the amount of longitudinal reinforcements of columns, which lead the sudden change of the strength of columns, along the storey at the damaged floor (shifting floor from SRC to RC structures).

Photo. 3.2.1.4 3 story SRC structure
governmental building
The shear fracture of the yield strength wall (resistant wall) of the 7th floor

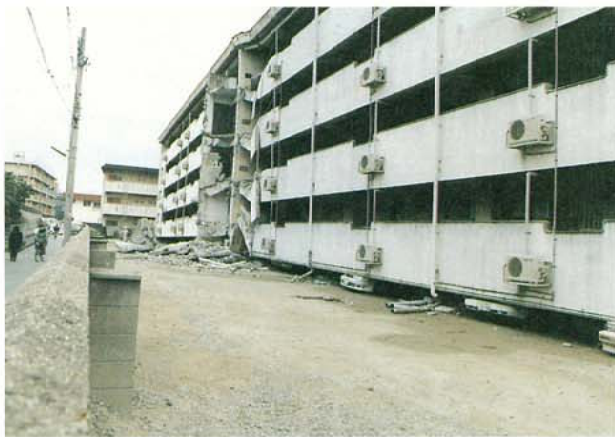
2) Collapse or Severe Damage of *Tiloti* Floors.(Photo 3.2.1.2)

floors were utilized as apartment houses with stiff walls had the damages especially at those first floors where the stiffness were low. The stiffness distribution towards the height of those buildings were not even. The damages were represented as the story collapse of the piloti floors and the severe damage of columns accompanied with the columns longitudinal shrink(shear fracture).

Photo. 3.2.1.2 5 story apartment house building
Collapse of the first piloti floor

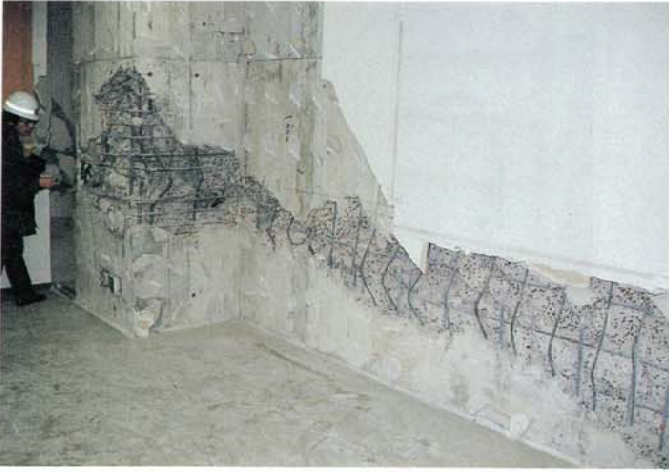
Some fractures of attached plate at the steel joint part of the SRC column were seen at the SRC structures. The SRC columns shown in the Photo. 3.2.1.6 and 3.2.1.7 are the peripheral columns to moment resisting wall and a large tensile axial stress was loaded at the time of the earthquake. This can be also presumed through the crack caused by the tension seen in the adjoining columns. It is recognized that such a tensile strain caused an excessive plastic strain on the joint position of which the tensile stiffness and the strength are less than those of the main part of steel structure, which lead the fracture of the splice plate of the joint part. A slip at the bottom of anchor plate was also seen at the column base of first floor. The lack of tensile strength and pull out strength of anchor bolt is presumed for the reason.

Photo. 3.2.1.7 11 story SRC structured governmental building
Damage of the steel joint part of the peripheral column

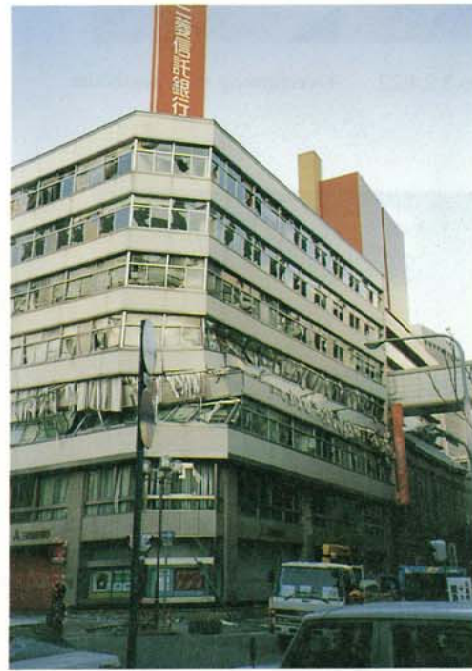
Photo. 3.2.1.19 Story collapse caused by the twist response

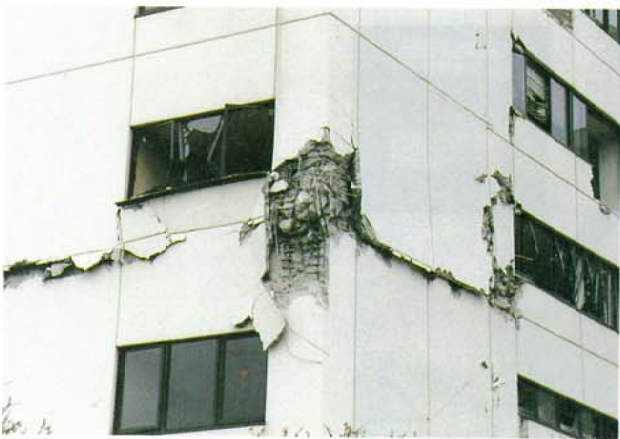
Photo.3.2.1.20 Fracture between the different structural types (SRC and RC)

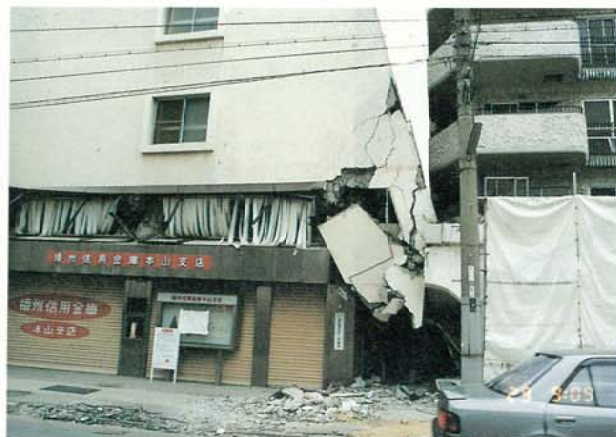
Photo. 3.2.1.26 Collapse caused by the collision of the buildings

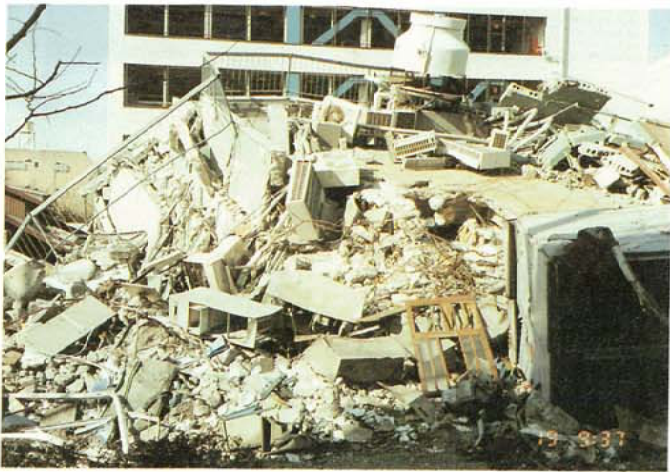
Photo. 3.2.1.27 Collapse in the form of a pan cake

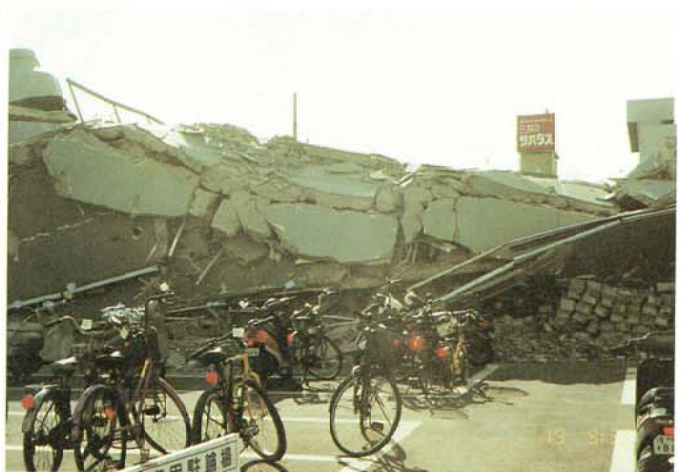
Photo. 3.2.1.28 Fracture in the form of a pan cake

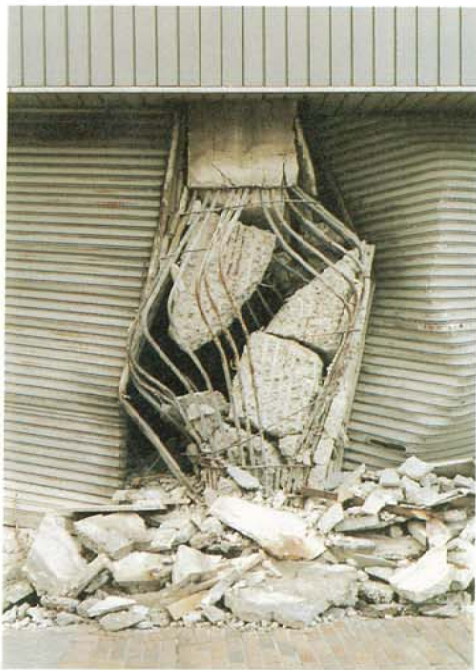
Photo. 3.2.1.29 Shear fracture of a column

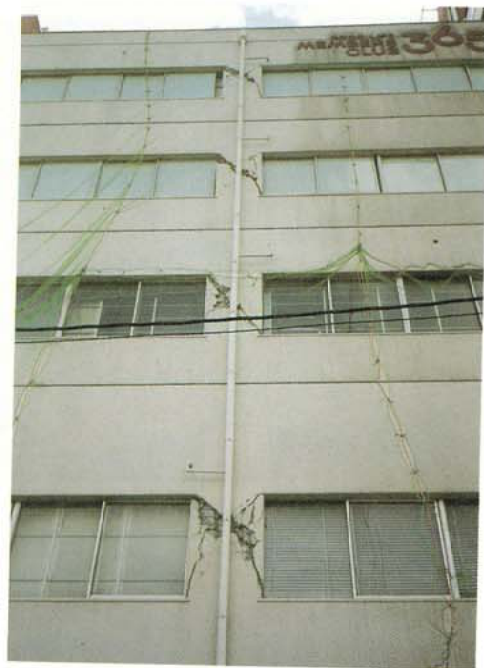
Photo. 3.2.1.30 Shear fractures of short columns

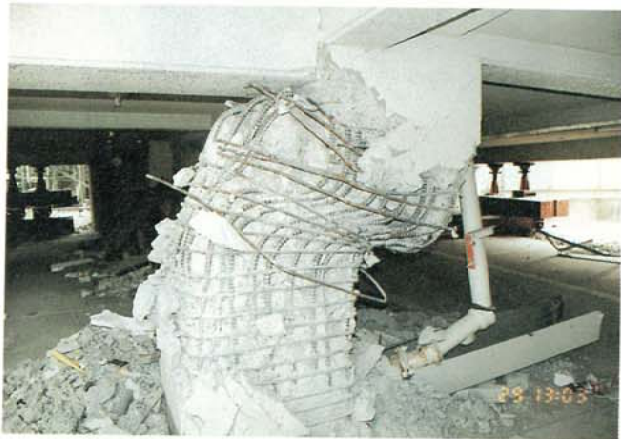
Photo. 3.2.1.31 Shear fracture of a column

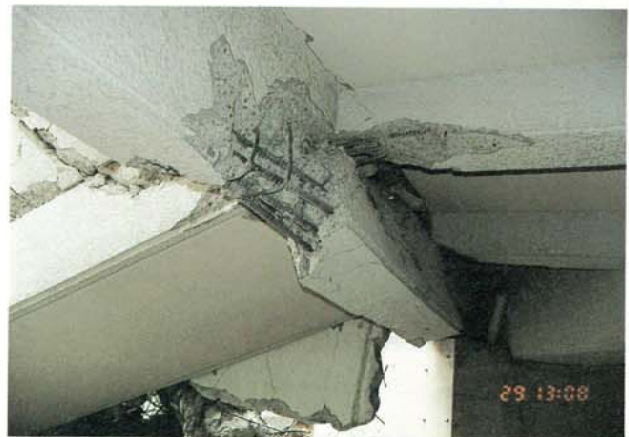
Photo. 3.2.1.32 Twist fracture of a beam

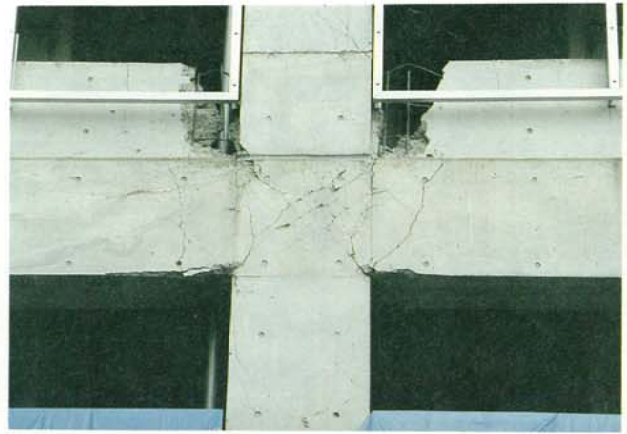
Photo. 3.2.1.34 Fracture at the beam-column joint part(RC)

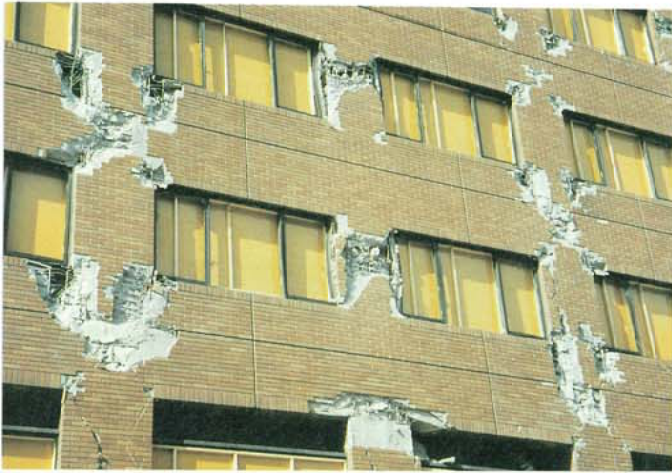
Photo. 3.2.1.35 Shear fracture Beam-column joints(SRC)

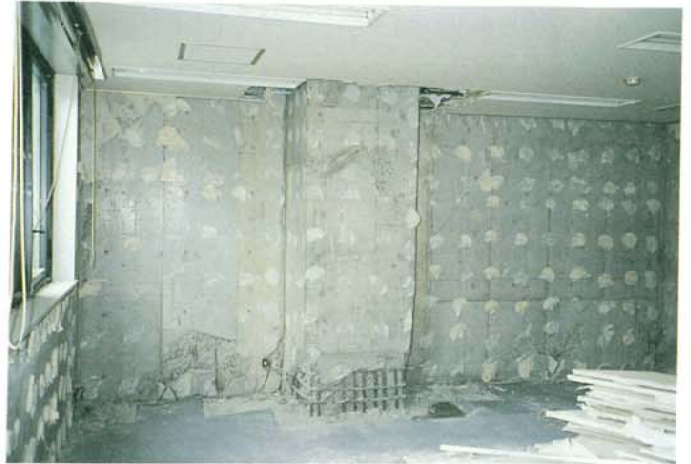
Photo. 3.2.1.36 Flexural compressive failure of columns

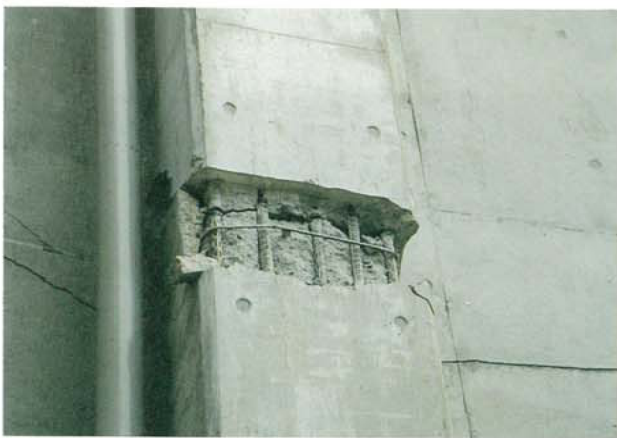
Photo. 3.2.1.37 Fracture of the gas pressure welding of the reinforcements

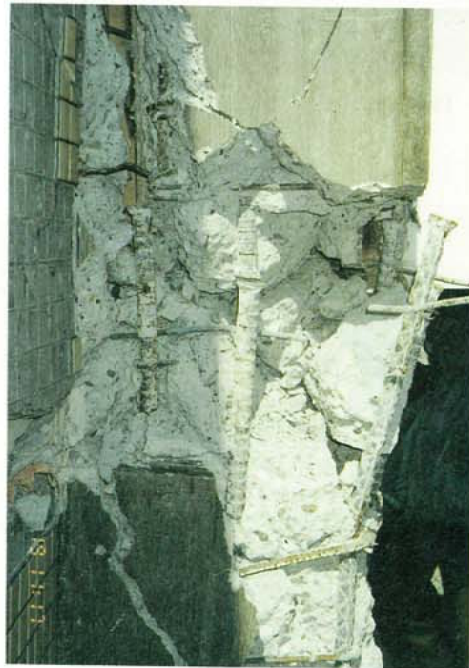
Photo.3.2.1.38 Fracture of the gas pressure welding of the reinforcements

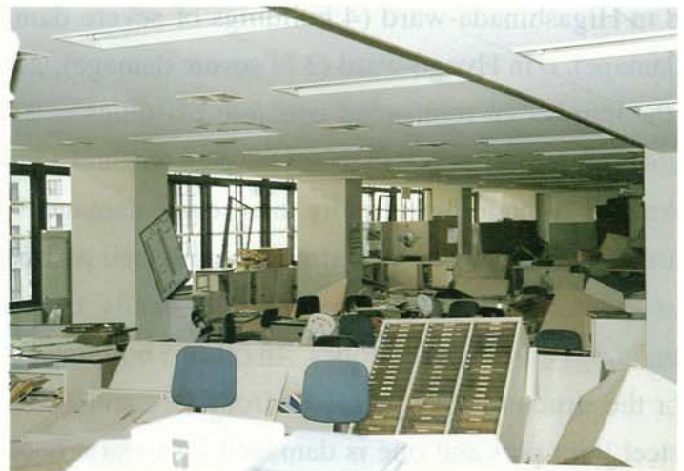
Photo. 3.2.1.48 Damage condition of the 7th roof floor of the 6th floor is pushed out to the 7th floor

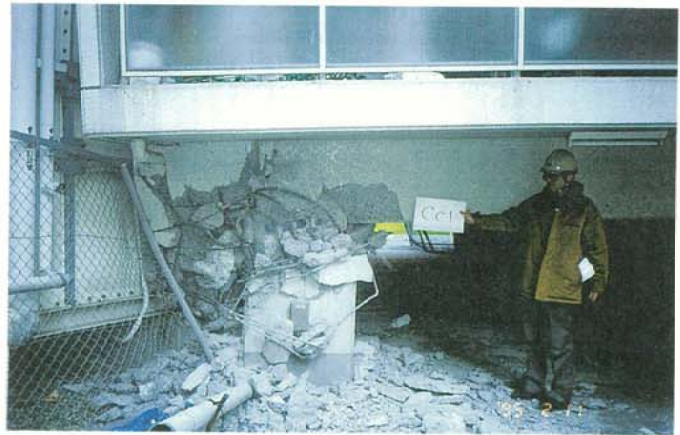
Photo. 3.2.1.52 Shear Fracture of 1 FL Column

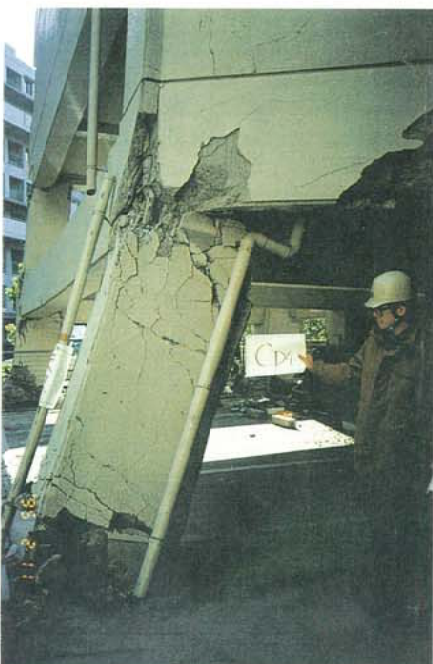
Photo. 3.2.1.53 Flexural Fracture (1FL)

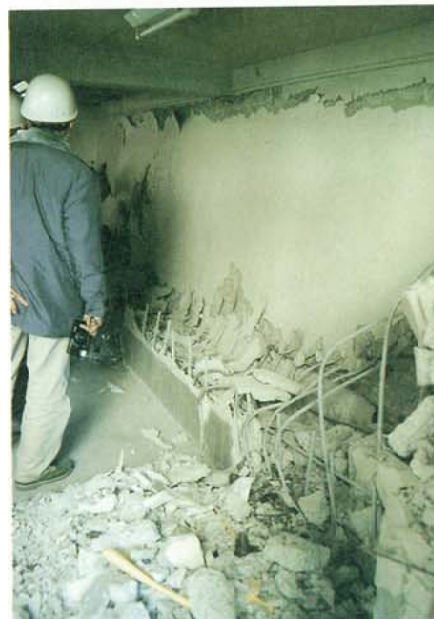
Photo. 3.2.1.54 Fracture of Shear Wall

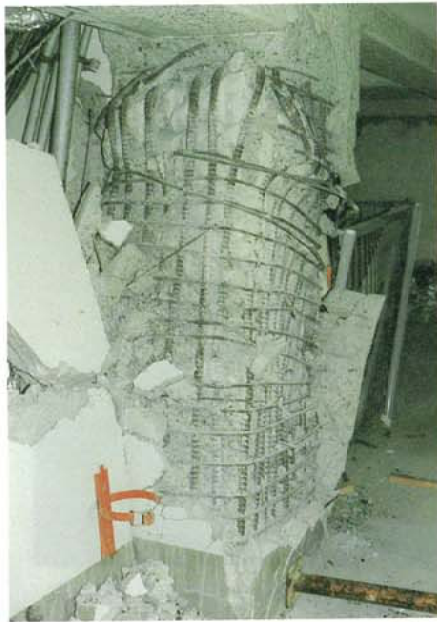
Photo. 3.2.1.55 Shear Fracture of Column(1FL,CD3)
Rupture of Gas Pressure Welding of
Longitudinal Bars

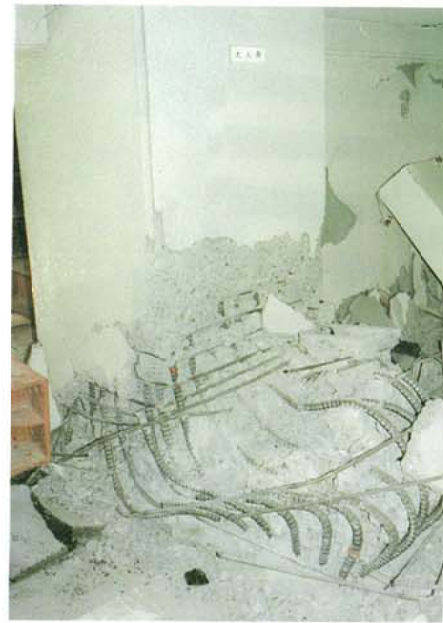
Photo. 3.2.1.56 Shear Crush of Column
(1FL)

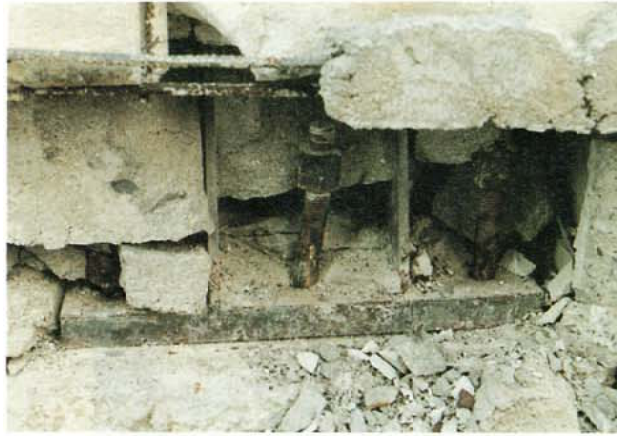
Photo 3.2.2.1

Pull out of anchor bolts from the basement, crack of concrete around the anchor bolts, and a little damage of finishing materials above the second story.

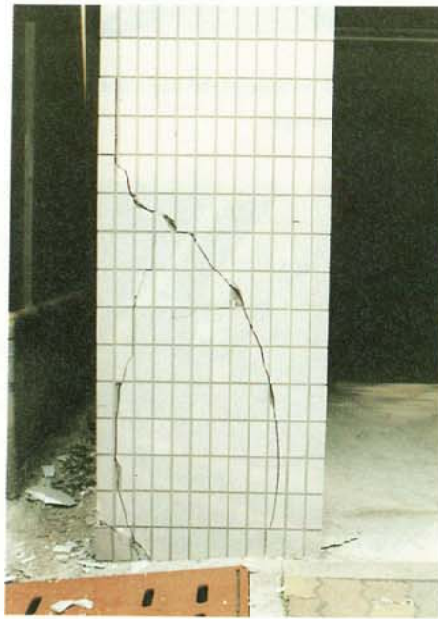
Photo 3.2.2.2

Crack of reinforced concrete foundation beam

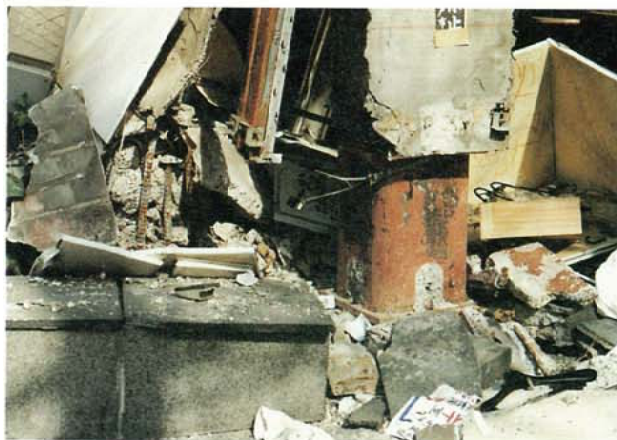
Photo 3.2.2.3

The first story column at the corner was pull out from the foundation and moved to the front road, the reinforced concrete part around the column base was completely damaged.

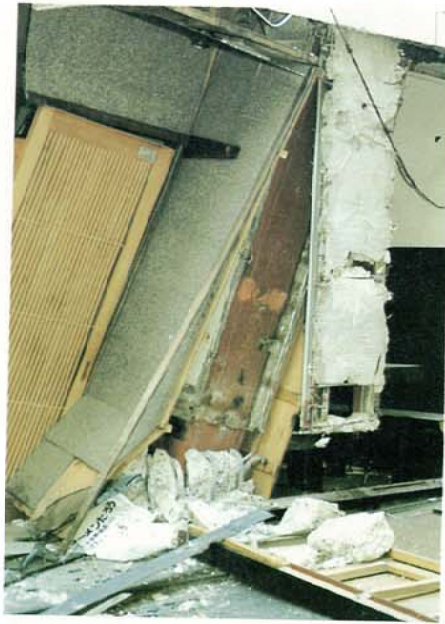
Photo 3.2.2.4

The first story column was inclined because of the large story drift, and the reinforced concrete part of the column base was severely damaged.

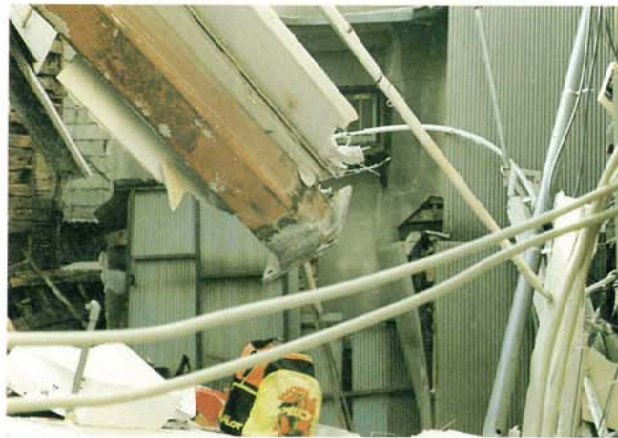
Photo 3.2.2.5

Four anchor bolts of the first story column base was cut, and the structure was tilted.

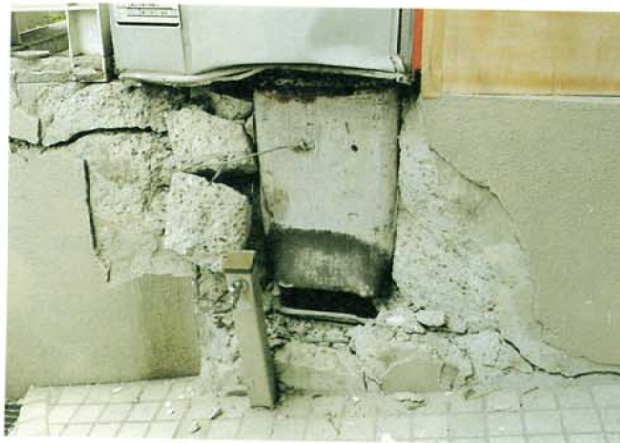
Photo 3.2.2.6

The column with the square-hollow-box section was fractured in the foundation beam, where local buckling was observed.

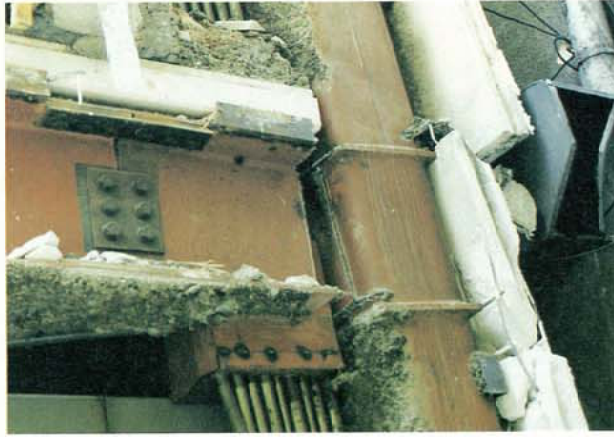
Photo 3.2.2.7

The damage was concentrated into the lower three stories, especially into the first story. At the beam-to-column connection in the second floor, the welding joints were fractured. The lower flange of the beam was connected to the panel zone without diaphragm.

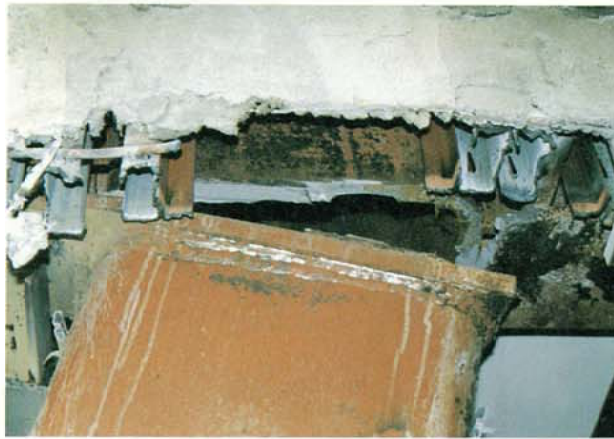
Photo 3.2.2.8

The panel plate of the beam-to-column connection in the second floor was fractured. The brittle crack was observed at the welding joint between panel plate and diaphragm.

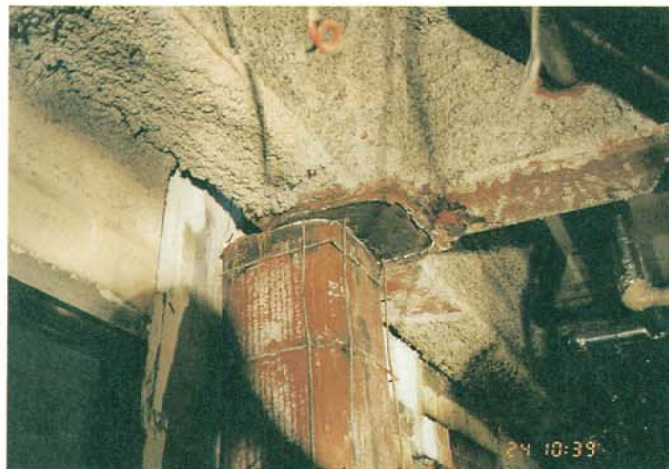
Photo 3.2.2.9

The fracture of the welding joint between the column and diaphragm at the beam-to-column connection in the first story.

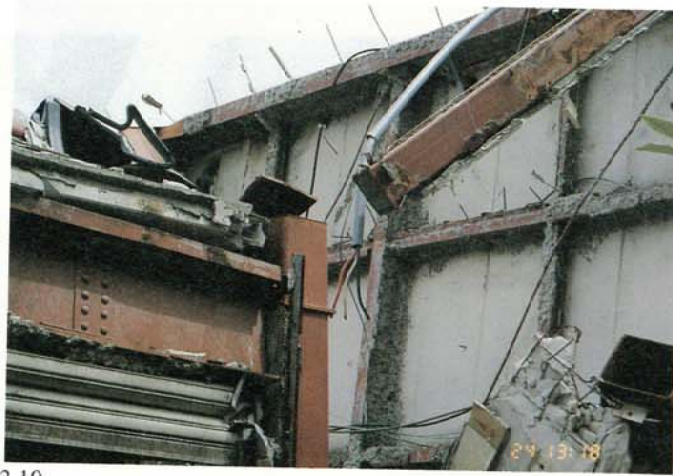
Photo 3.2.2.10

The welding joint between the column and diaphragm at the beam-to-column connection in the first story was fractured. The upper stories of the structure was collapsed.

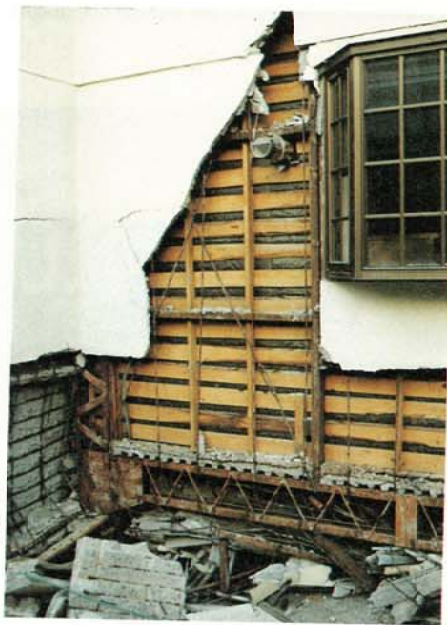
Photo 3.2.2.11

The first story was collapsed. The structure has two stories of moment resisting frames with vertical braces of steel bars. The members rusted heavily.

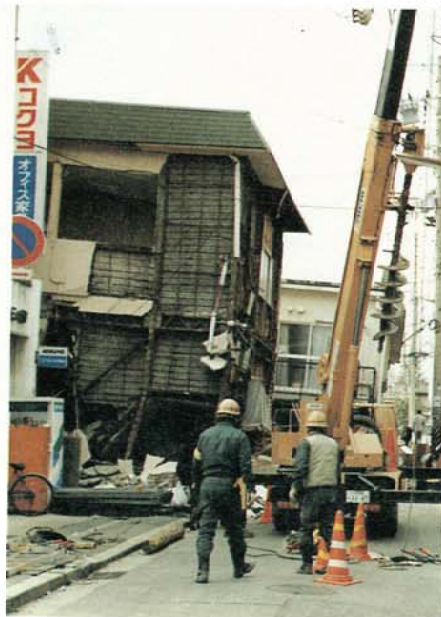
Photo 3.2.2.12

Two storied house rusted severely.

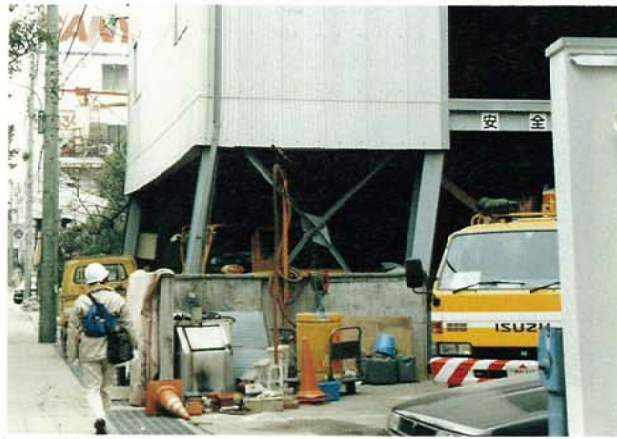
Photo 3.2.2.13

The damage was concentrated into the first story. The story drift was 1/8.

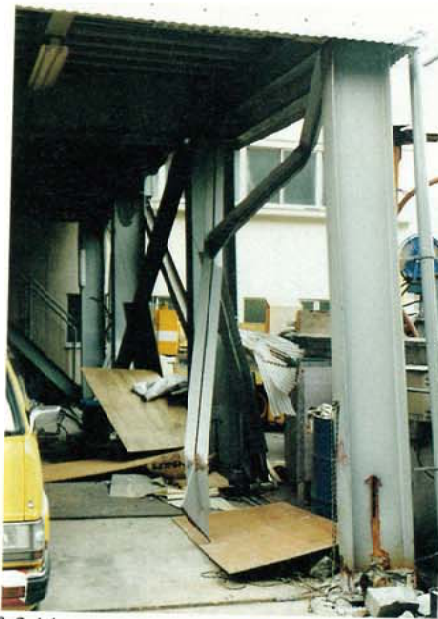
Photo 3.2.2.14

The gusset plate was fractured by the tension force from the brace.

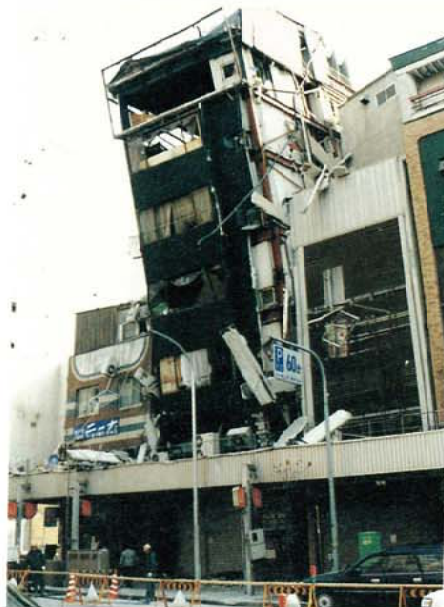
Photo 3.2.2.15

Large lateral displacement was observed in the upper stories. The long braces were fractured.

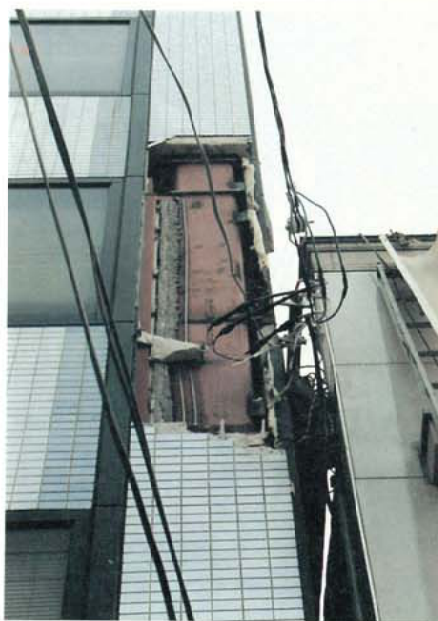
Photo 3.2.2.17
Two buildings collided.

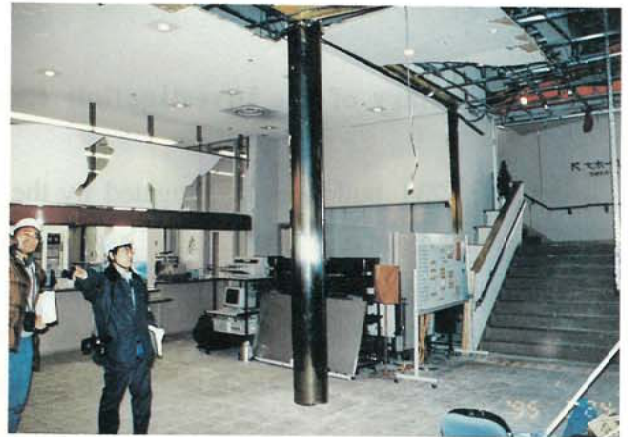
Photo 3.2.2.19 Damaged building interior due to pounding on parking building below (Building B)

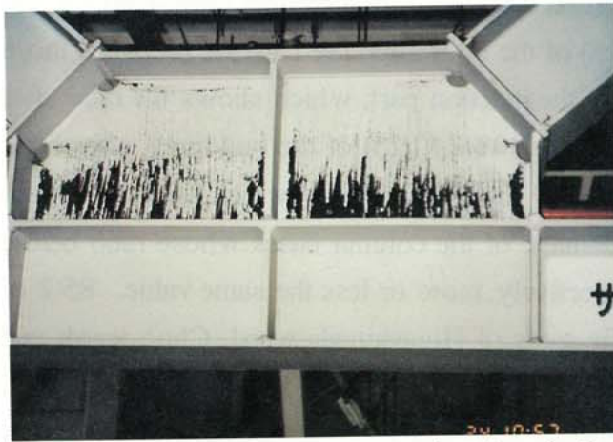
Photo 3.2.2.20 Shear yielding in the gusset plate at brace junction (Building C)

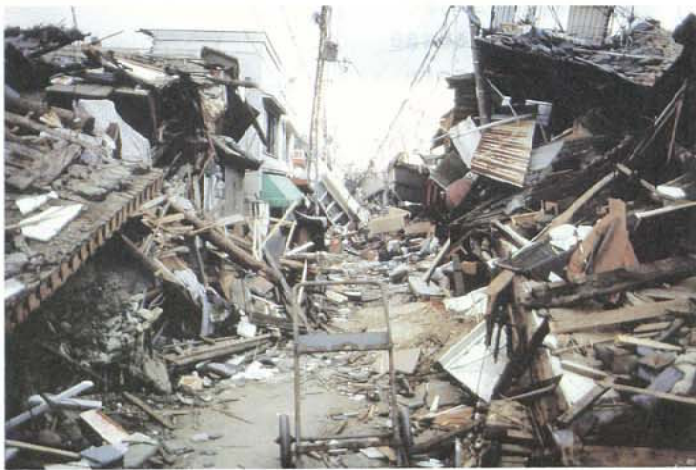
Photo 3.2.3.1 Collapse of wooden houses

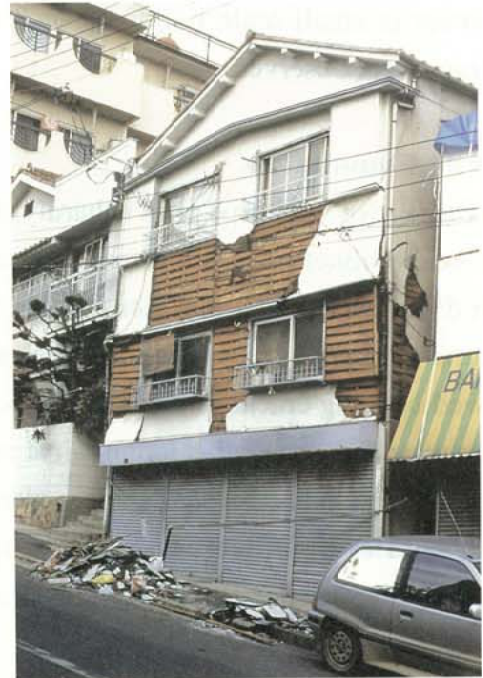
Photo 3.2.3.10 Damage of the exterior lath-mortar

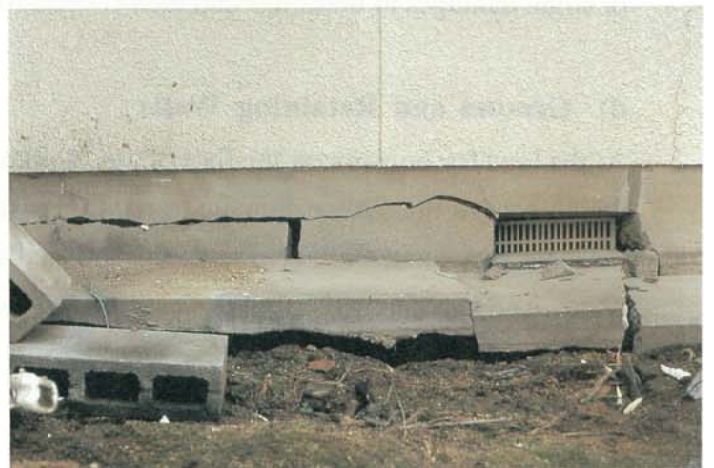
Photo 3.2.3.12 Damage of the foundation
