Fire Safety Measures Enabling Construction of Large Wooden Buildings (Part II)

Full-scale Fire Testing on a Three-story Wooden School Building

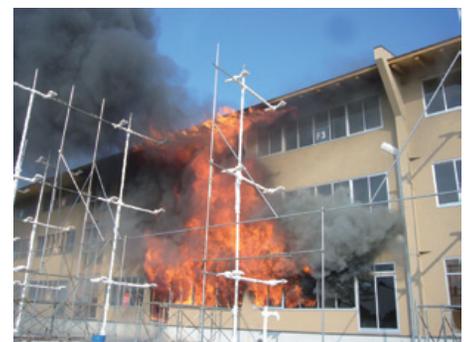
When a wood crib resembling a fixture placed in the center of the first-floor staff room was lit, the flames immediately reached the ceiling and ignited the wood-finished ceiling as well as the walls. In a short time, flashover—in which the interior became engulfed in flames—occurred. Flames which emerged from the windows of the room in which the fire started rose to a height that reached the third floor, and the fire spread through windows to the upper floors. For this reason, rather than spreading in order from the first to second floor and then second to third floor, approximately thirty minutes after the fire was lit all three stories were burning simultaneously (Photos 7 and 8).

Photo 7: Fire spreading to upper floors due to emerging flames (six minutes after ignition)

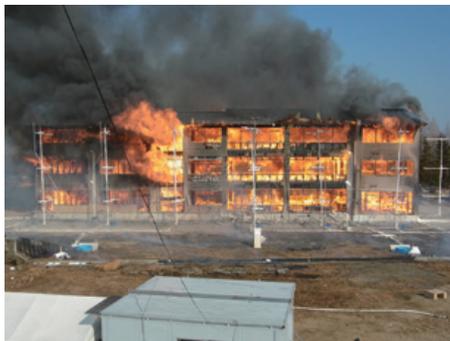
Photo 8: Three stories burning simultaneously (33 minutes after ignition)

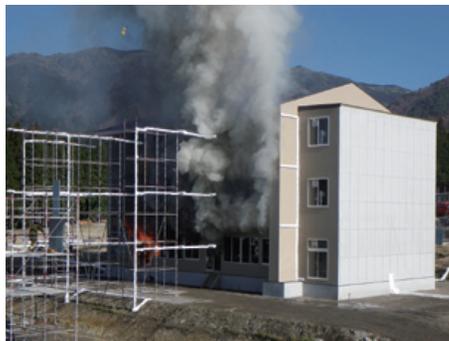
While the flames immediately reached the ceiling after the fire was lit, as the ceiling had been made non-combustible it did not ignite, and flashover did not occur. In response, 50 minutes later a flaming torch was thrown in to relight the fire, and after approximately 37 minutes the fire had spread to the entire room in which the fire had started (Photo 9).

Photo 9: Flashover occurs in ignition room (89 minutes after ignition)

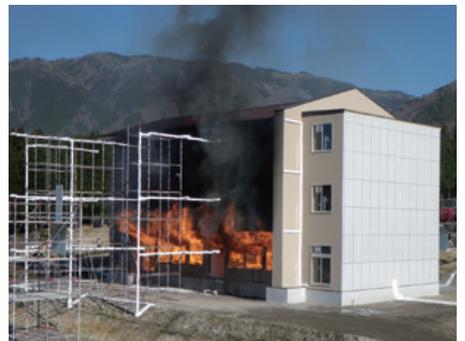
of the room in which the fire started continued to emerge and approached the third floor, but due to the balcony and eaves, the fire did not spread immediately to the upper floors. Thereafter, the fire spread to the second floor when its floor burned through. When the floor of the second floor had burnt through, large flames emerged from windows on both the south and north sides of the second floor, and the fire spread to the inside of the room on the third floor from openings (Photo 10).

Photo 10: Flames also emerge from second floor opening (131 minutes after ignition)

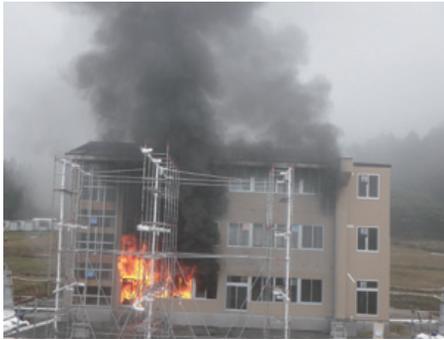
Photo 11: Flashover occurs in ignition room (68 minutes after ignition)

After the fire was lit, the wooden interior walls caught fire, and the flames reached the ceiling approximately three minutes later, but the non-combustible ceiling failed to ignite and after around ten minutes the fire died down naturally. When the fire was subsequently relit 20 minutes later, the flames again reached the ceiling, and after approximately 66 minutes the flames spread rapidly under the ceiling, with the fire spreading throughout the room in which it started (Photo 11).

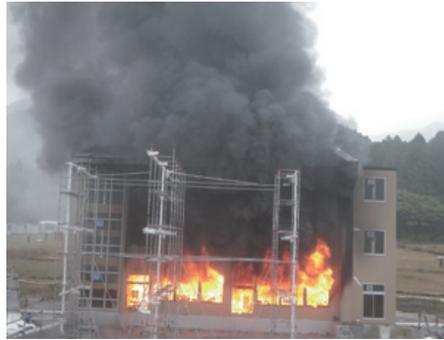
Photo 12: Fire spreads to the second floor (83 minutes after ignition)

floor broke due to emerged flames from the south-side window of the room in which the fire started. This was followed by flames entering the interior from the north-side windows and the walls starting to burn, and 87 minutes later the entire interior of the floor became engulfed in flames (Photo 12).

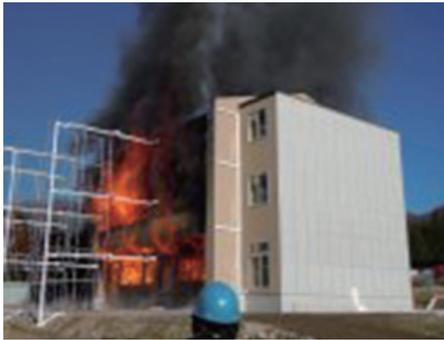
Photo 13: Fire spreads to the third floor

Emerged flames from the first and second floors reached near the eaves, and the fire spread to the third floor from an opening. However, water was sprinkled intermittently from sprinkler equipment installed on the third floor, and the test continued with the burning controlled in the third floor (Photo 13).

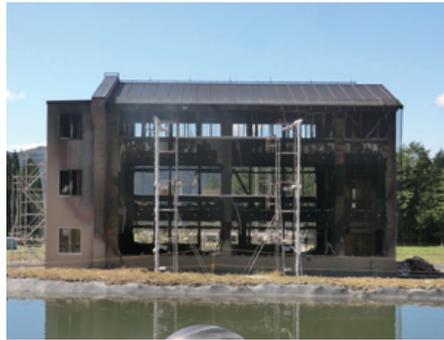
Photo 14: After test completion (following day)

Inflow of light smoke from gaps in the first floor fire door was observed after 68 minutes using a video camera set up in the staircase, but no fire spread to the staircase. In addition, with respect to the opposite side of firewalls, although inflow of light smoke through gaps in fire doors was observed, the fire did not spread (Photo 14).
