# LESSONS FROM THE GREAT NORTHERN PAKISTAN EARTHQUAKE

**Najib AHMAD**

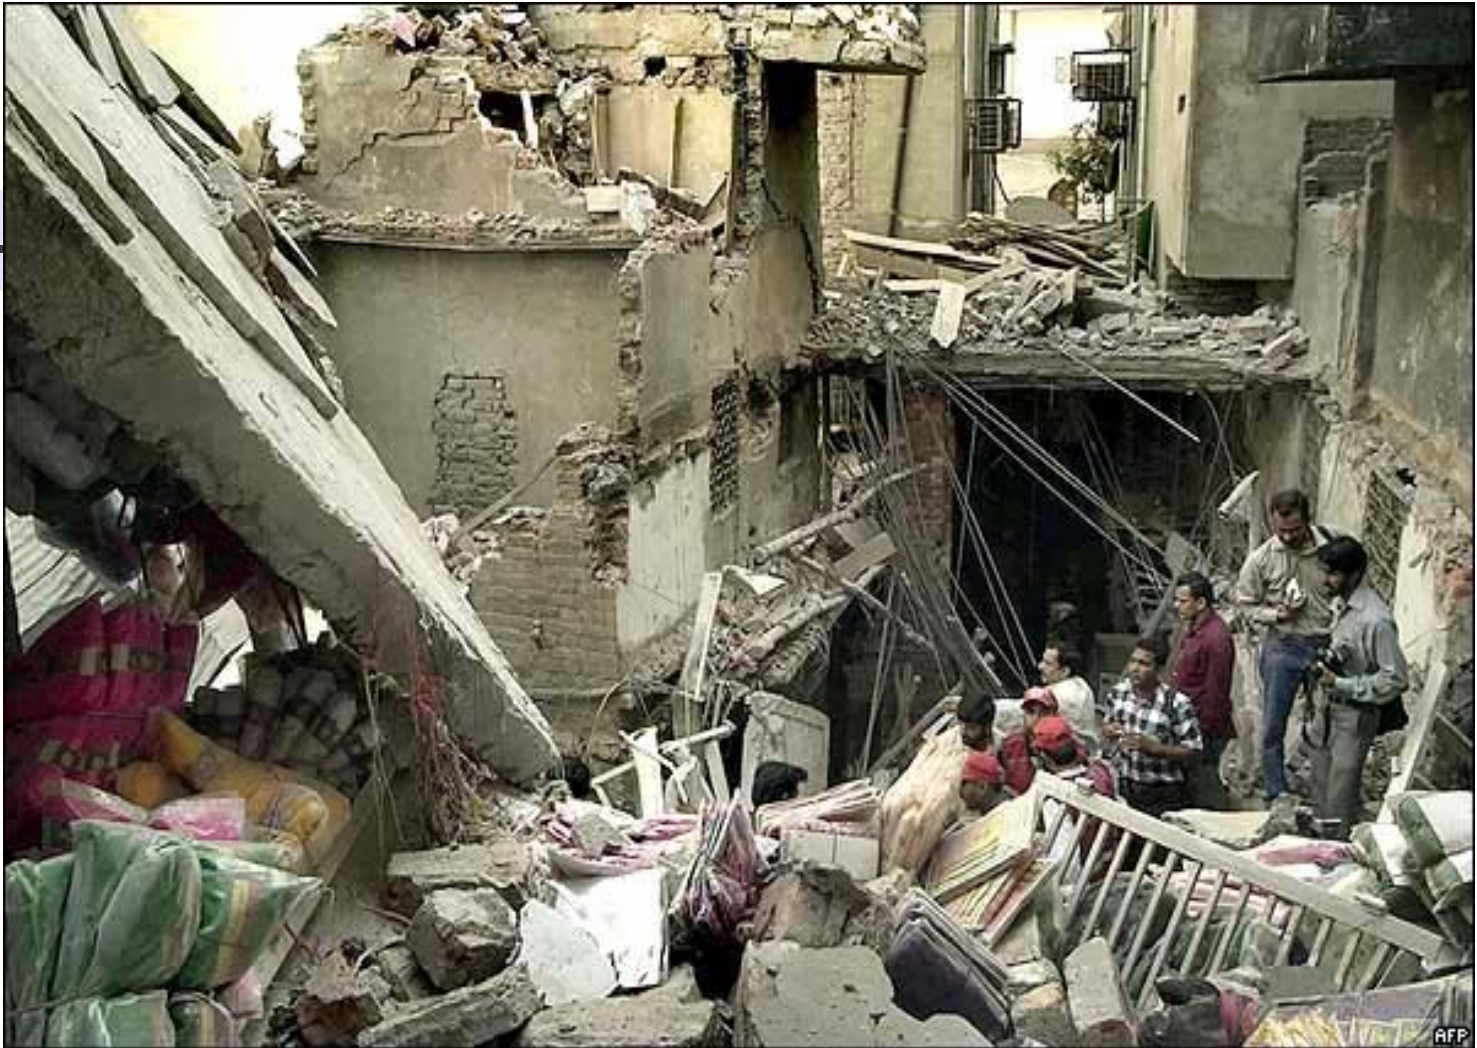
**Pakka House**

- The earthquake killed over 73,000 people and affected more than 3 million others, completely destroying hundred of villages and large sections of towns in “Kashmir and NWFP (North Western Frontiers Province of Pakistan). The effected area was nearly 30000 square kilometers, and the shocks destroyed and damaged an estimated 450,000 homes, 6000 schools and hundreds of hospitals/clinics and other infrastructural facilities. The earthquake left in its wake millions of survivors to face devastation in form of destruction of their homes and means of livelihood. Some of the damage is visible in following photographs. (Figure-3).
