# Bulletin Information on Damages to Adobe Houses by Peru Earthquake August 15, 2007 and Activities after the Earthquake

September 4, 2007

Tatsuo Narafu, Senior Coordinator for International Cooperation,  
Building Research Institute (BRI), Japan

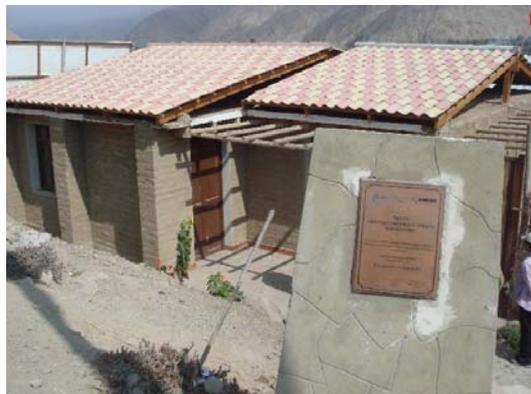
Photo 1 Model house in Canete in Lima State with almost no damage

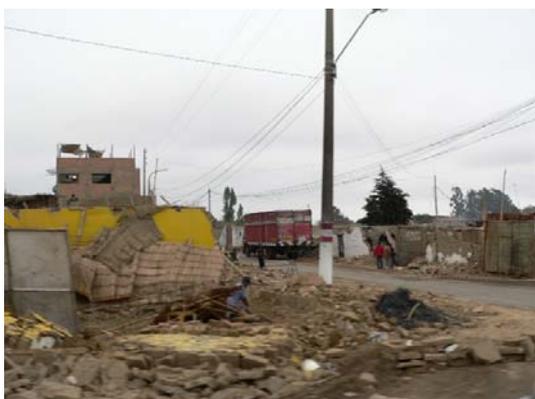
Photo 2 Damage by the Earthquake in Canete in Lima State

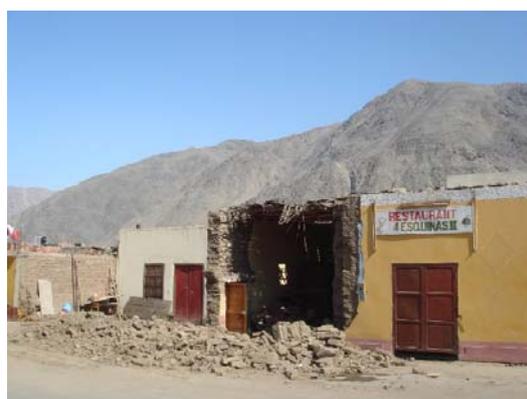
Photo 3 Adobe houses damaged by the Earthquake

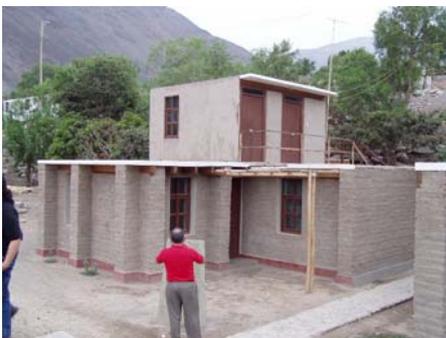
**Photo 4 Completed model house with many buttresses and raised foundation of concrete for prevention of humidity from ground (red pars H:30cm)**

The seismic design applied to the model houses was developed by researchers in Pontificia Universidad Catolica del Peru (PUCP) and their partners and adopted into a Peruvian official standard (Norma Tecnica E.080). The key points of the seismic design are as follows.

1. Ring beams on the top of adobe walls
2. Vertical and horizontal reinforcement of canes inside of adobe walls
3. Foundation of concrete

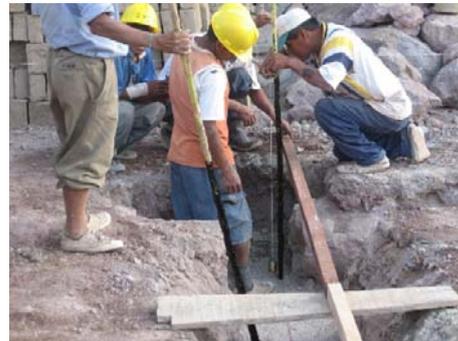
**Photo 5 Setting of vertical reinforcement  
Nails are placed on center lines of walls drawn on concrete (t:10cm) in every 80cm for fixing vertical reinforcement of canes**

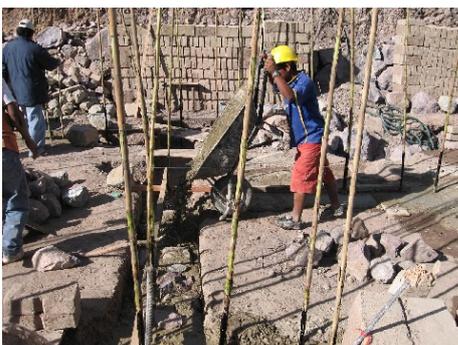
**Photo 6 Casting of concrete for foundation  
Foundation: W:55cm, H:80cm, no reinforcement  
Vertical reinforcements are anchored to foundation**

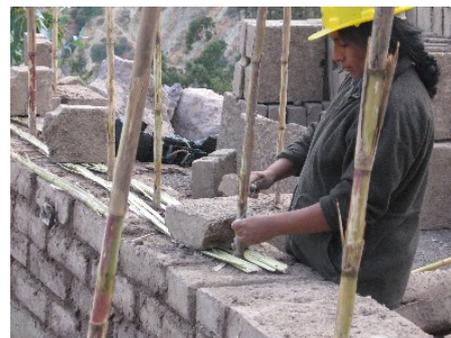
**Photo 7 Setting of horizontal reinforcement of crashed canes in every four layers connected to vertical reinforcement with nylon strings**

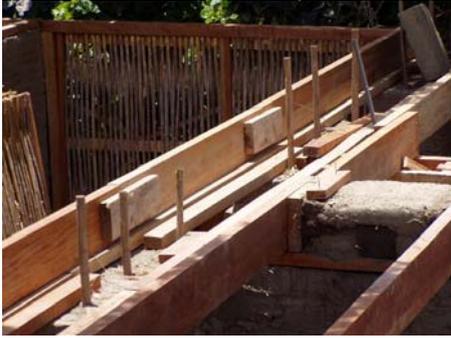
**Photo 8 Ring beams on top of adobe walls**  
Composed of two main members of timbers  
(7.5x7.5cm) and connecting members

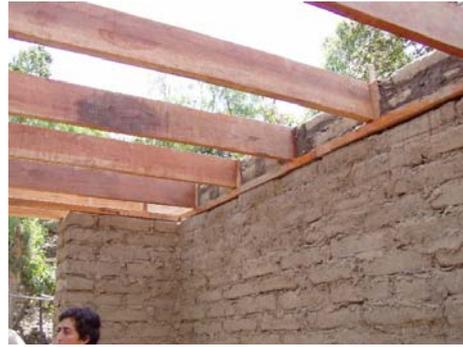
**Photo 9 Wooden roof beams (5x20cm) connecting**  
walls facing each other at intervals of 60cm
