7. Damage to Buildings in Inundation Areas Induced by Tsunami

7.1 Introduction

8. Damage of Buildings, etc. due to Fire

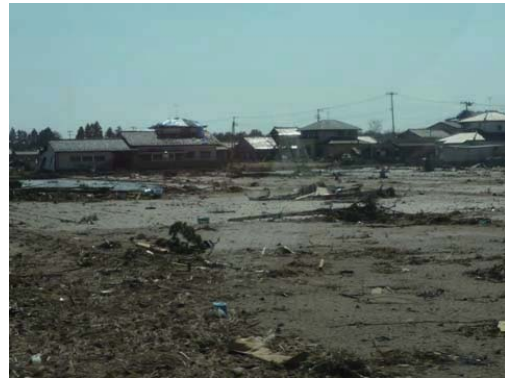
Photo.7.4-6. Many wood houses remained.

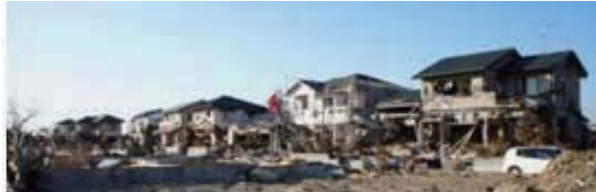
A line of wood houses remained were confirmed in Arahama-shin, Wakabayashi ward, Sendai city, as shown in Photo 7.4-8. The front survived house of the line was non-wooden. The water depth in this area was estimated at the level about 4-5 m. On the other hand, some wood houses which didn't have survived buildings in the direction where the tsunami came remained, but suffered heavy damage, as shown in Photo 7.4-9. Several such houses were confirmed in each surveyed area, and they were built by the construction methods with many metal fasteners.

Photo 7.4-8. A line of wood houses remained in Arahama-shin, Wakabayashi ward, Sendai city.

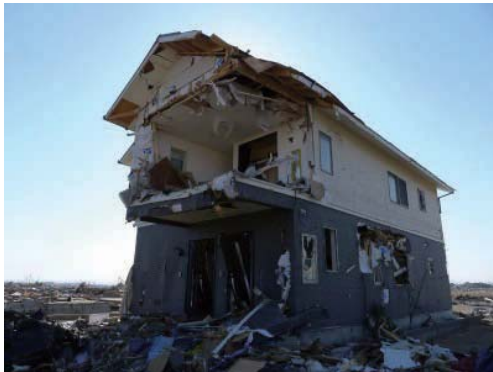
Photo 7.4-9. Remained house which didn't have survived buildings in the direction where the tsunami came in Arahama-shin, Wakabayashi ward, Sendai city.

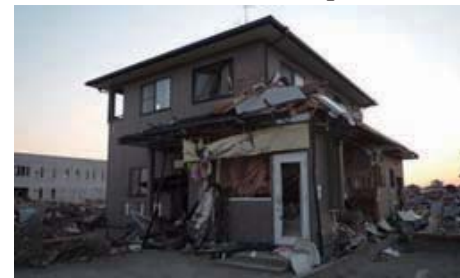
Photo 7.4-13. Wood house with store (⁵) remained in the downstream of the survived buildings in Yuriage.

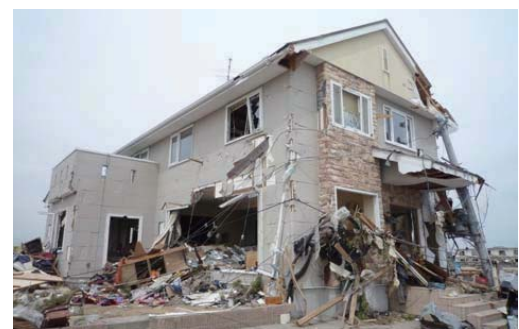
Photo 7.4-19. Light frame construction wood house (12) remained alone

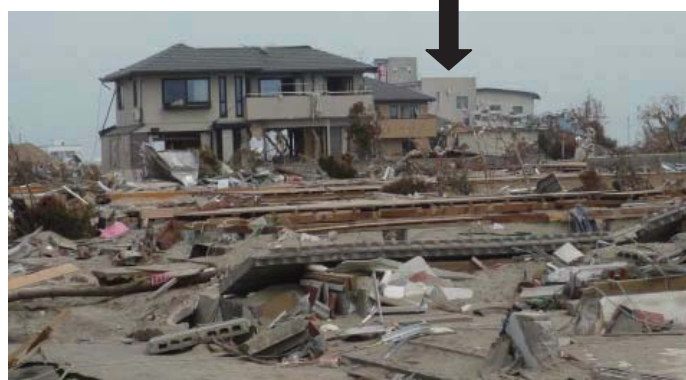
Photo 7.4-21. Wood houses (15) which were not washed away selectively in the downstream of a factory building.

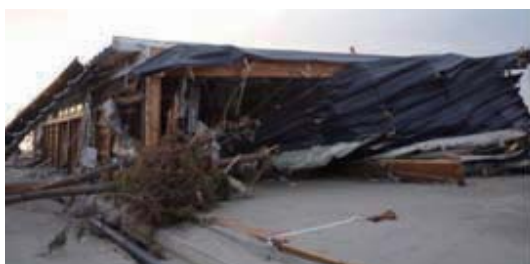
Photo 7.4-22. Glulam frame structure remained in Arahama, Watari town.

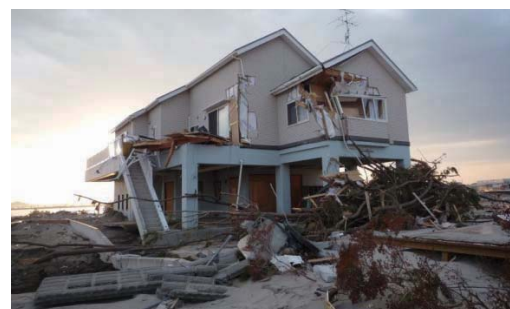
Photo 7.4-23. Mixed structure which has 1st story of RC structure and wooden 2nd story.

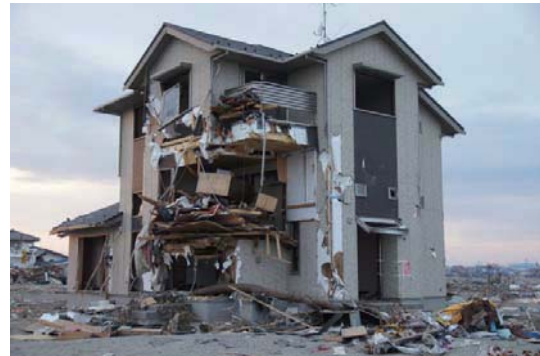
In the north area of the Arahama port, a 3-story wood house (Photo 7.4-25) remained. The reason might be that the lateral strength of 1st story in 3-story building was larger than that in 2-story building.

Photo 7.4-25. 3-story wood house remained in the north of Arahama port.

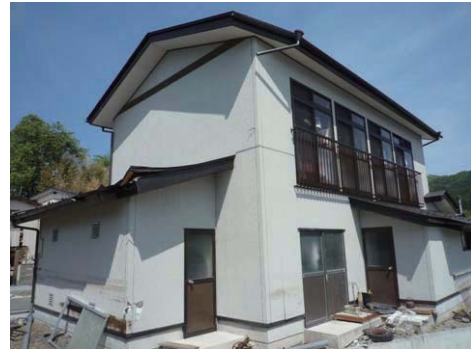
Photo 7.4-28. Wood house (3) without damage under the water depth of over 7 m in Akasaki-cho, Oofunato city.

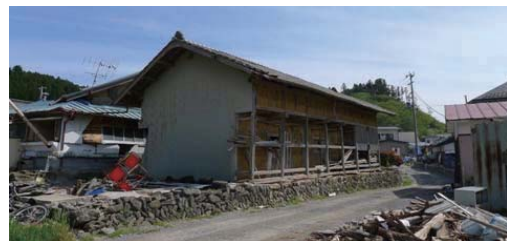
Photo 7.4-32. Survived soil warehouse (10) which seemed to have comparatively slight structural specifications in Akasaki-cho, Oofunato city.

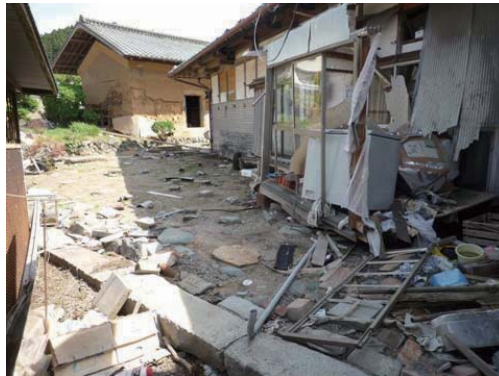
Photo 7.4-33. Survived old house (12) which rotated and moved horizontally in Akasaki-cho, Oofunato city.

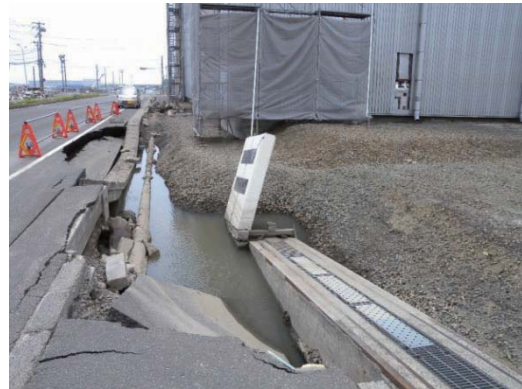
Photo 9.2-9 Excavation of ground
