2.9. Report on Monitoring of Construction Practices of Confined Masonry Structure in Indonesia
(Keiko SAKODA)

**Monitoring activity report
on
housing reconstruction
in Yogyakarta, Indonesia**

12.Mar.2008

NPO EVAA
(Ex-volunteers association for Architects)
Keiko Sakoda

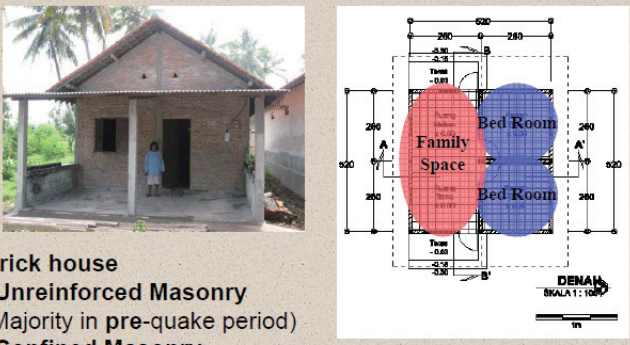
Typical type of house in Indonesia

Brick house

- Unreinforced Masonry
(Majority in pre-quake period)
- Confined Masonry
(Majority in post-quake period)
