Non-Engineered Construction and its Earthquake Damage

Yuji Ishiyama
Professor Emeritus
Hokkaido University

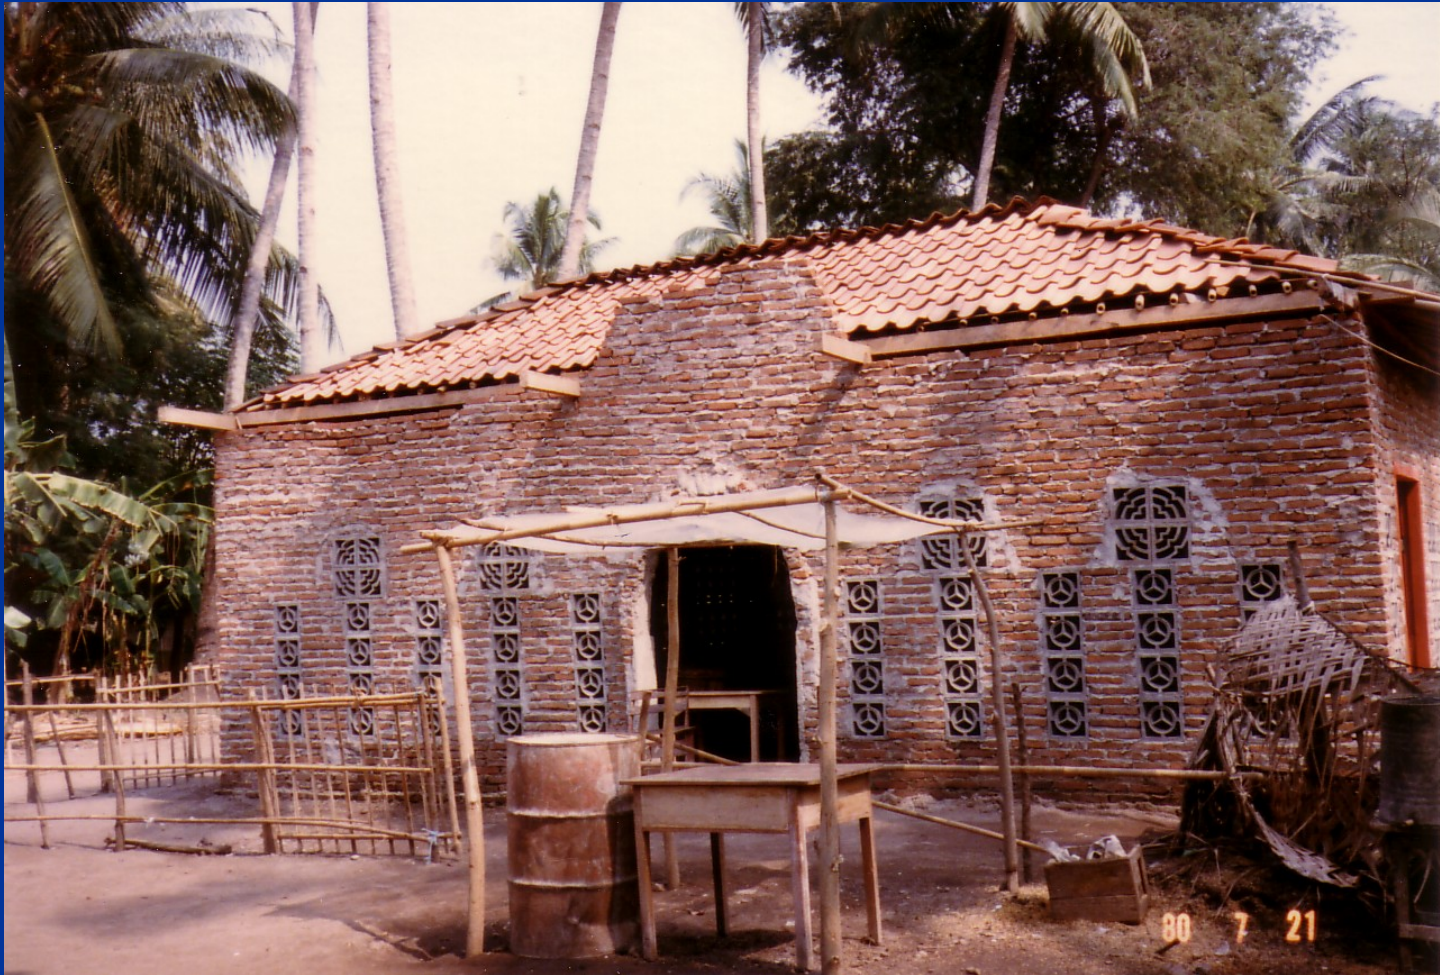
Un-reinforced brick masonry (Java, Indonesia)

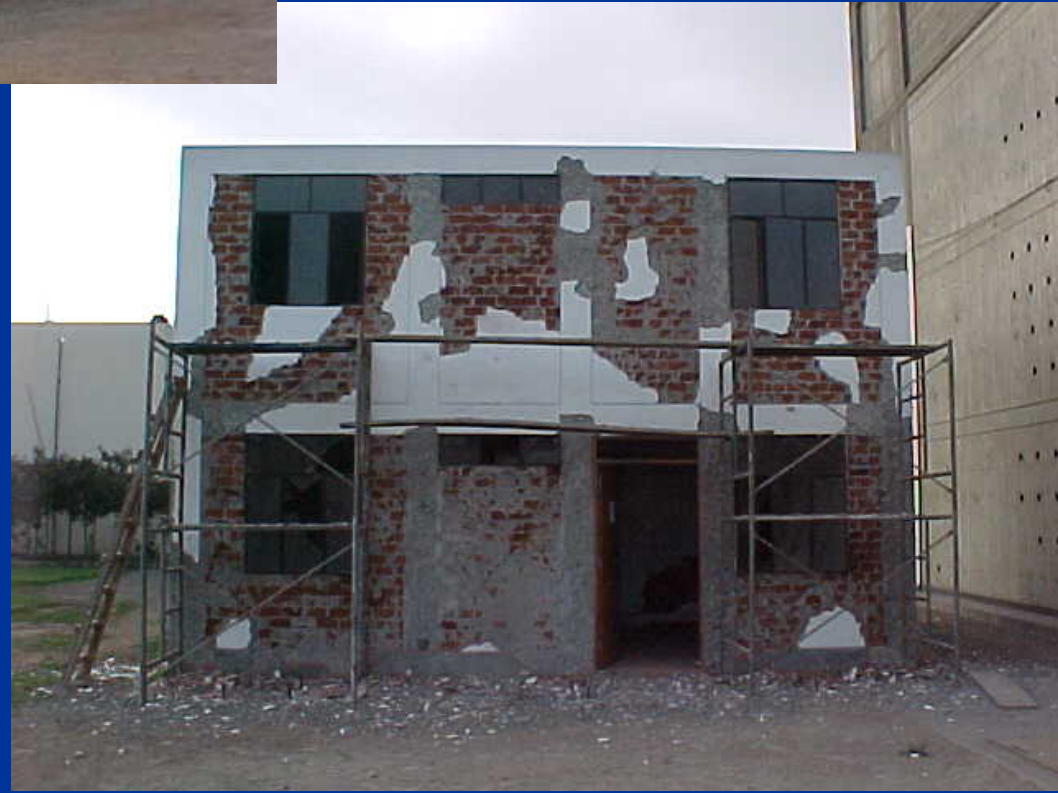
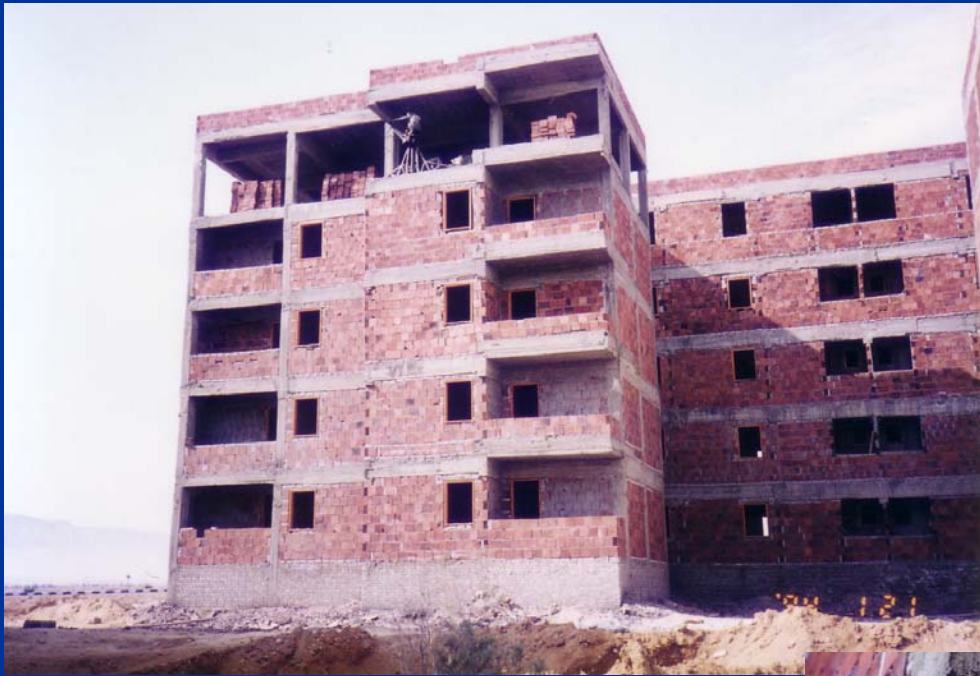
Reinforced concrete
frame with
unreinforced brick
infill walls

Unreinforced masonry infill walls are used in many countries.
