September 2011

**Summary of the Field Survey and Research on  
“The 2011 off the Pacific coast of Tohoku Earthquake”  
(the Great East Japan Earthquake)**

National Institute for Land and Infrastructure Management (NILIM)  
Ministry of Land, Infrastructure, Transport and Tourism, Japan

Building Research Institute (BRI)  
Incorporated Administrative Agency, Japan

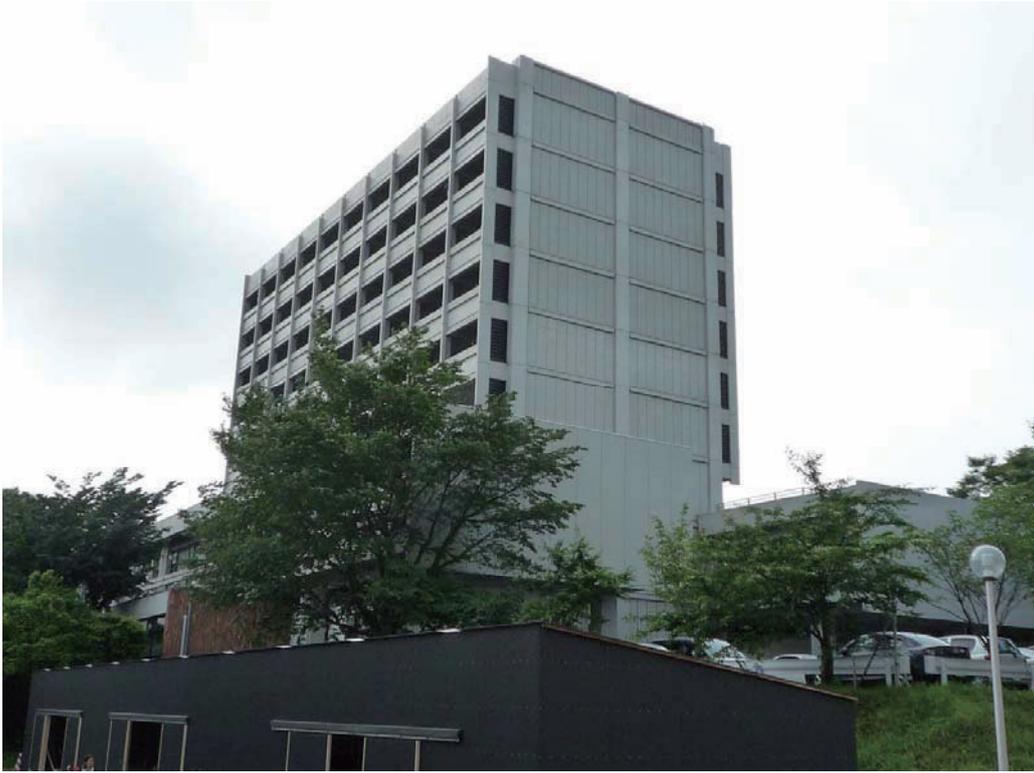
Photo 5.3-1 The research building of Tohoku University

Among buildings in the BRI strong motion network, at least 4 buildings suffered severe earthquake motions and then some damage. One example of the damaged buildings is the research building of Civil Engineering and Architecture, Tohoku University (Photo 5.3-1). This is the 9-story reinforced concrete with embedded steel frames (SRC) school building that is located in the Aobayama Campus of Tohoku University. This building has a long history of strong motion observation. Among them, strong motion records on the ninth floor of the building that had been obtained in the 1978 Miyagi-ken-oki earthquake are well known to have represented a maximum acceleration of more than  $1,000 \text{ cm/s}^2$ .

During the Tohoku earthquake, multi-story shear walls suffered flexural failure and other damage. Strong motion records were obtained during the mainshock as shown in Fig. 5.3-3. Maximum accelerations on the first floor exceeded  $330 \text{ cm/s}^2$  in both of the directions. A maximum acceleration on the ninth floor was twice to three times larger than that on the first floor, and exceeded  $900 \text{ cm/s}^2$  in the transverse direction. The fundamental natural periods in Fig. 5.3-3 (e) represented about 0.7 s at the initial time of the earthquake motion in both of the directions, but increased to about 1 s in the first wave group at the time of 40 to 50 s, and increased from 1.2 s to about 1.5 s in the second wave group at the time of 80 to 100 s. Due to the seismic damage, the fundamental natural period finally became twice longer than the natural period at the initial stage. The stiffness of the building was reduced to 1/4.

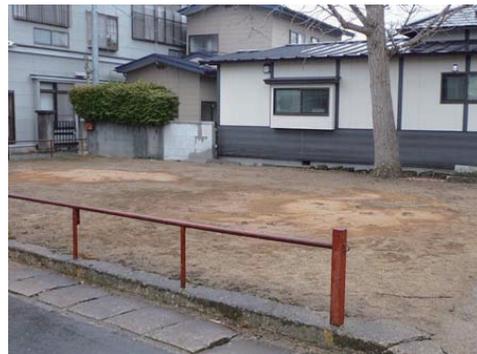
Photo 6.2-2 Sand boil due to liquefaction

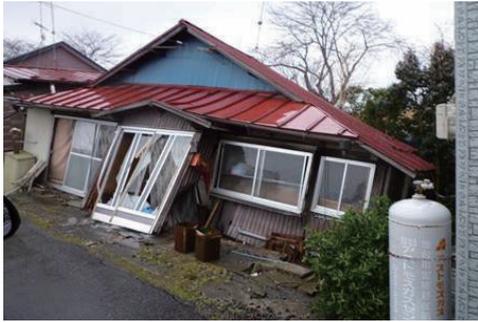
K-NET Kurihara Tsukidate (MYG004 : Instrumental seismic intensity 6.6) is set up on the hillock 3m higher (by eye measurement) than south of parking lot of Kurihara lyceum. There was a possibility of the amplification of earthquake motions (Photo 6.2-1). In Wakayanagi district, the ground was bad and sand boil due to liquefaction was observed (Photo 6.2-2). Damage to houses caused by ground transformation (Photo 6.2-3) and damage to houses with store were also observed (Photo 6.2-4).

Photo 6.2-3 Damage of houses caused by ground transformation

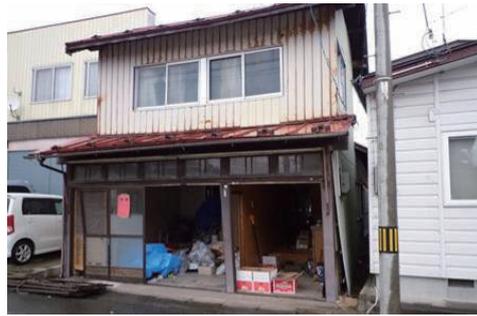
Photo 6.2-4 Damage of houses with store

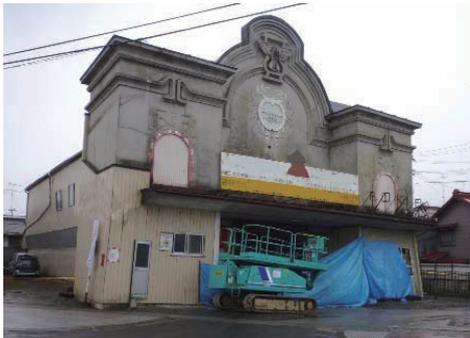
A large residual deformation was observed in the longitudinal direction in the large-scale wood building used as a movie theatre then renovated to a factory (Photos 6.2-5, 6.2-6)

Photo 6.2-5 Large-scale wood building renovated to a factory

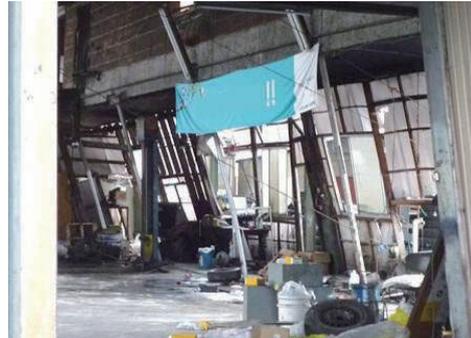
Photo 6.2-6 Inside of the building shown in Photo 6.2-5

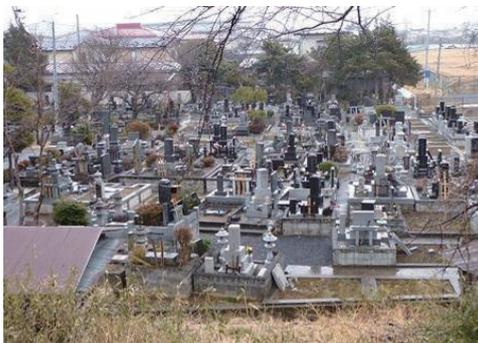
Photo 6.2-7 Overturning of tombstones

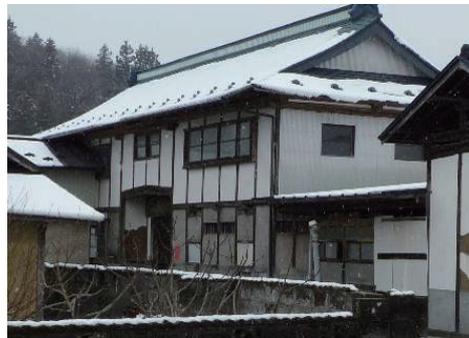
In Kurikomasakurada district, collapse of work hut, drop of the mud plasters of Nagaya-mon gates (Photo 6.2-8), damage of plastered storehouses were observed, but any heavy damage in house was not observed.

Photo 6.2-8 Drop of mud plasters of Nagaya-mon gate (Kurikomasakurada)

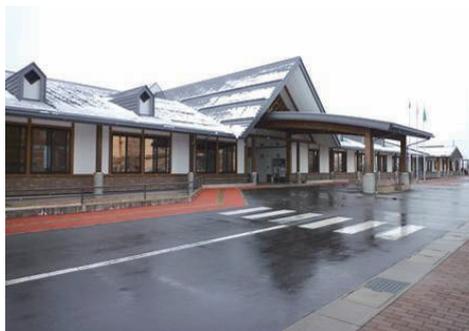
The Seismograph of Kurikoma (JMA seismic intensity 6-) is set up on the parking lot in the west of “Michinoku-Densokan (Photo 6.2-9) ”. From the exterior damage investigation, damage was not observed in “Michinoku-Densokan” and Kurikoma Branch office (Glulam frame structure: Photo 6.2-10).

Photo 6.2-10 Kurikoma Branch office (Glulam frame structure)

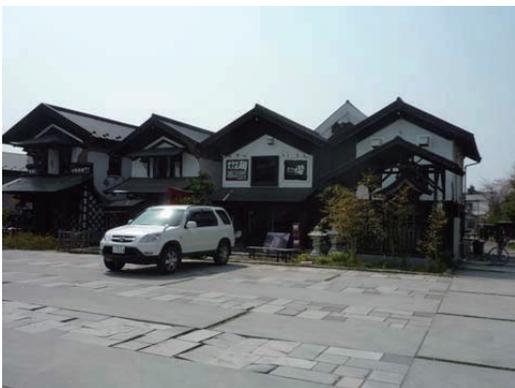
For example, warehouse with the mud walls renovated as store or gallery (Photo 6.2-11) was damaged heavily or slightly. There was the one whose roof system with roof tiles collapsed and fell down, as shown in Photo 6.2-12. In the area of these warehouses, there was a Japanese traditional post and beam construction house with large deformation (Photo 6.2-13) which was renovated as a store. On the opposite side of this house, there was the house with store (Photo 6.2-14) with story shear deformation whose exterior mortar came off and wood lath under the mortar near the opening of the ventilation fan was deteriorated and attacked by termites, as shown in Photo 6.2-15. Such damage was confirmed in the other buildings. Most of these damage occurred along a small river, except for a few case, and it was considered that the soft ground near the river might amplify the earthquake ground motion.

Photo 6.2-11 Warehouse with mud walls damaged heavily or slightly

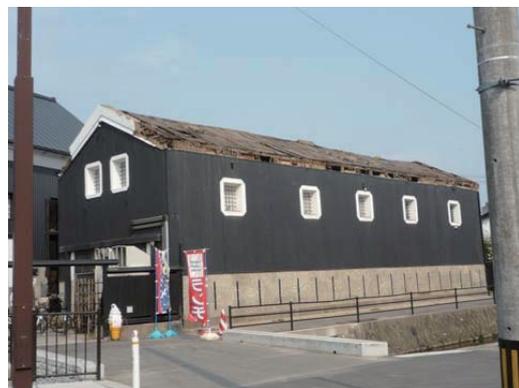
Photo 6.2-12 Warehouse with mud walls whose roof system with roof tiles fell down

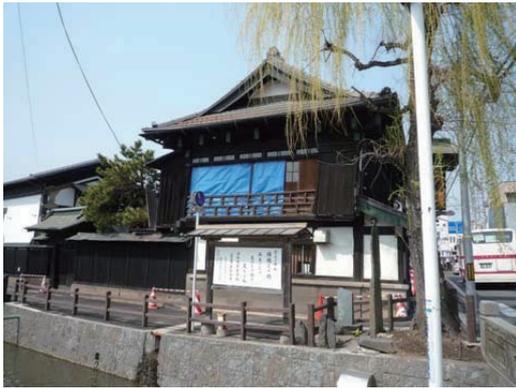
Photo 6.2-13 Damaged Japanese traditional house with large story deformation

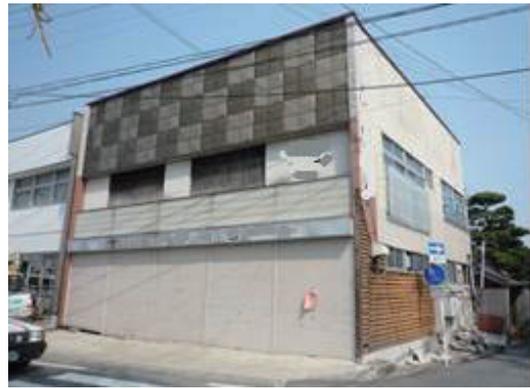
Photo 6.2-14 House with store with large story deformation

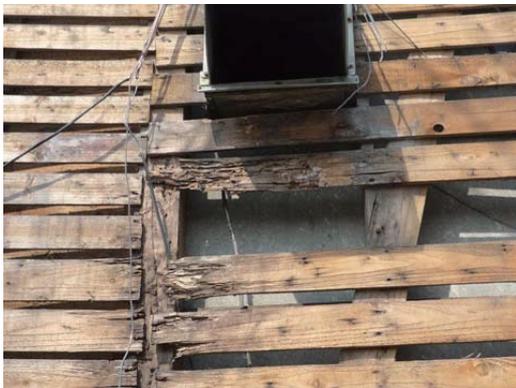
Photo 6.2-15 Deterioration in building of Photo 6.2-14

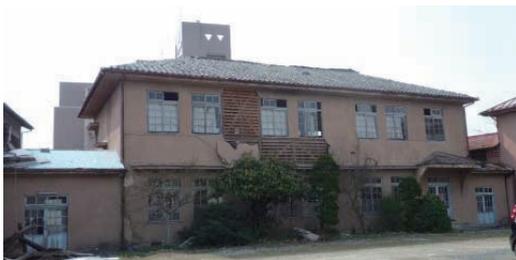
Seismograph at JMA Furukawa (Photo 6.2-16) which recorded seismic intensity 6+ was located in the northeast corner of the Mikkamachi park. There were the former school buildings around it. One of them was not almost damaged (Photo 6.2-17), while the other was damaged on roof tiles and exterior mortar without story drift. In addition to them, a rare damage example (Photo 6.2-18) that only the 2<sup>nd</sup> story collapsed was observed. On the other hand, a wood school building (Photo 6.2-19) in the west of the Osaki city office seemed not to be damaged in the appearance. Besides these, the house with store with large story drift in 1<sup>st</sup> story (Photo 6.2-20), those with large story drift in 2<sup>nd</sup> story (Photo 6.2-21), and 1-story wood house with large story drift caused by the land liquefaction were observed.

Photo 6.2-17 School building suffering damage on roof tiles and exterior walls

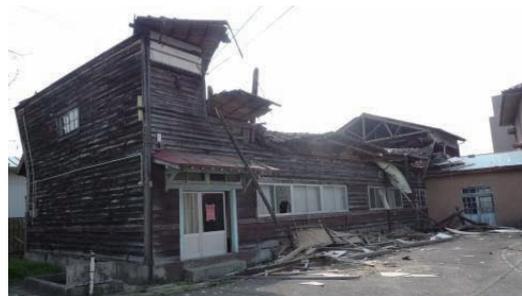
Photo 6.2-18 School building whose 2<sup>nd</sup> story collapsed

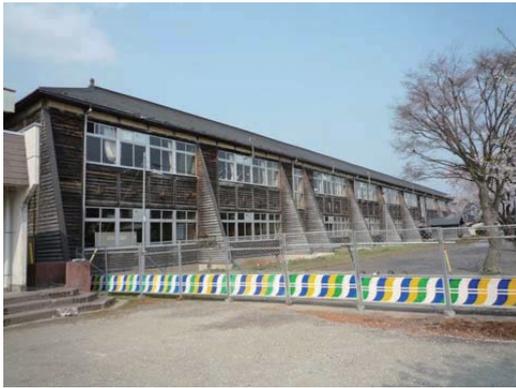
Photo 6.2-19 Seemingly slightly damaged School building

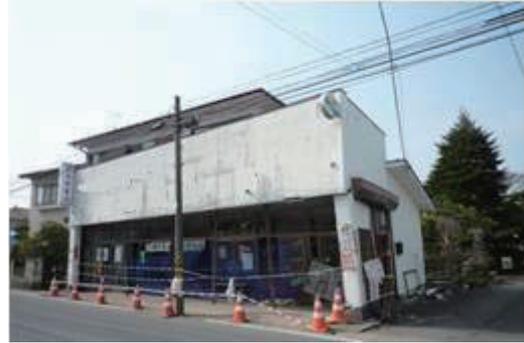
Photo 6.2-20 House with store with large story deformation

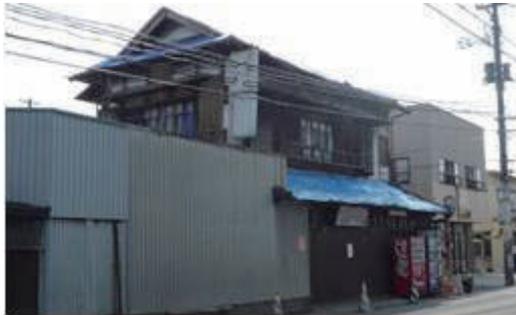
Photo 6.2-21 House with store with 2<sup>nd</sup> story drift more than that of 1<sup>st</sup> story

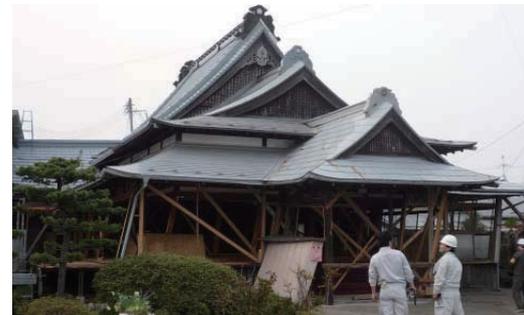
In the northwest of JR Freight Company Furukawa Station, a collapsed steel frame building, an RC structure apartment house with rocking drift caused by the land deformation, and a temple building (Photo 6.2-22) with large story deformation were observed.

Photo 6.2-22 Heavily damaged temple building

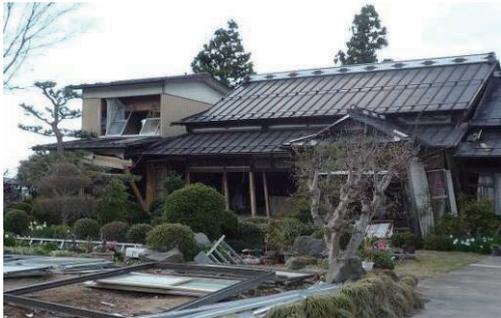
Photo 6.2-23 Largely tilted house

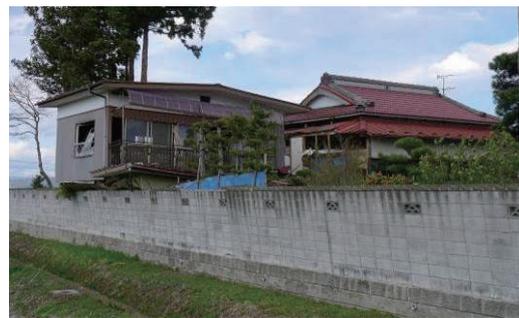
Photo 6.2-24 Collapsed wood house

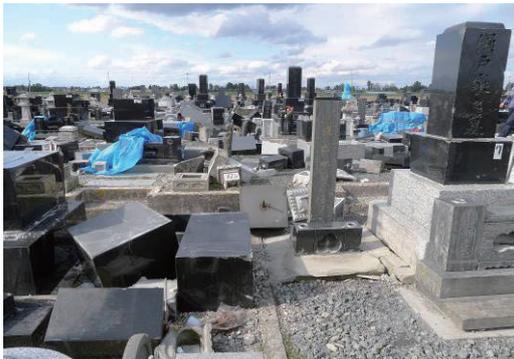
Photo 6.2-25 Tombstones in Hirabari

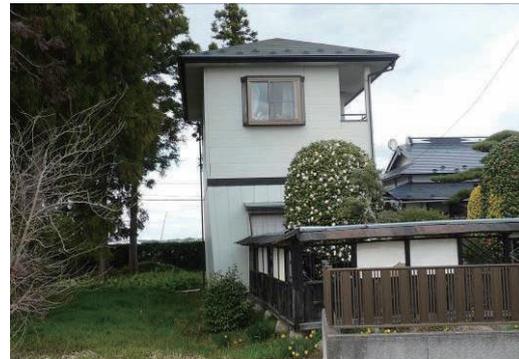
Photo 6.2-26 Tilted two-story house

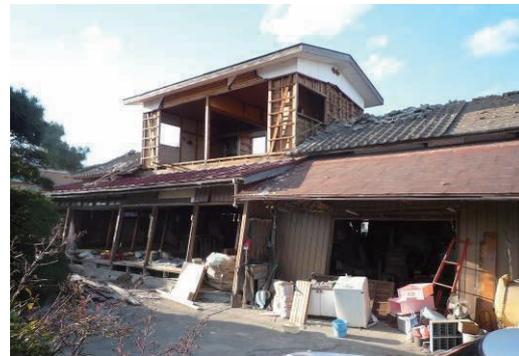
which two-story might have been extended. In the southern side of Eaigawa river, there were log house without damage (Photo 6.2-27), wood house which tilted largely at first story (Photo 6.2-28) and tilted shrine building (Photo 6.2-29).

Photo 6.2-28 Largely tilted wood house

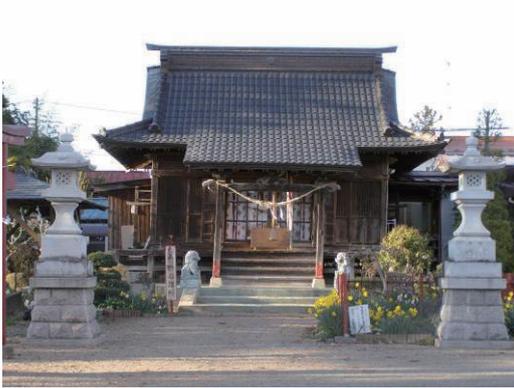
Photo 6.2-29 Damaged shrine

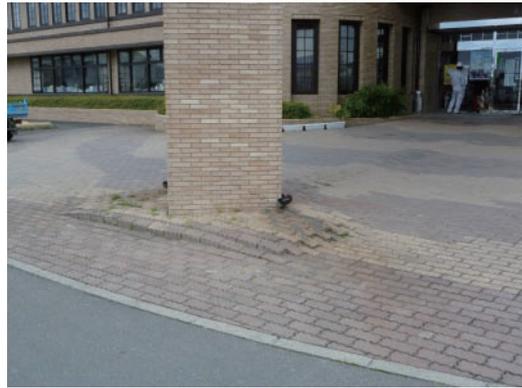
In Nango area, ground deformation was observed in the branch town office (Photo 6.2-30), but there were few damaged houses. Photo 6.2-31 shows the tilted wood house in Nango area. The structures in this area were damaged in a certain level during the 2003 northern Miyagi prefecture earthquake. There is a possibility that damaged buildings were retrofitted or rebuilt after the 2003 earthquake, because structures in this area seemed to be new.

Photo 6.2-30 Ground deformation in Nango branch town office

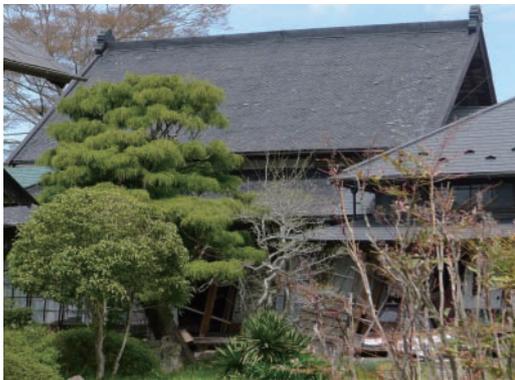
Photo 6.2-31 Heavily damaged house

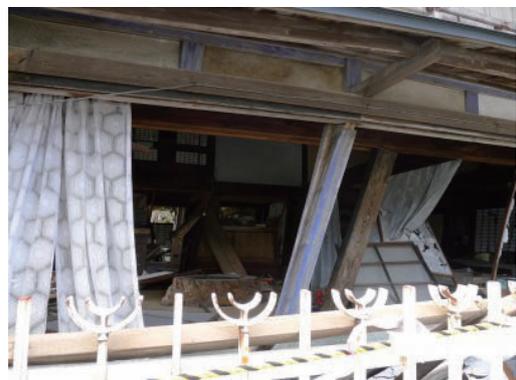
Photo 6.2-32 Inside of the house in Photo 6.2-31

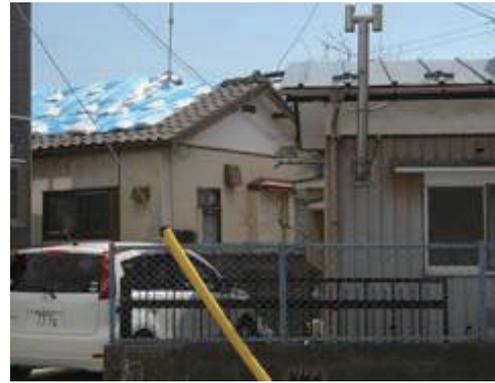
Hiyorigaoka and Izumi-cho in Ishinomaki city are located on a hill (max. Altitude, 56.4m) at the western side of Kyu-kitakami river, almost all of the buildings are residence without public facilities (Photo 6.2-33). There were not heavily damaged wood houses and a few wood houses of which roof tile damaged (Photo 6.2-34).

Photo 6.2-34 Damaged roof tile in Hiyorigaoka

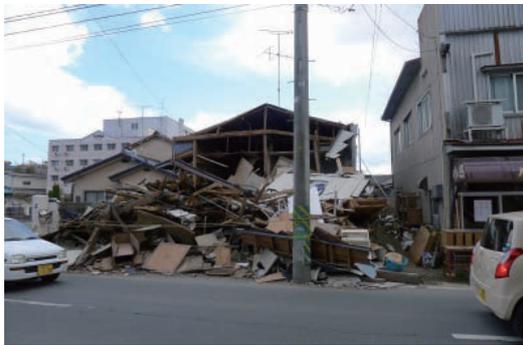
On the both sides of the street, there were collapsed wood house by earthquake (Photo 6.2-35) and tilted wood house with store (Photo 6.2-36). It was estimated that the wood houses with store which have less seismic elements at the first story were heavily damaged.

Photo 6.2-35 Collapsed wood house

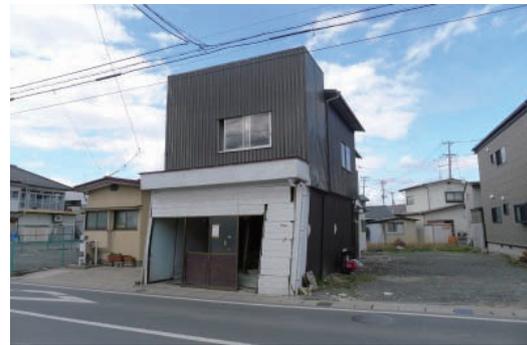
Photo 6.2-36 Tilted wood house with store

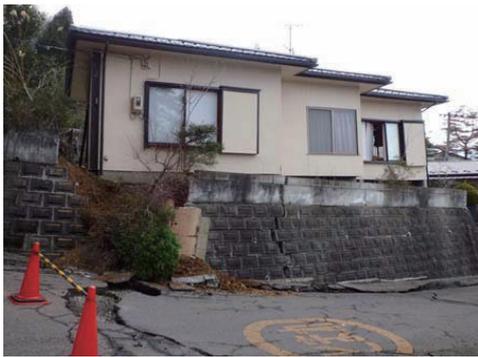
From the results of investigations on Oritate and Seikaen where the damage of the houses were serious, it was found that almost all of the damage of house were caused by ground transformation. Moreover, ground transformation caused retaining wall collapse (Photo 6.2-37, 6.2-38), landslide and damage of houses (Photo 6.2-39). On the other hand, there were some sloping lands in Kaigamori and Asahigaoka where the number of damage of retaining wall was minor, and damage of roof tile, collapse of concrete block wall and outer wall were observed. In Komatsujima, Aoba ward, drop off the mortar wall and damage of columns and biodeterioration by termites were observed in the house with store (Photo 6.2-40). Moreover, the house with large residual deformation on the 1st floor was observed (Photo 6.2-41). In Mukaiyama, Taihaku ward, collapse of a Japanese-style hotel was observed because of the sudden fall of stone of hillback (Photo

Photo 6.2-37 Damage of retaining wall and houses (Oritate, Aoba ward)

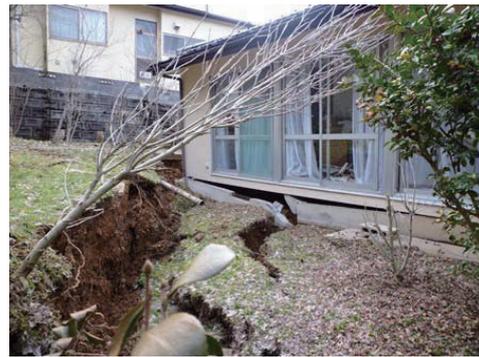
Photo 6.2-38 Damage of house in Photo 6.2-37

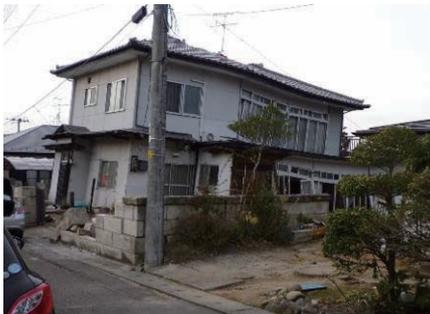
Photo 6.2-39 Damage of house caused by the ground transformation (Oritate)

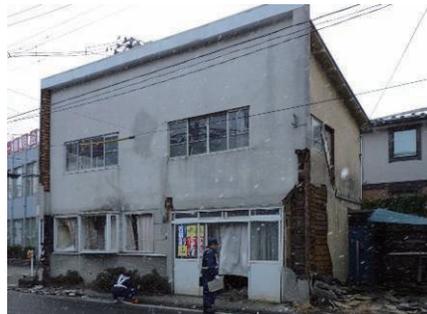
Photo 6.2-40 Drop off the mortar wall (Komatsujima)

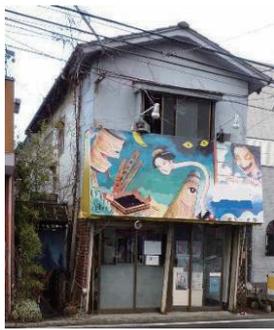
Photo 6.2-41 House with large residual deformation (Komatsujima)

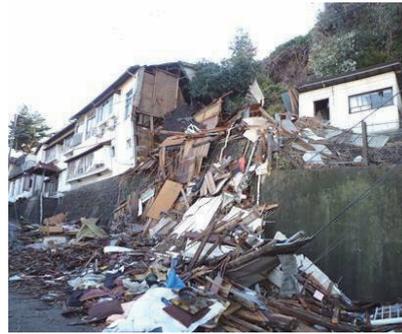
Photo 6.2-42 Collapse of Japanese-style hotel (Mukaiyama)

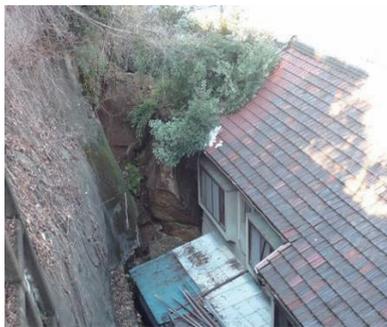
Photo 6.2-43 Hillback of the hotel

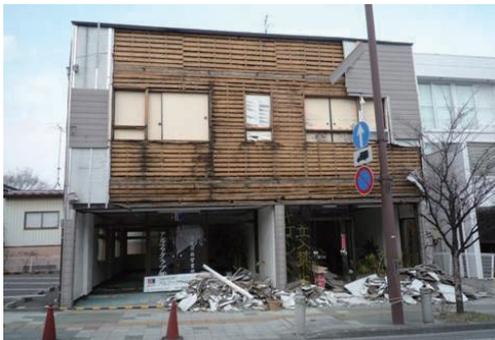
A lot of damaged wood houses were observed around the collapsed RC structure building. Examples are as follows: the failed exterior mortar wall of the 2<sup>nd</sup> floor in a house with store (Photo 6.2-44), deterioration and damage by *Reticulitermes* on a part of structural member and wood lath of exterior mortar wall (Photo 6.2-45), a wood house whose stair hall was removed and collapsed (Photo 6.2-46), and so on.

Photo 6.2-44 Fallen mortar of wall (Wood house with store)

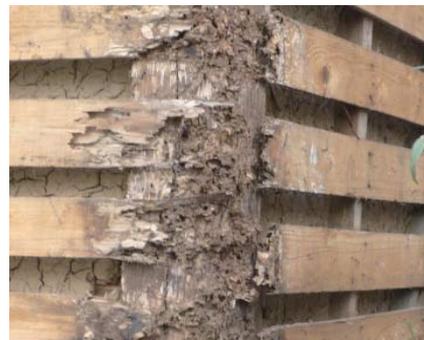
Photo 6.2-45 Deterioration and damage due to termite on column and wood lath of exterior mortar

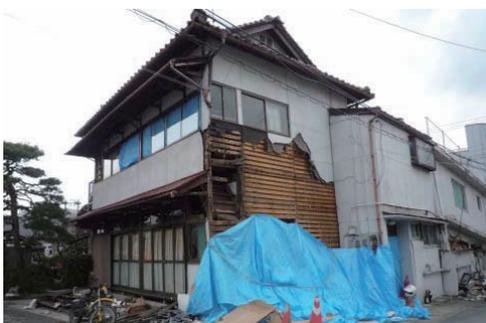
Photo 6.2-46 Collapsed stair hall

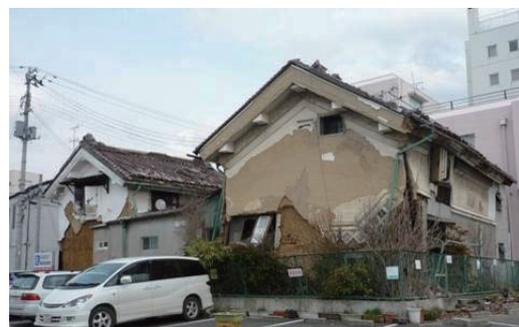
The wood warehouses with mud wall were heavily damaged near the hotel with the window glass broken. For example, the warehouses which deformed much (Photo 6.2-47) and whose roof system collapsed (Photo 6.2-48) were observed. A few wood houses with roof tiles damaged (*e.g.* Photo 6.2-49) were found. On the other hand, roof tiles of temple gate (called as “*Sanmon*”) were damaged, while the main hall of the

Photo 6.2-47 Failed warehouse with mud wall

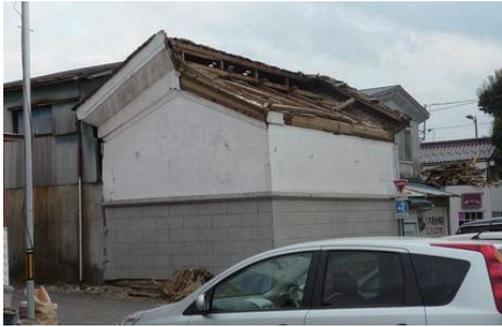
Photo 6.2-48 Fallen roof of warehouse with mud wall

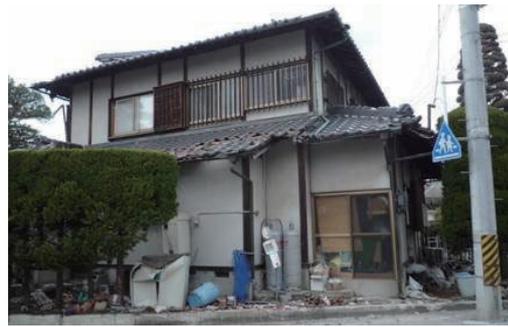
Photo 6.2-49 Damage of roof tile

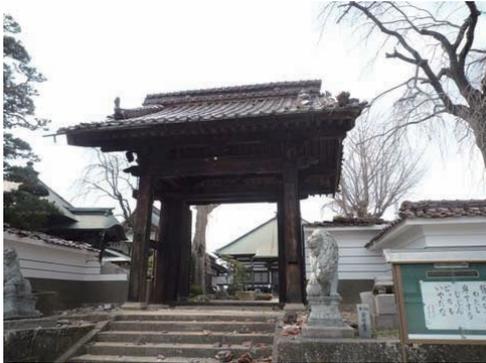
Photo 6.2-50 Minor damage of temple gate

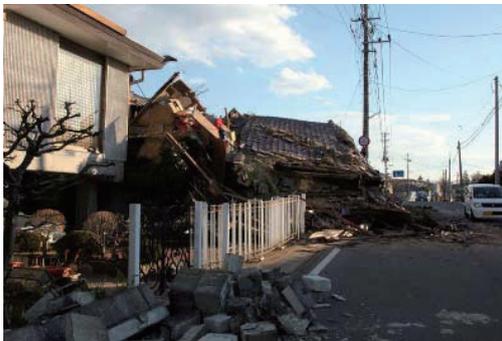
Photo 6.2-52 Collapsed wood house at Minami-machi (From Sukagawa city website)

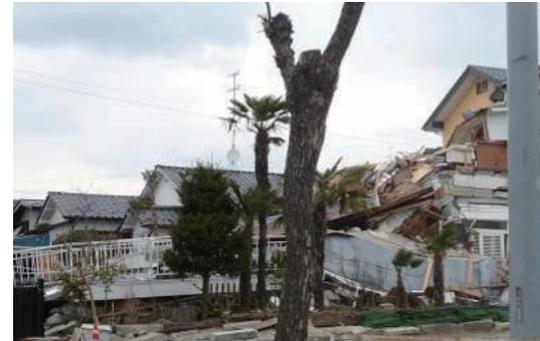
Another collapsed building with uncertain structural type was found (Photo 6.2-53). According to the damage overview seen from the east of Minami-machi (Photo 6.2-54), it was observed that the wood houses with roof covered temporarily with blue vinyl sheet which was guessed to be damaged to roof tiles were relatively many.

Photo 6.2-53 Collapsed building (Unknown structure type)

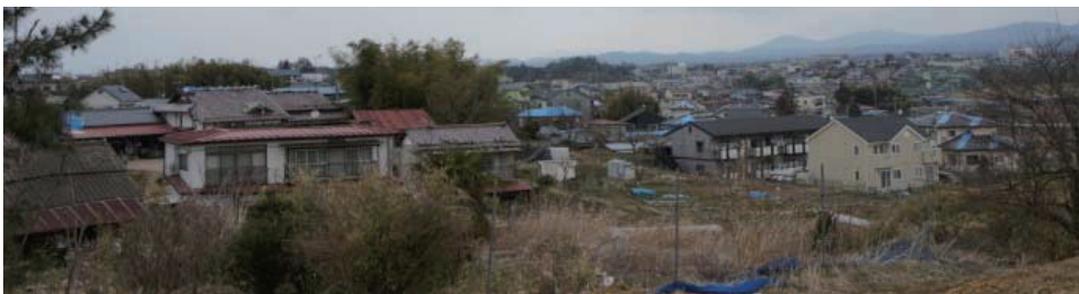
Photo 6.2-54 Damage overview from the east of Minami-machi (Many roofs covered with blue vinyl sheet)

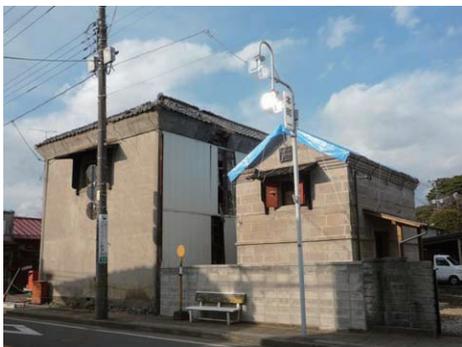
The stone-built warehouse was heavily damaged near the town office (Photo 6.2-55). The exterior stonewall of the former post office was failed (Photo 6.2-56).

Photo 6.2-55 Damage of stone-built warehouses

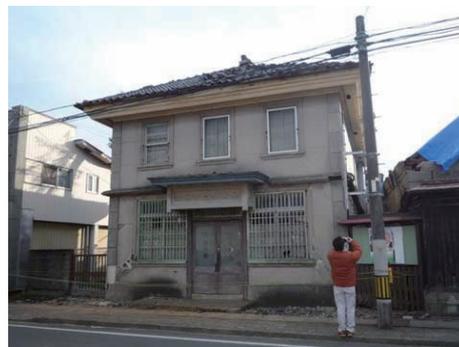
Photo 6.2-56 Damage of an old post office

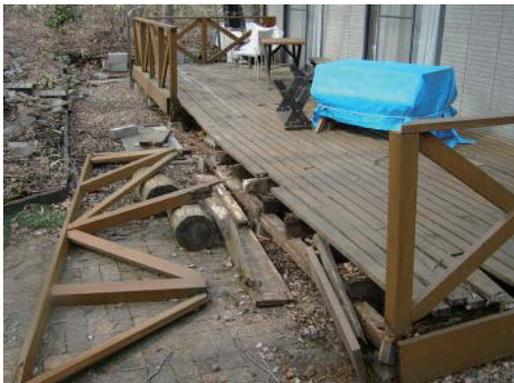
Photo 6.2-57 Damage of wood deck in Toyohara-Otsu, Nasu town

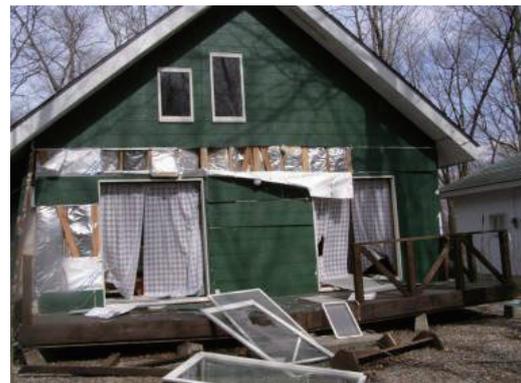
Photo 6.2-58 Heavily damaged wood house

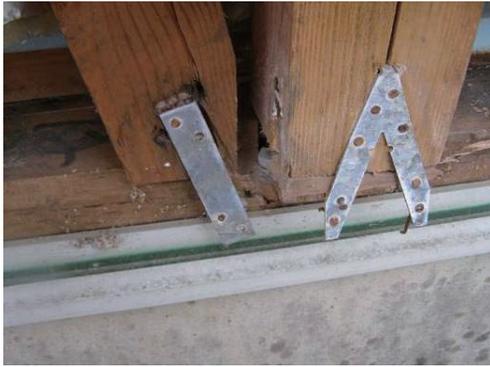
Photo 6.2-59 Metal fastener at the end of column and brace

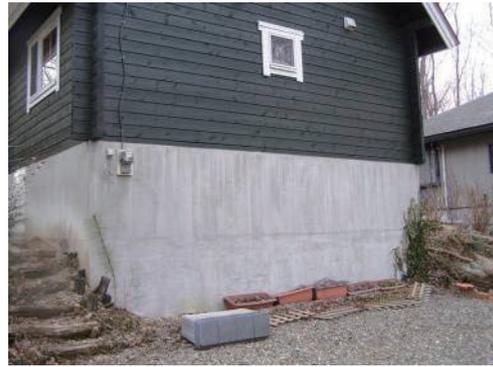
Photo 6.2-60 Crack of foundation

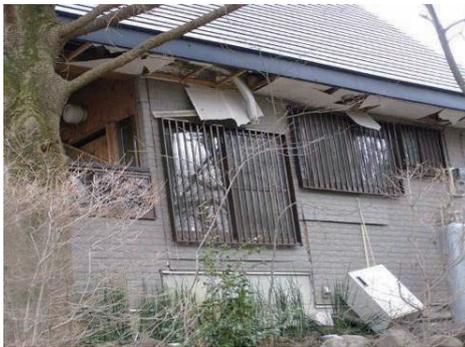
Photo 6.2-61 Failed ceiling of eave

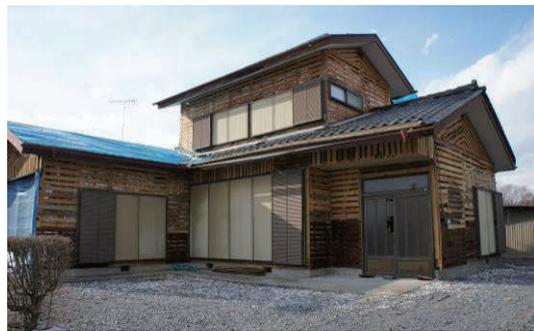
In Nishi-Ohkubo area, several wood houses whose exterior mortar wall in the 1<sup>st</sup> floor was almost failed were found (Photo 6.2-62). And, the wood house with large story drift (Photo 6.2-63) and the other one damaged due to deformation of the residential land (Photo 6.2-64) were found.

Photo 6.2-62 Damage of exterior mortar wall

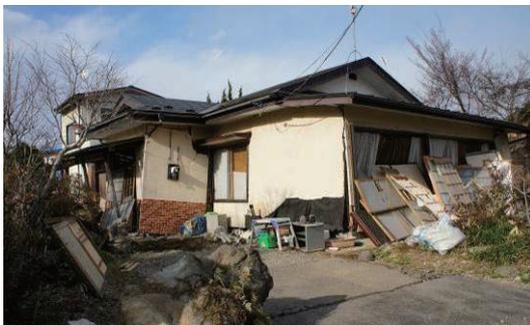
Photo 6.2-63 Wood house with large story drift

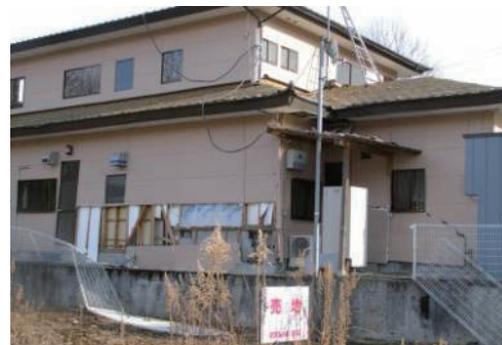
Photo 6.2-64 Damaged house due to deformation of residential land

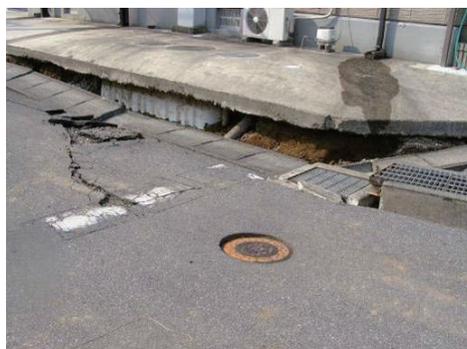
In Lobin-city (Photo 6.2-65), cracks of fence and retaining wall, caving of road bed, ups and downs of the residential land (Photo 6.2-66) and cracks of the foundation concrete (Photo 6.2-67) were often observed. In addition, damage on the roof tile, especially top of the roof, and collapsed concrete block fences were observed.

Photo 6.2-66 Ups and downs of residential land

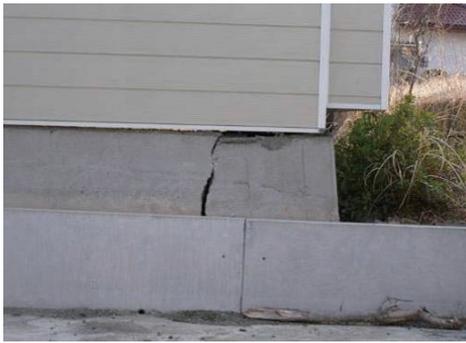
Photo 6.2-67 Crack of foundation

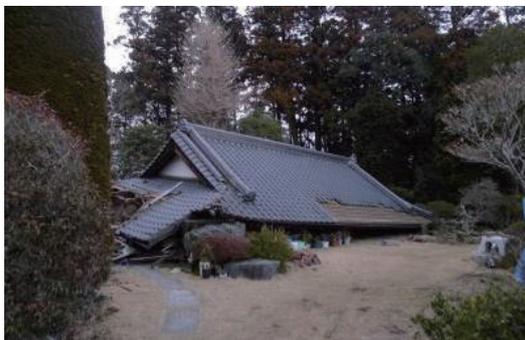
There were a lot of damaged fence made by the Ohyaishi stone. A collapsed farm type house was observed (Photo 6.2-69, 6.2-70). The mortar plastered wall finish of the wood house at the land filled paddy field fell down (Photo 6.2-71).

Photo 6.2-69 Collapsed wood house

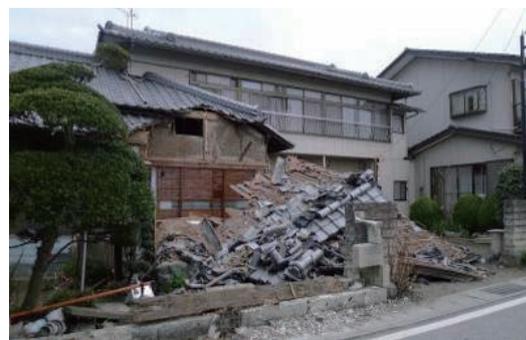
Photo 6.2-70 Breakage of entrance part.

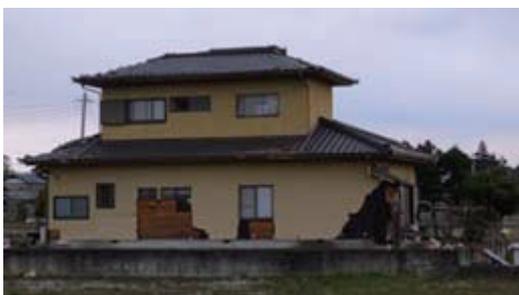
Photo 6.2-71 Falling down of mortar plastered wall

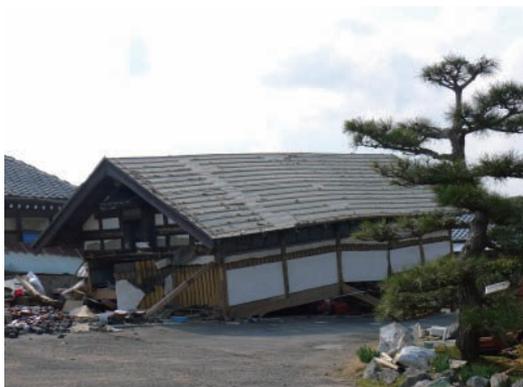
At Kadobe-shimogawara in Naka city, there were a lot of collapsed barns (Photo 6.2-72) and heavily damaged nagayamon gates (Photo 6.2-73). A damaged house with store was observed (Photo 6.2-74). A lot of collapsed barns were observed at Kadobe-akutsu.

Photo 6.2-72 Collapsed nagayamon gate (Kadobe)

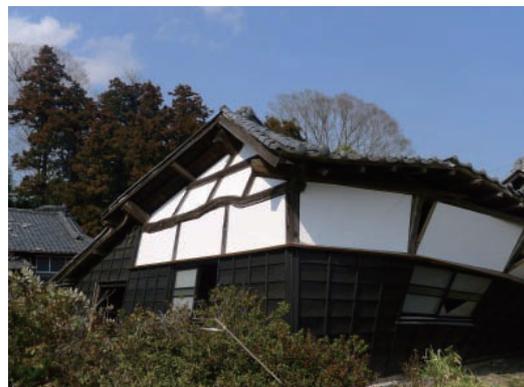
Photo 6.2-73 Tilted nagayamon gate (Kadobe)

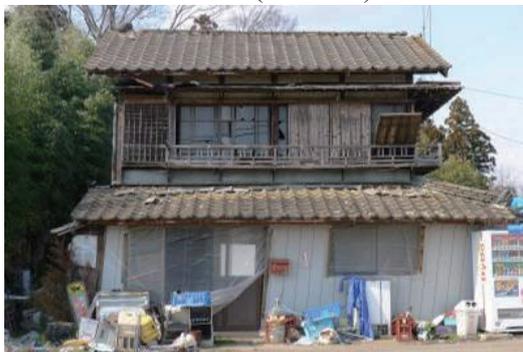
Photo 6.2-74 Damaged house with store (Kadobe)

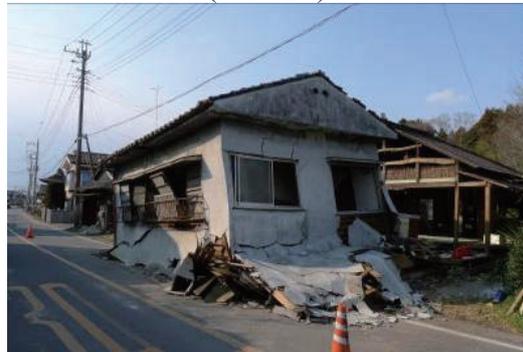
A two story wood house with mortar finish collapsed at the urban area of Urizura in Naka city (Photo 6.2-75).

Photo 6.2-75 Collapsed house (Urizura)

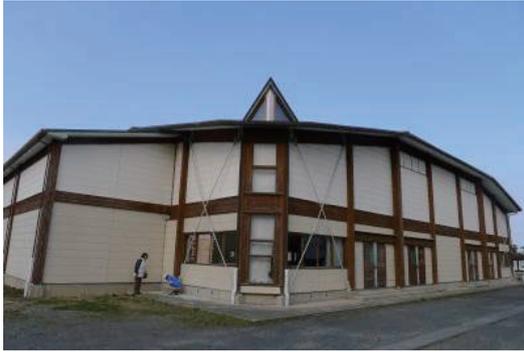
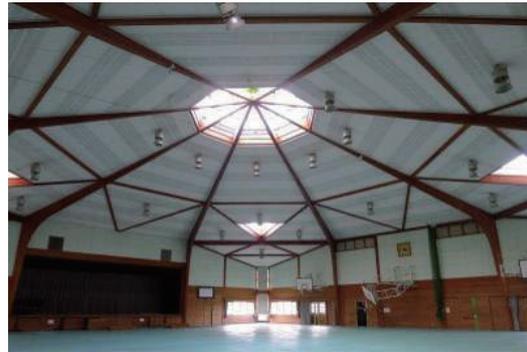
At the wood gymnasium (Photo 6.2-76, Photo 6.2-77) with curved glue laminated timber built in 1985-1989 in Urizura, buckling and tensile failure of the steel braces, the breakages of the foundation concrete at the brace joint were observed (Photo 6.2-78). At the wood school building (Photo 6.2-79), the slip of wood braces (Photo 6.2-80), the deformation of steel roof plate, wood flooring and interior material due to the contact with the stairway made by reinforced concrete were observed.

Photo 6.2-76 Wood gymnasium

Photo 6.2-77 Inside of the gymnasium

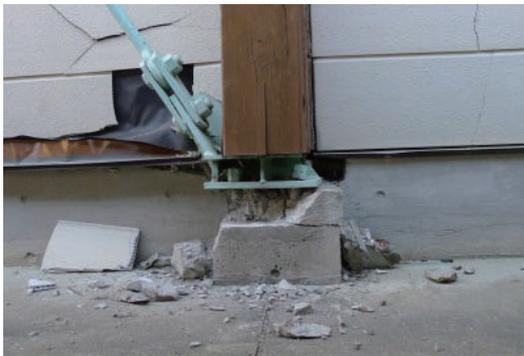
Photo 6.2-78 Breakage of the foundation concrete

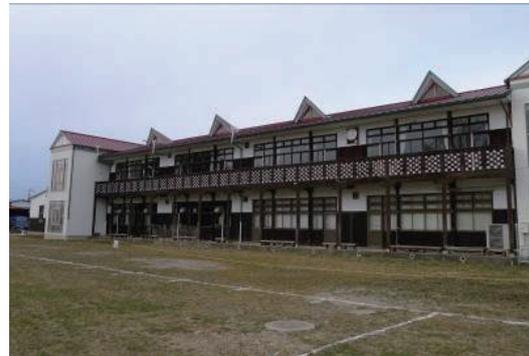
Photo 6.2-79 Wood school building

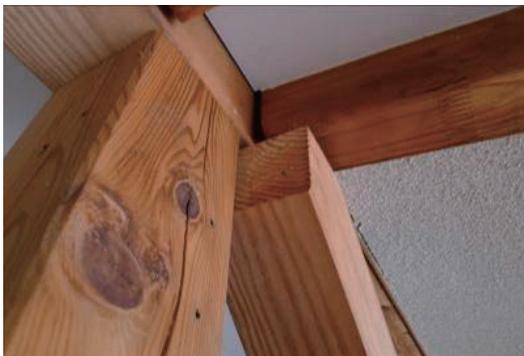
Photo 6.2-80 Slip of the wood brace

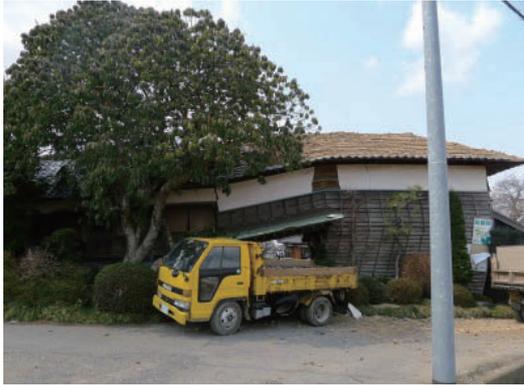
There was a heavily damaged Nagayamon gate at Yoshinuma-cho (Photo 6.2-81). The damaged barns were observed at Aoyagi-cho, Yanagawa-cho, Taya-cho (Photo 6.2-82).

Photo 6.2-81 Heavily damaged Nagayamon gate (Yoshinuma-cho)

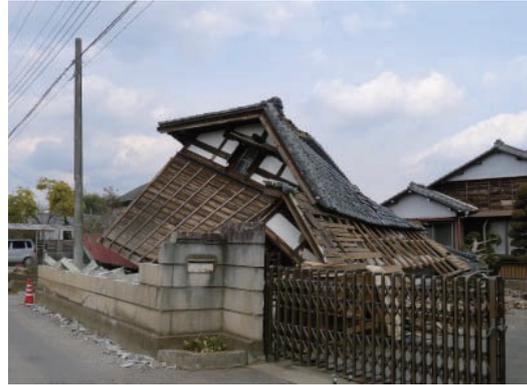
Photo 6.2-82 Damaged barn (Aoyagi-cho)

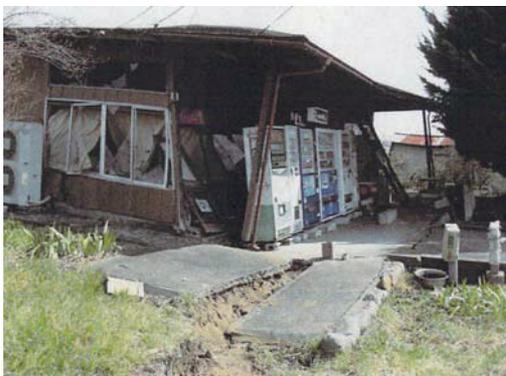
According to the Joso city office, Ibaraki prefecture, structural damage was not observed for houses. An announcement of collapsed house immediately after the earthquake, was the damage to a wood hut in a resting place. The house built in the side of Lake of crescent was inclined because of the soil liquefaction (Photo 6.2-83, 6.2-84). Although there were several inclined houses because of the soil liquefaction, a lot of damage to the roof tile were observed, and it seemed that the ratio of the damage of the roof tile was comparatively high.

Photo 6.2-83 Damage of resting place (Joja-machi, offered by Joso city office)

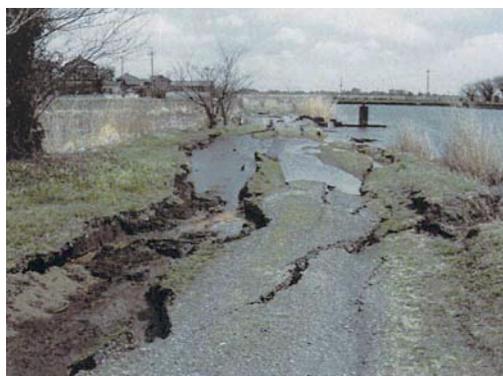
Photo 6.2-84 Damage of ground near the resting place (offered by Joso city office)

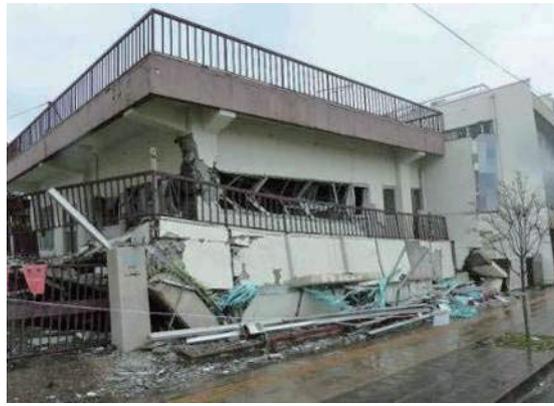
The first story in a two-story RC office building shown in Photo 6.3-1 was completely collapsed in Wakabayashi ward, Sendai city. In addition, the shear failure and the axial deformation of the columns on the second floor of this building caused the buckling of the longitudinal reinforcements and the fracture of the hoops of columns in the first story.

Photo 6.3-1 First-story collapsed building (Wakabayashi ward, Sendai city)

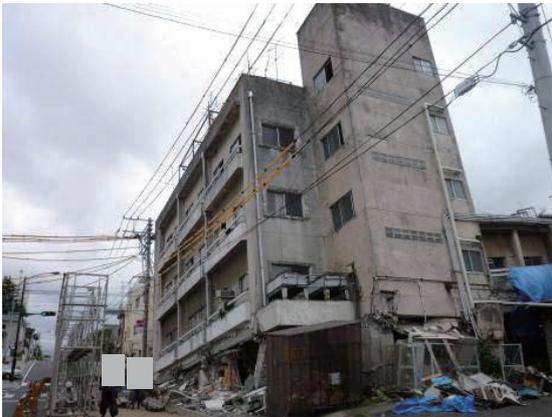
The soft-first story collapse occurred on a four-story RC residential building with a shop in the first floor in Koriyama city, and was attributed to the shear failure of the columns on the first story and the torsional deformation (Photos 6.3-2 and 6.3-3). The RC shear wall on the first story was collapsed out-of-plane with buckling of reinforcing bars.

Photo 6.3-2 First-story collapsed building (Koriyama city)

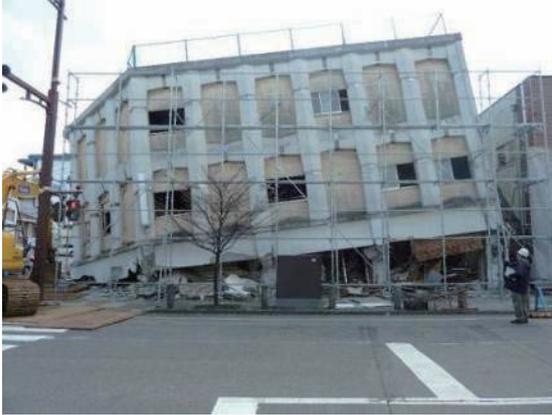
A three-story RC building shown in Photo 6.3-4 was severely damaged on the first story, which was located at the intersection in Sukagawa city, had a few walls on the facade on the first story and many walls on the back of the first story and the second story and higher. The corner columns faced to the intersection were significantly destroyed as shown in Photo 6.3-5. The loss of axial load carrying capacity of the first-story columns caused the drop of the second and higher stories.

Photo 6.3-4 First-story collapsed building (Sukagawa city)

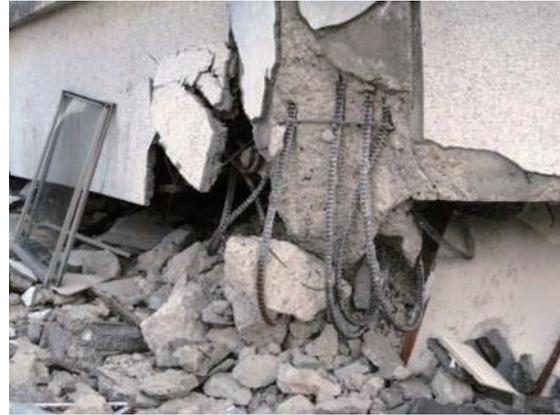
Photo 6.3-5 Close-up view of the fallen story

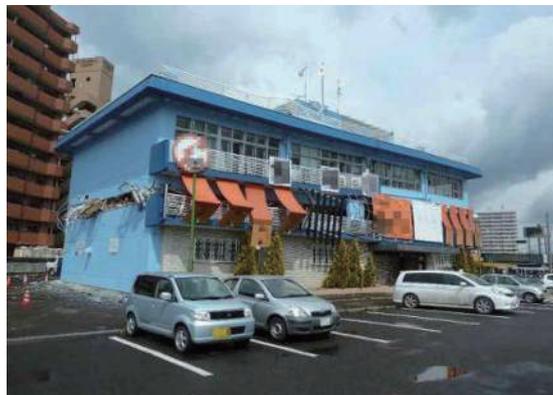
A three-story office building shown in Photo 6.3-6 in Wakabayashi ward, Sendai city partially collapsed on the second story and the building tilted. Only the second story has openings on the wall at the gable side, as shown in the left of Photo 6.3-6. For this reason, it was assumed that the openings were intensively deformed and resulted in shear failure of the short columns formed by the hanging and spandrel walls. The shear failure of the long columns on the third story was observed possibly due to the effect of the collapse of the second story. The damage to the columns and beams on the first story was not seen, while shear cracks were observed on the nonstructural walls.

Photo 6.3-6 Mid-story collapsed building (Wakabayashi ward, Sendai city)

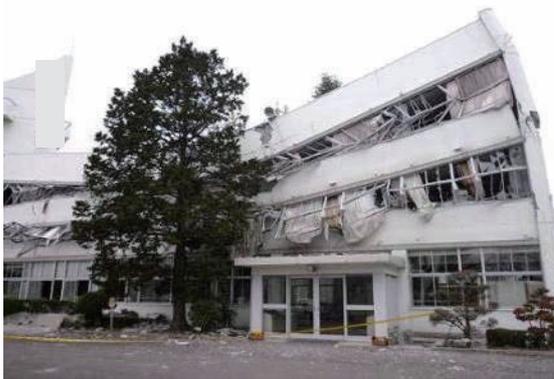
1966 and has a Y-letter shape plan in Fukushima city. The mid-story collapse occurred on the second story, and the part of the third story was heavily damaged. In addition, the shear failure also occurred on the columns in the first story, as shown in Photo 6.3-8. Visual damage was not seen in other school buildings and the gymnasium on the same site. The seismic indices of the structure,  $I_S$  on the first and second stories of the building were below the seismic demand index of structure,  $I_{S0}$  by the seismic evaluation method <sup>6.3-1)</sup>, therefore the seismic retrofit of the building had been planned.

Photo 6.3-7 Mid-story collapsed building (Fukushima city)

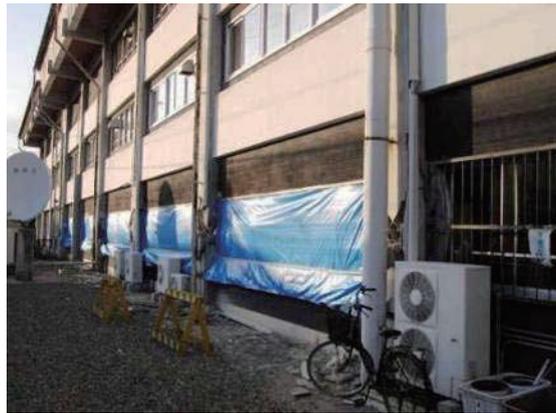
A three-story RC building constructed in 1963 was suffered from the shear failures of columns in Tono city of Iwate prefecture, where the JMA seismic intensity was 5 upper (5+) (Photo 6.3-9). Two extremely short columns on the first-story, four columns on the northern plane of structure and an interior shear wall were failed in shear as shown in Photo 6.3-10, and short columns with spandrel wall, some long columns on the southern plane of structure had shear cracks. The post-earthquake damage evaluation <sup>6.3-2)</sup> was conducted for the building in the longitudinal direction. In the result, the building was determined to represent heavy damage (residual seismic performance ratio,  $R=57.8\%$ ). The building had been damaged in the South Sanriku Earthquake in 2003 (JMA seismic intensity 6 lower). For this reason, cover concrete was then recast on the shear-cracked columns, and the existing columns were temporary strengthened with H-shaped steel, as shown in Photo 6.3-11. However, the 2011 Tohoku earthquake affected these columns again.

Photo 6.3-9 Appearance of the damaged building (Tono city)

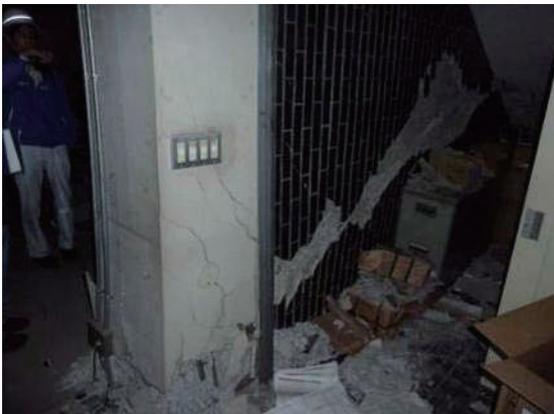
Photo 6.3-10 Shear crack on shear wall

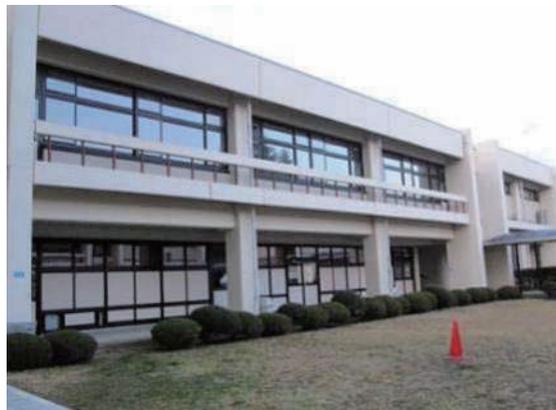
The next case is that the shear failure occurred on the first-story columns in a two-story RC building in Aoba ward, Sendai city (Photos 6.3-12 and 6.3-13). Some columns of the building were intact after the mainshock on March 11, but aftershocks caused shear failure to some of them, as shown on the right of Photo 6.3-13. It was confirmed that the aftershocks accelerated the damage level of this building.

Photo 6.3-12 Appearance of the damaged building (Aoba ward, Sendai city)

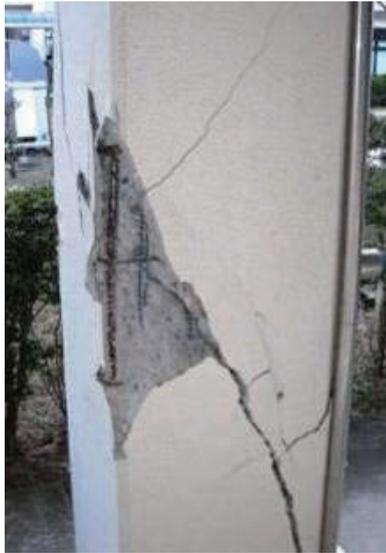
Photo 6.3-13 Shear cracks of first-story columns

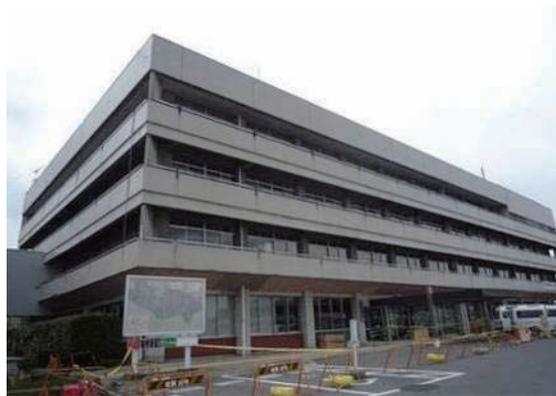
Photo 6.3-14 shows the four-story RC building that was constructed in 1970 in Sukagawa city. The columns with the spandrel wall on the first story were heavily damaged in shear and shorten in the axial direction as shown in Photo 6.3-15. The same damage was observed on the second-story exterior columns. Some of the reinforcing bars of the damaged columns that were raised from the foundation were anchored with a 180-degree hook near the mid height of story. It is considered that the shear failure began at this point. Two shear walls were severely damaged, which were arranged in the center core of the building to resist mainly horizontal forces. In particular, the second-story core wall was failed in shear in both of the span and longitudinal directions, and the longitudinal reinforcements in the boundary column of shear wall were heavily buckled as shown in Photo 6.3-16.

Photo 6.3-14 Appearance of damaged building (Sukagawa city)
