September 2011

**Summary of the Field Survey and Research on  
“The 2011 off the Pacific coast of Tohoku Earthquake”  
(the Great East Japan Earthquake)**

National Institute for Land and Infrastructure Management (NILIM)  
Ministry of Land, Infrastructure, Transport and Tourism, Japan

Building Research Institute (BRI)  
Incorporated Administrative Agency, Japan

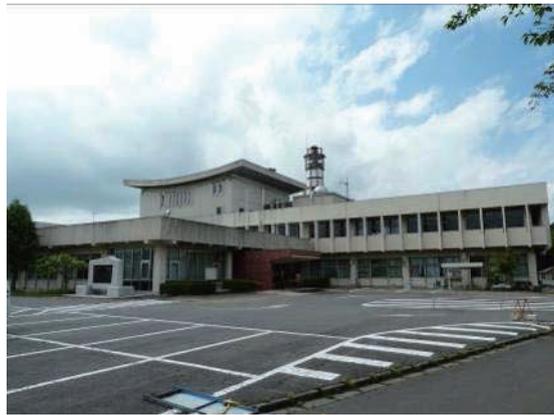
A three-story RC building constructed in 1964 on a hill in Kasama city of Ibaraki prefecture shown in Photo 6.3-17 also suffered damage. Cracks in the ground were observed around the building. As seen in the photo, the RC structure on the first story was severely damaged. Shear failure occurred on many exterior columns, which were made shorter in clear height by the hanging and spandrel walls without structural slit, as shown in Photo 6.3-18. In addition, the failure of the shear wall with opening was observed (Photo 6.3-19).

Photo 6.3-17 Appearance of damaged building (Kasama city)

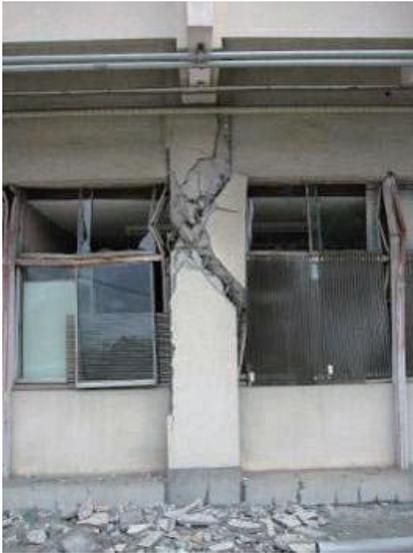
Photo 6.3-18 Shear failure of column

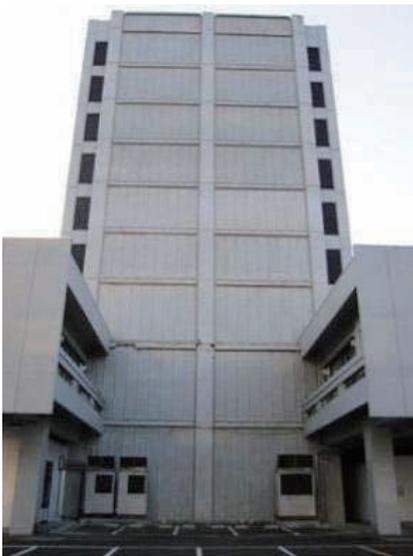
A building that consists of nine-story SRC and two-story RC structures in Aoba ward, Sendai city suffered from the earthquake (Photo 6.3-20). In the high-rise building, the multi-story shear wall of the gable side was subject to flexural failure at the third floor. Crushing of concrete and buckling of the longitudinal reinforcements was observed at the bottom of the boundary column of shear wall, as shown in Photo 6.3-21. This building was also damaged by the Miyagiken-oki Earthquake in 1978 and had been retrofitted.

Photo 6.3-20 Appearance of damaged building (Aoba ward, Sendai city)

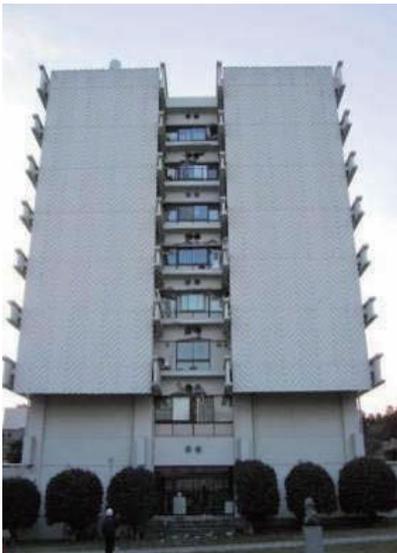
The shear failure or bond splitting failure occurred on the link beam connecting coupled shear walls from low-rise to high-rise stories on a eight-story RC building in Aoba ward, Sendai city, as shown in Photo 6.3-27. The link beams have two openings at the center of them, and were damaged around these parts (Photo 6.3-28).

Photo 6.3-27 Appearance of damaged building (Aoba ward, Sendai city)

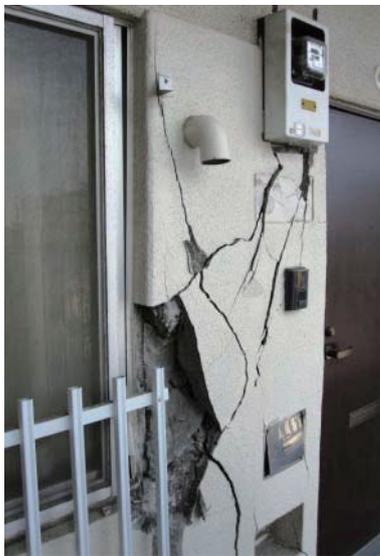
A fourteen-story RC building shown in Photo 6.3-29 was settled down and was tilted about 1/70 radian. The building is one of two residential buildings located in L-shape with expansion joint in Miyagino ward, Sendai city. The shear cracks on the nonstructural walls over every story and some parts of mullions occurred in both buildings as shown in Photos 6.3-30 and 6.3-31, which damage was classified as B-2). Though the other building without inclination had same shear cracks on the nonstructural walls from first to sixth story in the Miyagiken-oki Earthquake in 1978 and had been repaired with concrete replacement, almost same damage was happened on the similar part.

Photo 6.3-30 Shear cracks on nonstructural wall

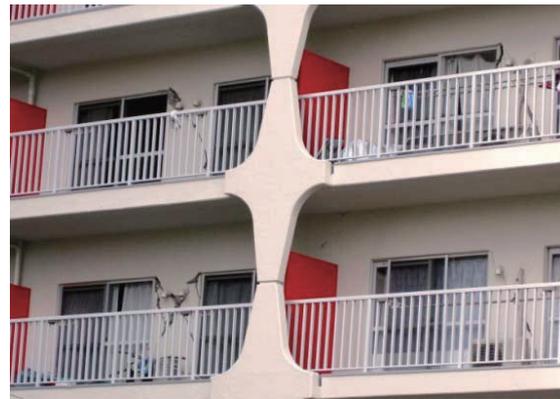
Photo 6.3-31 Shear cracks on mullion

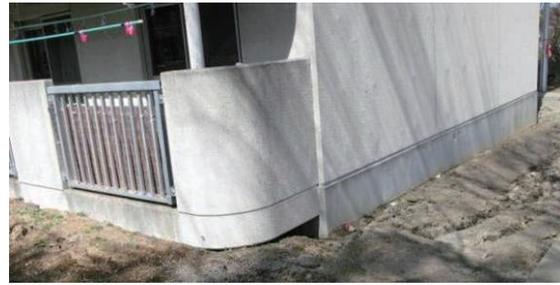
Photo 6.3-32 shows a residential building that sank and leaned in the longitudinal direction in Shirakawa city. The balcony, of which height above ground level was about 77cm, went down to ground surface in the gable side, as shown in Photo 6.3-33.

Photo 6.3-33 Sunken balcony

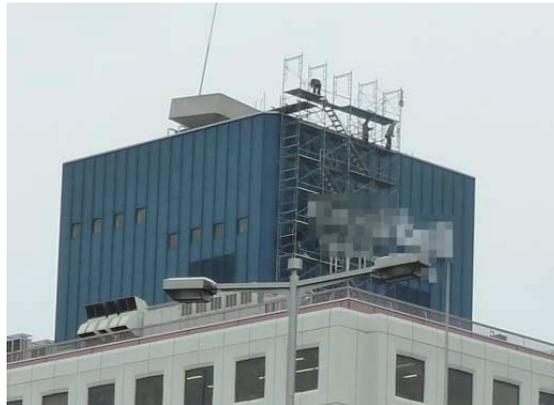
The damage on penthouses was observed everywhere, like tilting of it in Aoba ward, Sendai city, as shown in Photo 6.3-34. The clock tower attached to a five-story RC building constructed in 1954 was destroyed at the bottom of it, despite the building was heavily damaged in Fukushima city (Photos 6.3-35 and 6.3-36).

Photo 6.3-34 Damaged penthouse (Aoba ward, Sendai city)

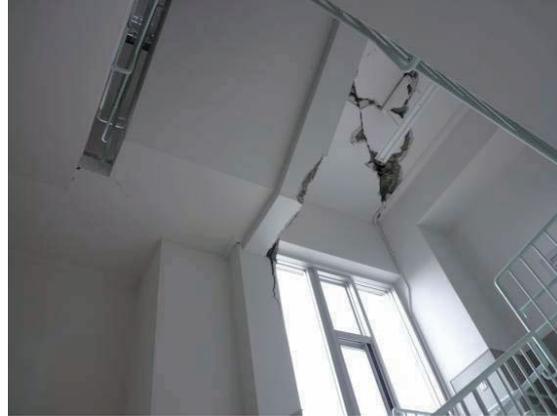
Photo 6.3-36 Bottom of the tower

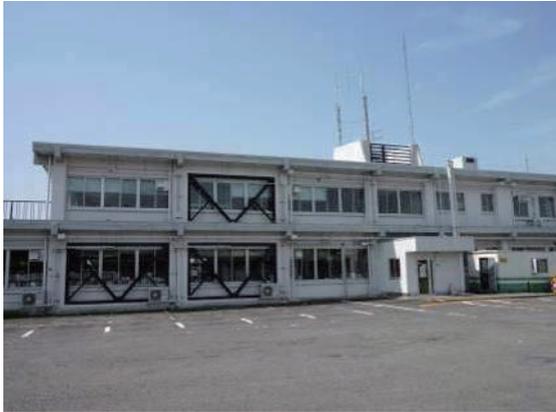
Photo 6.3-37 shows a two-story RC office building constructed in 1969 in Hitachiomiya city of Ibaraki prefecture. The building had been retrofitted with framed steel braces in the longitudinal direction in 2003, because the seismic index of structure,  $I_S$  on the first story of the building was below the seismic demand index of structure,  $I_{S0}$  by the seismic evaluation method <sup>6.3-1)</sup>. Meanwhile, the building in the span direction was not retrofitted, as a consequence the seismic index of structure in the direction satisfied the seismic demand index of structure. The steel braces had been eccentrically installed to the center axis of the beams and columns.

Photo 6.3-37 Appearance of damaged building (Hitachiomiya city)

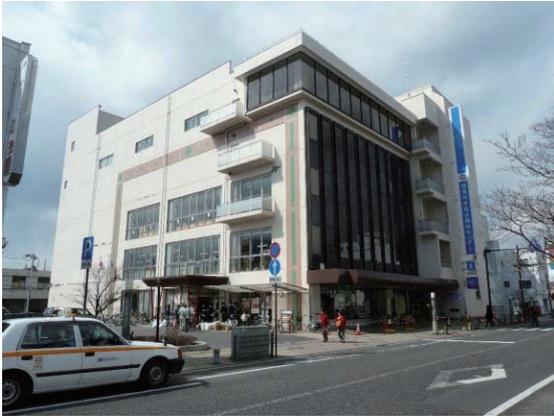
The separation of cover concrete at the bottom of wing wall was observed on a five-story RC building constructed in 2007 in Sukagawa city of Fukushima prefecture, as shown in Photos 6.3-39 and 6.3-40. In this report, that case is classified as the damage of nonstructural elements, because the wing wall is generally designed as the nonstructural element, which is not expected to resist the external force.

Photo 6.3-39 Appearance of damaged building (Sukagawa city)

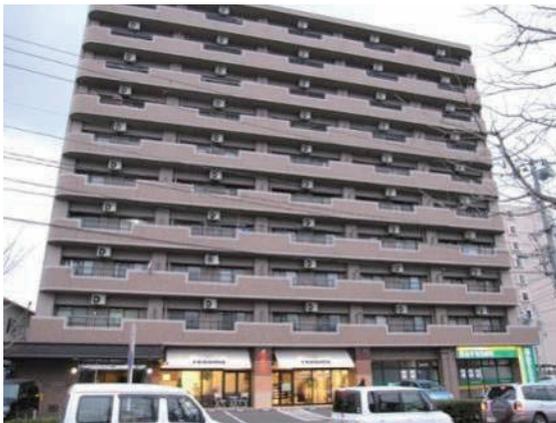
The nonstructural walls around the front doors from lower to top floors were subject to shear failure, while the doors were deformed on a ten-story SRC residential building constructed in Aoba ward, Sendai city in 1996, as shown in Photos 6.3-41 and 6.3-42. In addition, shear cracks were observed on the mullion walls on balconies in some of the lower floors.

Photo 6.3-41 Appearance of damaged building (Aoba ward, Sendai city)

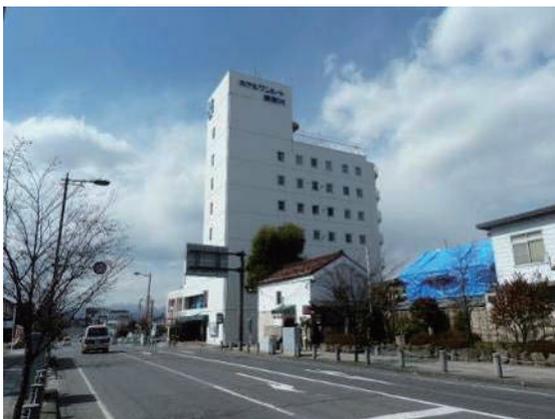
cracks occurred on the nonstructural wall in the longitudinal direction. For this reason, the front door was deformed out-of-plane as shown in Photo 6.3-44, and could not be opened and closed. The shear cracks on the mullion walls also occurred in a eight-story RC hotel building in Sukagawa city (Photos 6.3-45 and 6.3-46).

Photo 6.3-45 Appearance of damaged building (Sukagawa city)

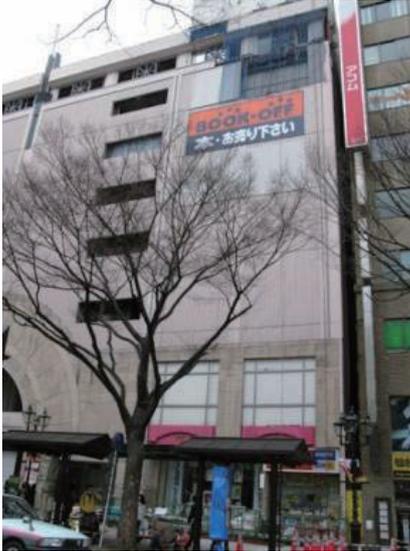
Photo 6.3-47 Damaged building with AAC panels (Aoba ward, Sendai city)

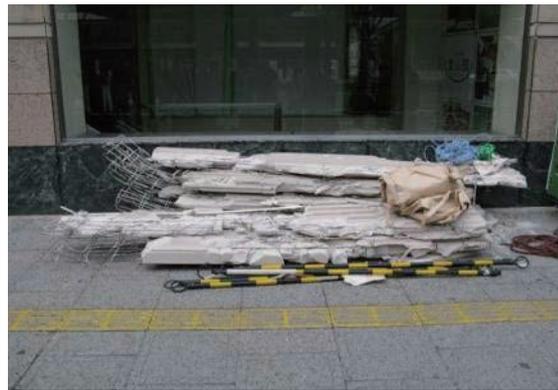
upper floor in a eight-story building fell down, and Photo 6.3-49 is the case where the tile on exterior wall was dropped, in Aoba ward, Sendai city.

Photo 6.3-48 Dropped AAC panels

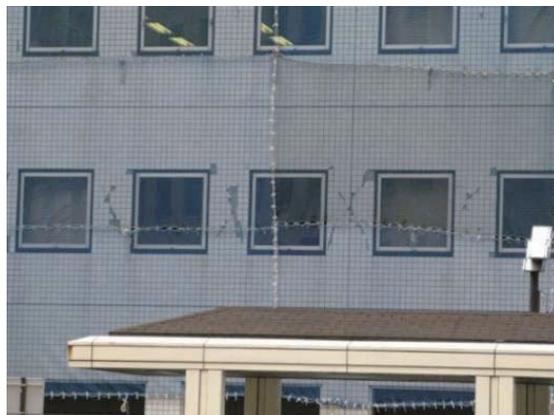
Photo 6.3-49 Damage of tile on exterior wall

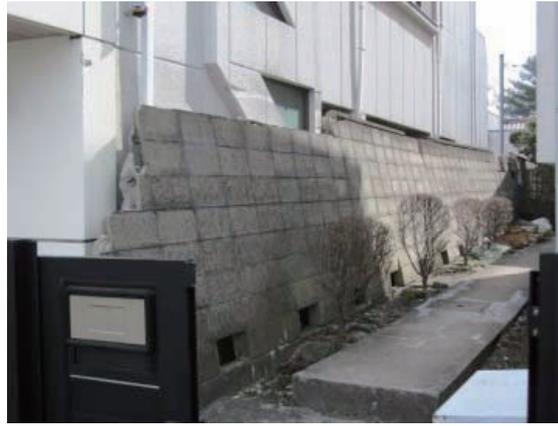
Photo 6.3-51 Collapse of concrete block wall (Sukagawa city)

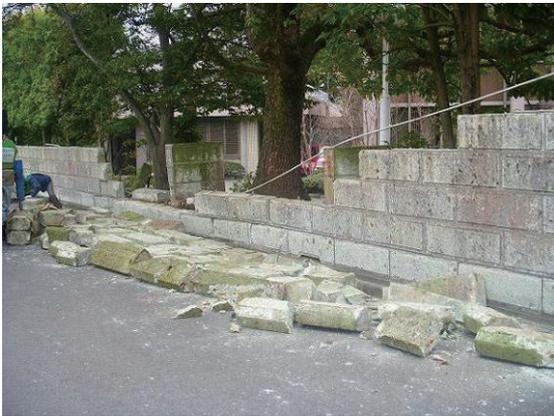
Photo 6.3-52 Collapse of stone masonry wall (Fukushima city)

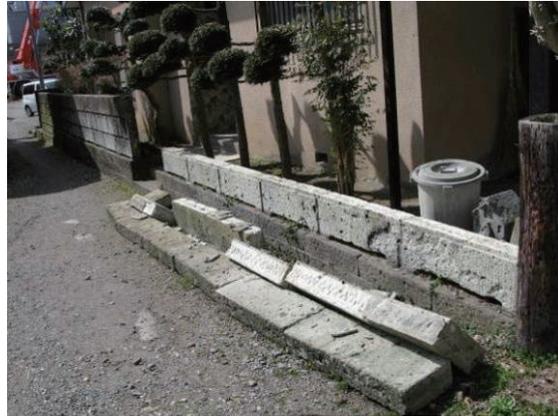
Photo 6.3-53 Collapse of stone masonry wall (Shirakawa city)

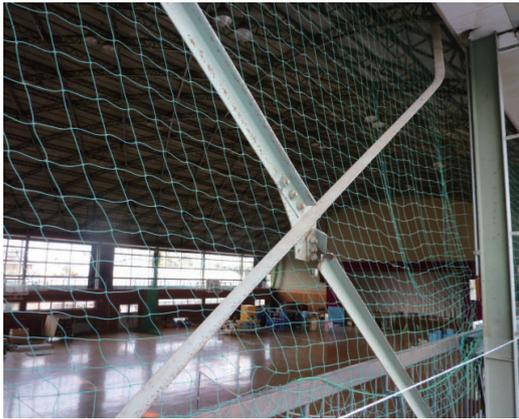
Buckling of brace member (Photo 6.4-1) and fracture of brace joint (Photos 6.4-2 ~ 6.4-4) were observed. Angle section was often used for many brace members, but circular hollow section steel (Photo 6.4-3) was also used for brace members. Fractured sections include steel plate inserted into steel pipe, end of bracing member and section loss part by bolt hole. These types of the damage are classified into the severe damage category based on the damage evaluation standard<sup>6.4-4)</sup>. The number of the gymnasiums of this type is 3. The gymnasiums constructed under the previous seismic code that had been severely damaged by the Mid Niigata Prefecture Earthquake in 2004 had accounted for about 30% of the total<sup>6.4-1)~6.4-3)</sup>. It is impressed that a rate of the gymnasiums severely damaged by the 2011 Tohoku earthquake was lower than by the Mid Niigata Prefecture Earthquake in 2004.

Photo 6.4-1 Buckling of brace

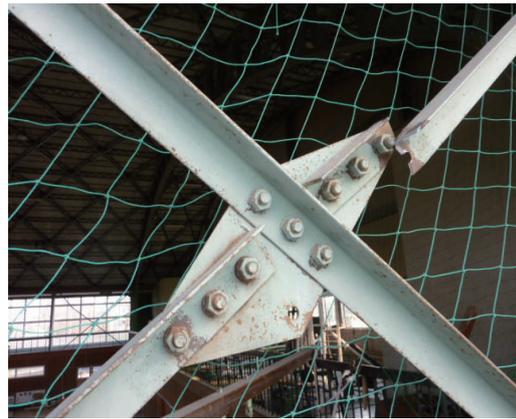
Photo 6.4-2 Net section fracture at bolt hole

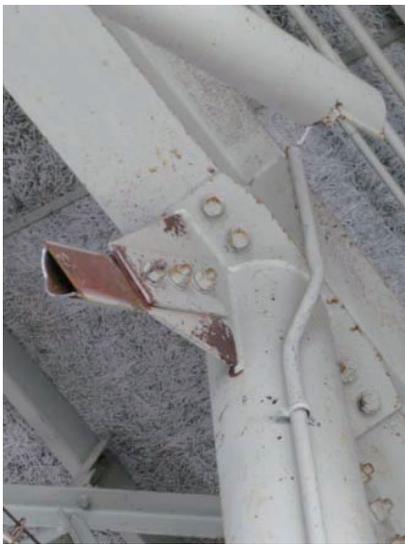
(a) Fracture at column top

Photo 6.4-3 Fracture of brace welded connection

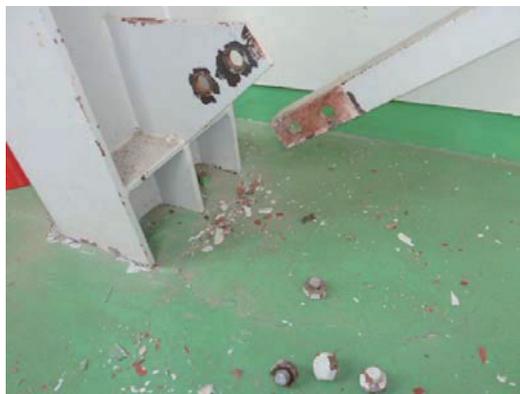
Photo 6.4-4 Fracture of bolts

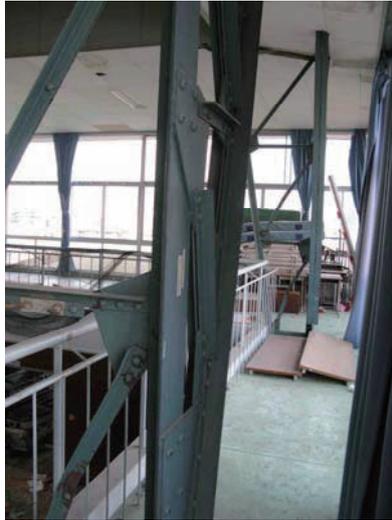
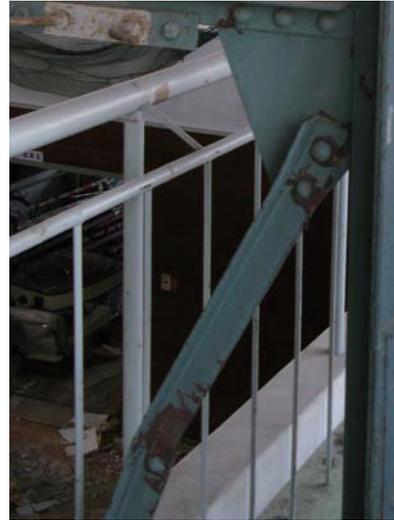
In one of the investigated gymnasiums, buckling of diagonal members in some latticed columns was observed (Photo 6.4-5). Damage of column buckling caused in steel frames for span direction had not been observed under the damage investigations of the Mid Niigata Prefecture Earthquake in 2004<sup>(6.4-1)~6.4-3)</sup>.

(a) Latticed column

(b) Buckling of diagonal member

Photo 6.4-5 Buckling of diagonal member of latticed column

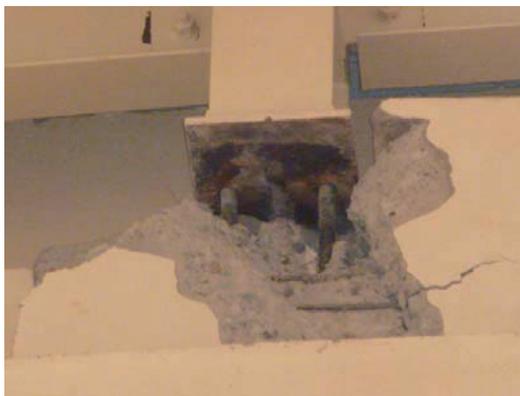
In the investigated gymnasiums, exposure of anchor bolts due to spalling of the concrete at connection (bearing support part) between the RC column and steel roof frame (Photos 6.4-6 and 6.4-7), spalling of finish mortars on the RC column at the roof bearing support part, and pullout of hole-in anchors (Photo 6.4-8) were often observed.

Photo 6.4-6 Spalling of concrete

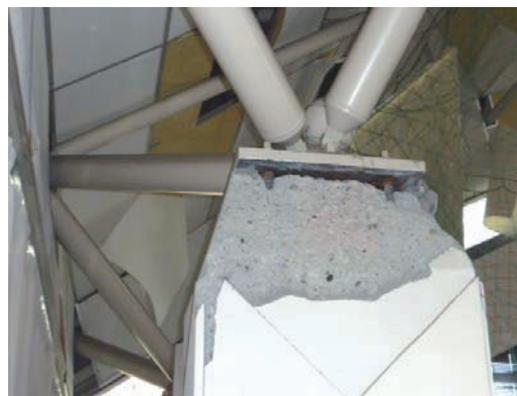
Photo 6.4-7 Spalling of concrete

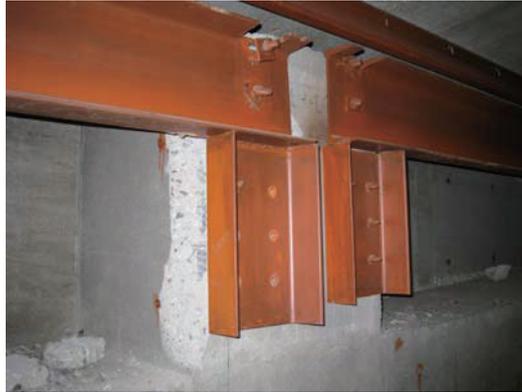
Photo 6.4-8 Pullout of hole-in anchors

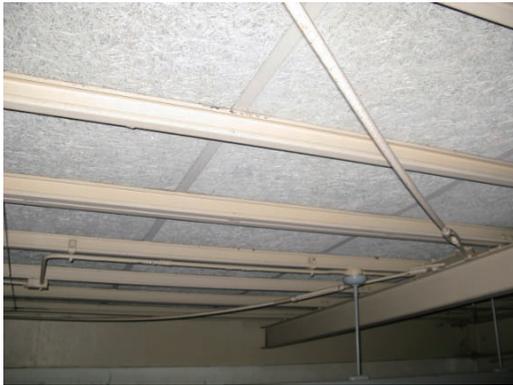
Roof horizontal braces were damaged in two high school gymnasiums and five elementary and junior high school gymnasiums. Such damage mainly occurred at horizontal braces with turnbuckles; obvious deflection of the horizontal brace (Photo 6.4-9) and fracture at thread and fracture of bolt connections were observed (Photo 6.4-10).

Photo 6.4-9 Deflection of horizontal braces

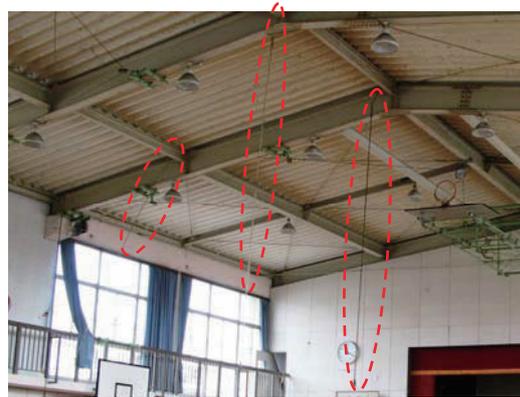
Photo 6.4-10 Fracture of horizontal braces

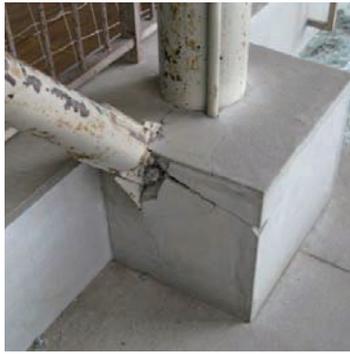
Damage of cracking of the column base concrete and mortar in the gallery of some gymnasiums was observed (Photo 6.4-11). Concrete and mortar of steel column base at a ground level was also cracked (Photo 6.4-12). However, almost all of these cracking are classified into minor or slight damage.

Photo 6.4-11 Cracking of column base concrete

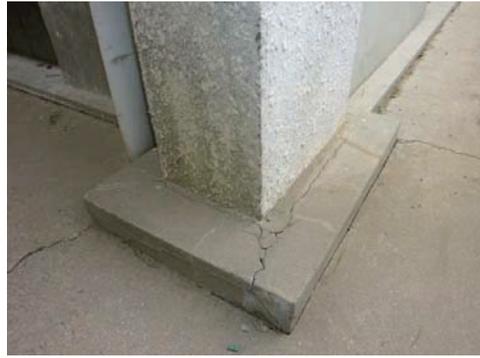
Photo 6.4-12 Cracking of column base concrete

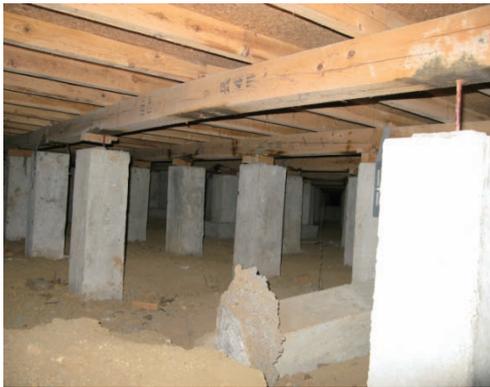
As the other types of the structural damage, the following damage was observed; (a) overturning of floor strut (Photo 6.4-13), (b) tilting of concrete block self-standing wall and (c) peeling of paint of beam members which was observed near the top of the V-shaped roof beams or arch beams (Photos 6.4-14 and 6.4-15). In terms of the peeling of paint, it was uncertain whether yielding of the beams occurred or not.

Photo 6.4-13 Overturning of floor strut

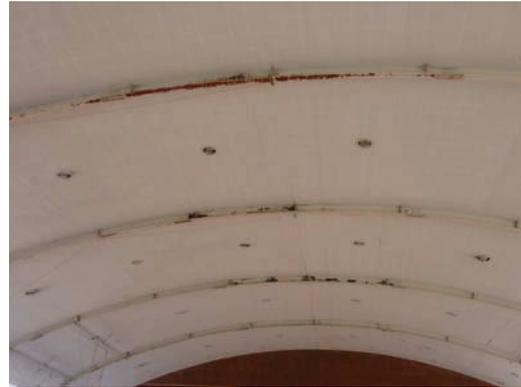
Photo 6.4-14 Peeling of paint of beams

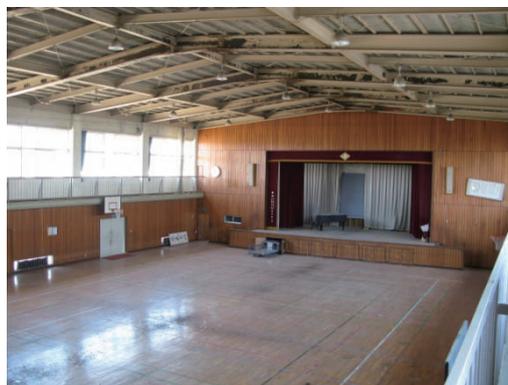
Photo 6.4-15 Peeling of paint of beams

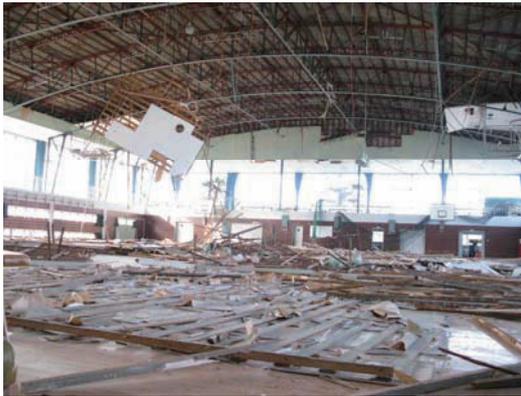
The types of nonstructural damage of gymnasiums included dropping of ceilings and lighting equipment (Photos 6.4-16 ~ 6.4-18), breakage of windows (Photo 6.4-19), dropping of exterior walls (Photo 6.4-20), dropping of interior walls and eave soffit (Photo 6.4-21). In particular, the severe damage such as dropping of extensive ceiling in the high school gymnasiums was observed more than in the elementary and junior high school gymnasiums.

Photo 6.4-16 Dropping of extensive ceiling components

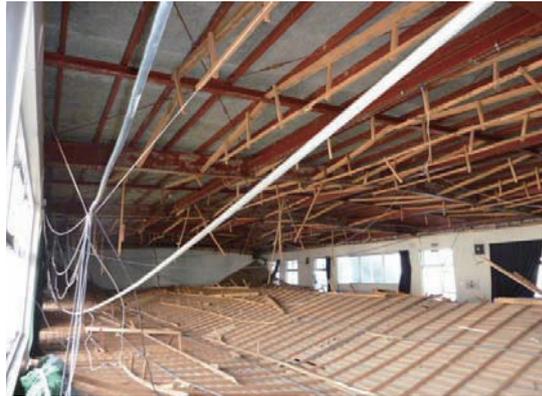
Photo 6.4-17 Dropping of extensive ceiling components

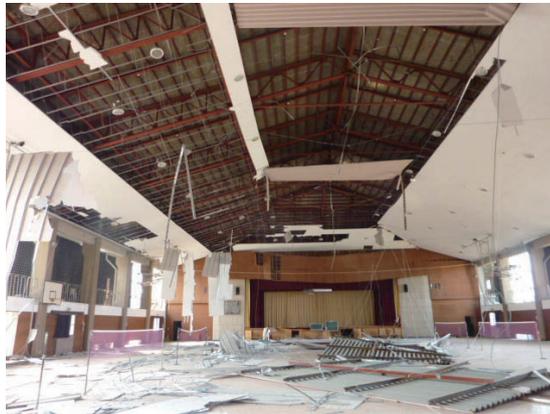
Photo 6.4-18 Dropping of extensive ceiling components

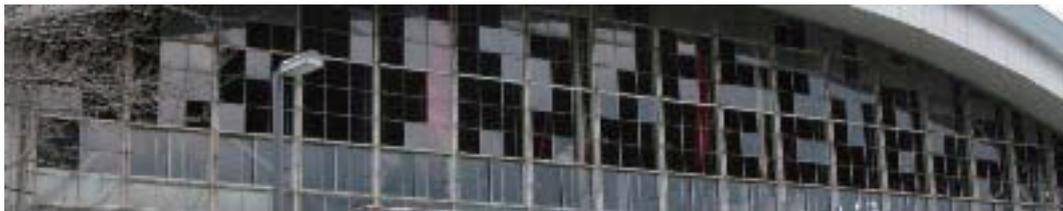
Photo 6.4-19 Breakage of windows

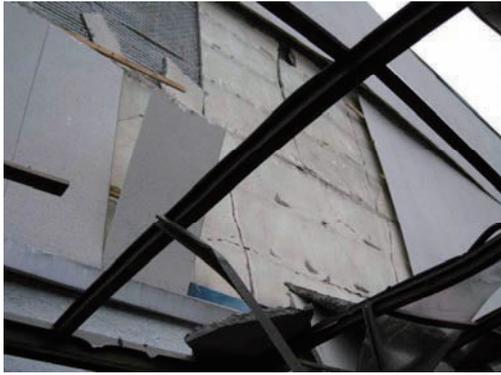
Photo 6.4-20 Falling of exterior finish components

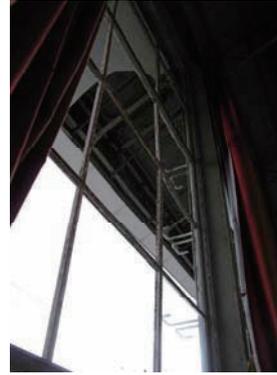
Photo 6.4-21 Falling of eave soffit

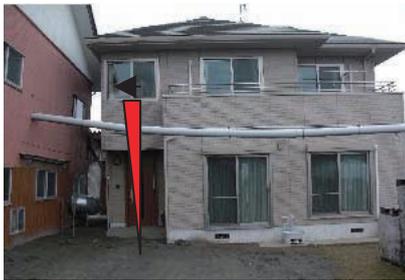
Photo 6.5-2 House tilted 5.0/100

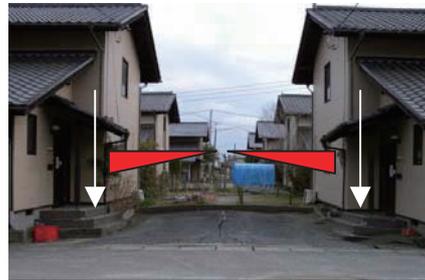
In Hinode, large-scale damage occurred in the area of about 200 m by 200 m along the Hitachi-tone River. Boiled sand, uplift of buried structures, and subsidence or tilting of utility poles, which were caused by liquefaction, were seen everywhere on the site. Many houses facing to the road subsided 20 to 30 cm from the front sidewalk (Photo 6.5-3). Foundation cracks or gaps were not observed.

Photo 6.5-3 Subsidence of two houses enclosing vacant land

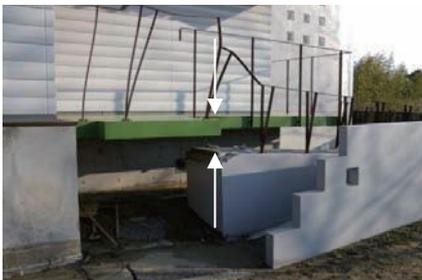
Photo 6.5-4 Slope difference in level

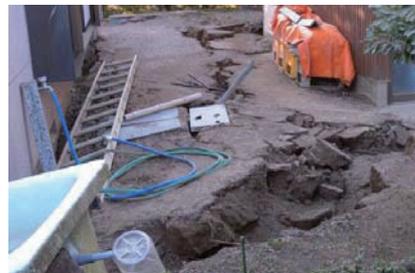
Photo 6.5-5 Crack in the site

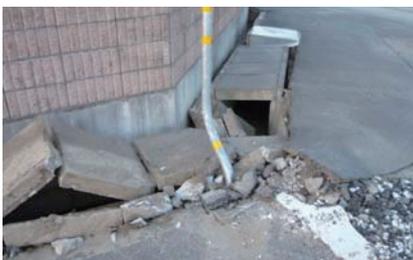
Photo 6.5-6 Damage to side ditch

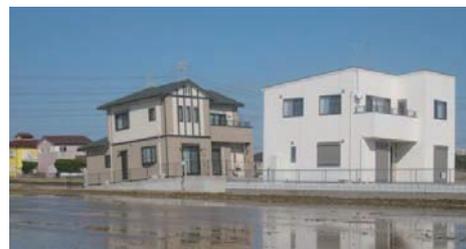
Fukashiba is located in the western part of Kamisu city and on the opposite side of Horiwai along Route 124. In this area, many houses were damaged due to ground deformation and embankment deformation. Most of the damage patterns of the houses seem to have included their movement, subsidence and tilting without structural damage on their upper structures and foundations (Photo 6.5-7).

Photo 6.5-7 Damage situations by liquefaction

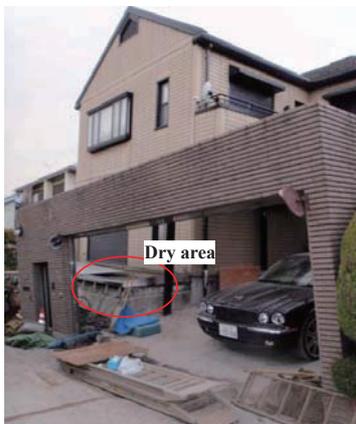
Photo 6.5-8 Tilted house

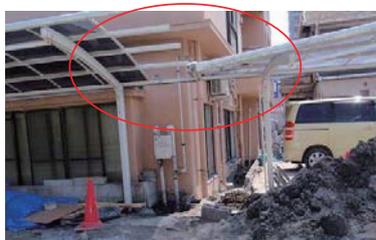
Photo 6.5-9 Moved carport

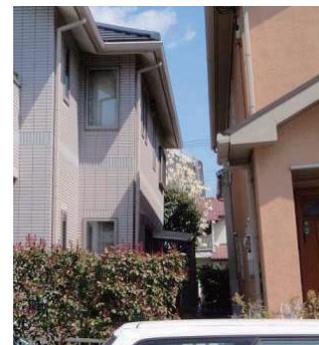
Significant tilting and subsidence of houses were observed at a zone in Benten (Photo 6.5-10). In another zone, the ground subsided by liquefaction, damage to the road that was waved and a 10 cm of difference in level was generated between a side ditch and the road. These types of damage were concentrated on an extension line of the boundary between the sites of tilted houses. Inhabitants told us that there was an old river on a straight line where the damage was concentrated.

Photo 6.5-10 Settled and tilted house

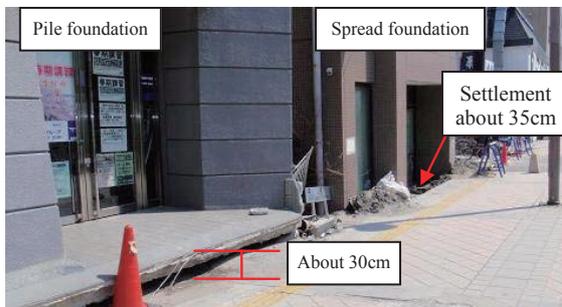
Photo 6.5-11 Difference in damage due to support mechanisms

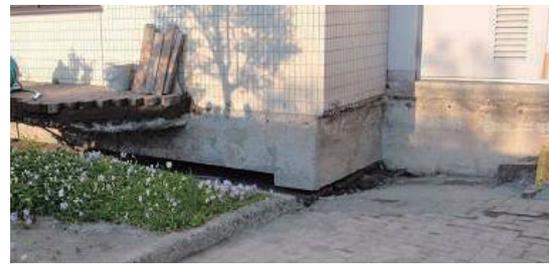
In Hinode, the ground subsidence was observed (Photo 6.5-12). This building is considered to have a pile foundation. A relative gap between the building and ground was about 50 cm. Building lifeline was damaged due to ground subsidence and displacement.

Photo 6.5-12 Building with subsidence of surrounding ground

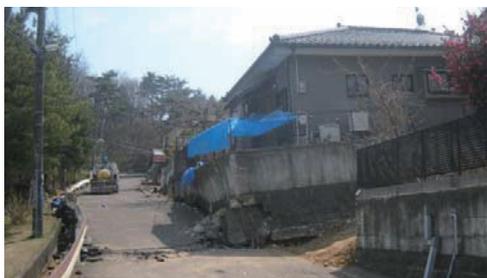
Photo 6.5-13 Damage to retaining wall and house due to sliding and ground deformation

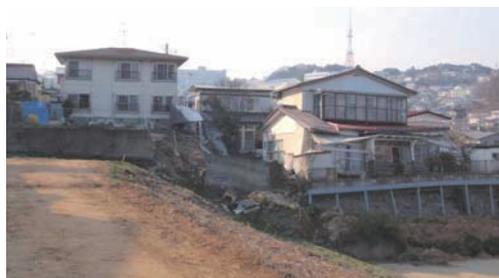
Photo 6.5-14 Group of houses damaged due to sliding and ground deformation

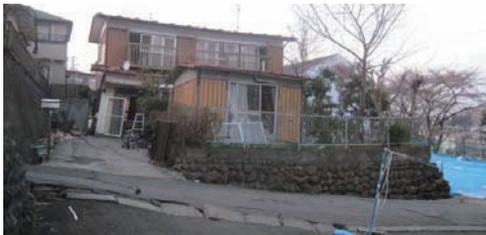
Photo 6.5-15 Damage to houses due to sliding and ground deformation

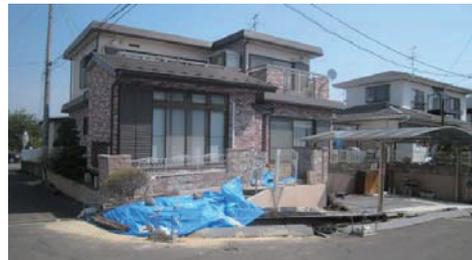
This is a housing area where a hill was developed. Fissures on the slope of the hill and near the top of the hill, and damage to housing foundations and retaining walls due to deformation of the reclaimed area by banking, were observed in the area. The slope in 1-chome, Midorigaoka had been significantly collapsed under the 1978 Miyagi-oki earthquake. A level of ground deformation on the slope under the 2011 Tohoku earthquake was lower than that during the 1978 earthquake. Near the top of the hill, ground deformation of the reclaimed area by banking caused fracture of the embankment retaining wall, damage to house foundations (Photo 6.5-16) and push-out of the retaining wall on embankment.

Photo 6.5-16 Houses damaged near the top of hill

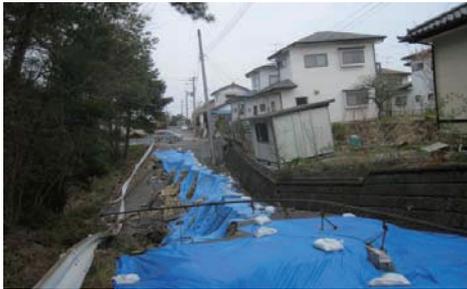
This area is located at one corner of a large-scale housing area where a hill was developed. The result of investigation was revealed ground deformation due to land sliding on the slope of the hill. This ground deformation caused serious damage to houses. In the result, several houses were in a state of sliding on the slope of the hill (Photo 6.5-18). On the other hand, houses near the top of the hill suffered only damage associated with slight deformation of the reclaimed area by banking.

Photo 6.5-17 Fracture of embankment retaining wall and houses tilting due to land sliding on the slope of hill end

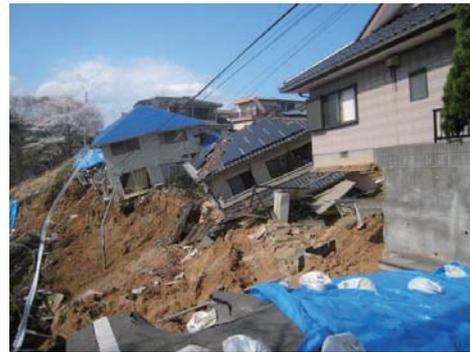
Photo 6.5-18 Land sliding of slope on the southwest of hill and sliding houses

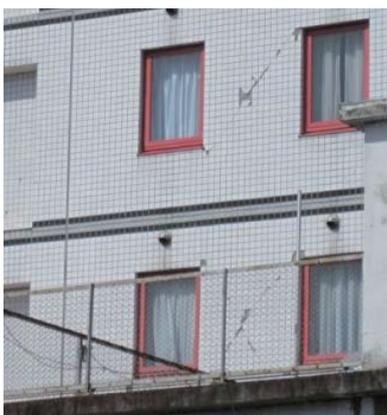
Detachment of ceramic wall tiles was often observed at buildings of RC nonstructural exterior walls. Types of the detachment were classified according to existence or nonexistence of crack on the damaged RC wall.<sup>6.6-1) 6.6-2)</sup> In Photo 6.6-1, ceramic wall tile detached from RC exterior wall. Cracks were observed on the damaged RC wall. Photo 6.6-2 shows detachment of ceramic wall tiles installed on a cylindrical RC wall above the building entrance (within a circle). No crack was externally observed on the undersurface RC wall. A net was placed over the damaged area to catch falling tiles.

Photo 6.6-1 Detachment of ceramic wall tiles from damaged RC exterior wall

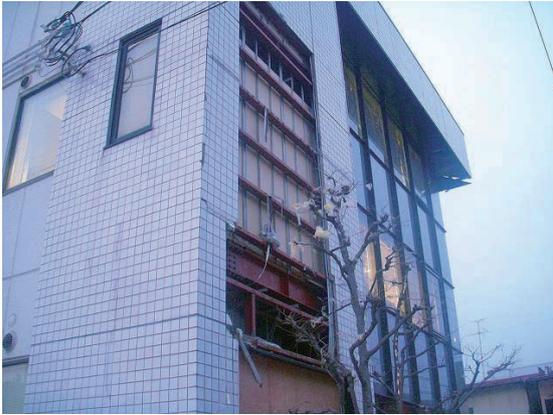
Damage to cement mortar and metal lath exterior walls was often observed in steel buildings. Photo 6.6-3 shows detachment of cement mortar and metal lath exterior wall in a 3-story building. Damage to the window glass was not observed, but cement mortar and metal lath fell from the exterior wall (shown in Photo 6.6-3) and from the parapet on another side. Photo 6.6-4 shows a one-story steel building in which cement mortar and metal lath detached from an exterior wall and from an eaves soffit. Photo 6.6-5 shows a damaged gable end wall of a gymnasium. This wall consisted of two layers. The undersurface wall was cement mortar and metal lath exterior wall. The surface one was exterior boards nailed to furring installed on the undersurface wall. Both were damaged and fell by the earthquake.

Photo 6.6-3 Falling of cement mortar and metal lath wall

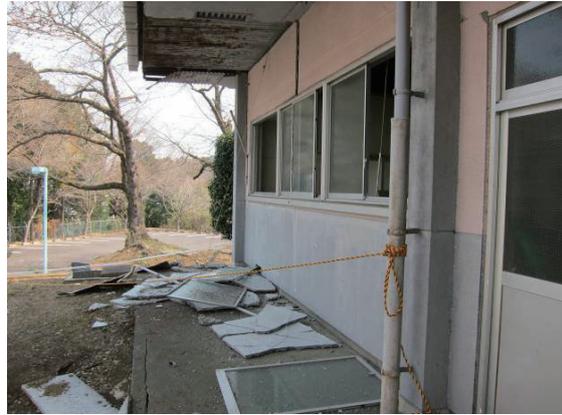
Photo 6.6-4 Falling of cement mortar and metal lath from eaves soffit

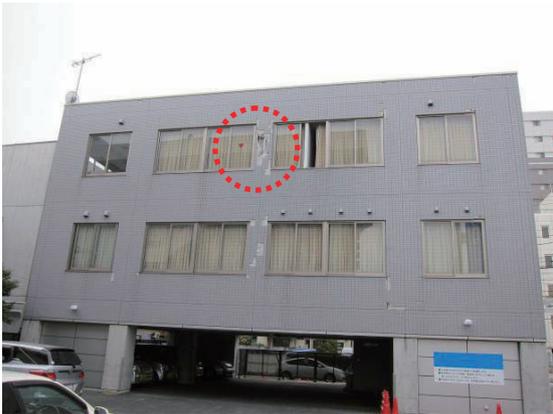
Photo from 6.6-6 to 6.6-7 shows damage to AAC panel exterior walls. Photo 6.6-6 shows falling of finishing ceramic wall tiles on AAC panels and broken light-weight aerated concrete in a 3-story building. Ceramic wall tiles on all faces of the exterior walls detached and the corners of the AAC panels were chipped. AAC panel was broken and internal iron wires were exposed at the circular broken line in the photo. AAC panels fell from another side. The construction method of the AAC panel exterior wall was not

observed in the external survey. Photo 6.6-7 shows falling of AAC panels from the top-floor of a 5-story building. The damaged AAC panels were observed to be installed to the support metal with cement mortar and steel bar. This AAC construction method appeared in 3rd edition of Japanese Architectural Specification Standard JASS 12 as one of standard construction methods for AAC panel exterior wall but not included in its 4th edition. <sup>6.6-3)</sup> <sup>6.6-4)</sup> AAC panels installed with this AAC construction method were frequently observed to be damaged.

Photo 6.6-6 Falling of ceramic wall tiles and breakage of AAC panels

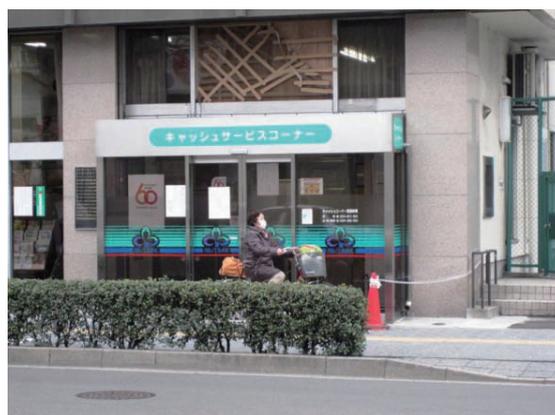
Photo 6.6-8 shows broken window glasses in the upper area of a windbreak room on the ground level of a 5-story building. Exterior ceramic wall tiles fell from another side.

Photo 6.6-8 Broken window glass

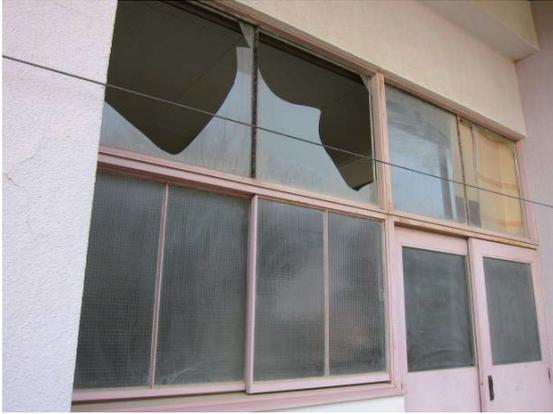
Photo 6.6-9 shows damaged window glasses installed to the upper fixed window with hardening putty at a gymnasium gable end wall. Cracked wired window glasses

were also observed at the lower double sliding window with hardening putty. Flaking of paints was observed on the center of an arch beam of the gymnasium. Photo 6.6-10 shows breakage of window glasses in a gymnasium. The window glasses were installed to fixed window frames with glazing bead and twelve window glasses were broken at three exterior surfaces. Flaking of concrete at the roof bearing support part, deformation of almost all roof horizontal braces and fracture of one roof horizontal brace in the gymnasium were observed.

Photo 6.6-9 Breakage of window glasses installed to fixed window frame with hardening putty

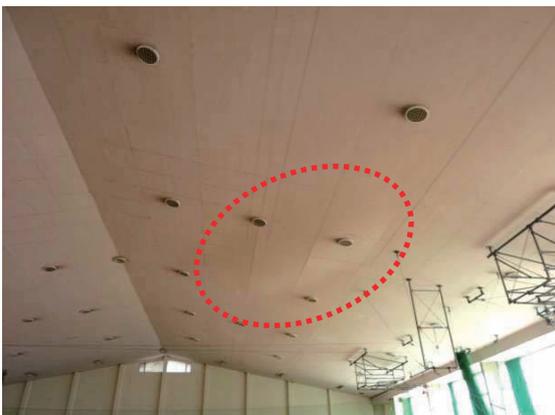
Photo 6.6-19 shows a damaged metal furring suspended ceiling in a gymnasium. Significant visual damage was not observed, but the ceiling board sagged near the center of pitched ceiling marked with a red dotted oval line in the photo. This was possibly due to the displacement of ceiling members in the plenum. Cement mortar finish of interior wall above the stage was flaked as shown in Photo 6.6-23, and the exterior boards were broken at the gable end wall. No damage to the structure was observed.

Photo 6.6-19 Sagging of metal furring suspended ceiling

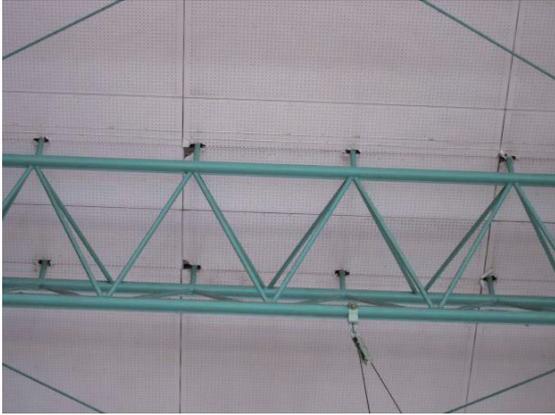
Photo 6.6-21 shows damaged ceiling boards at the connection with the structure of a gymnasium. It was reported that one window glass was broken. No damage to the structure was observed.

Photo 6.6-21 Damage to metal furring suspended ceiling at the connection

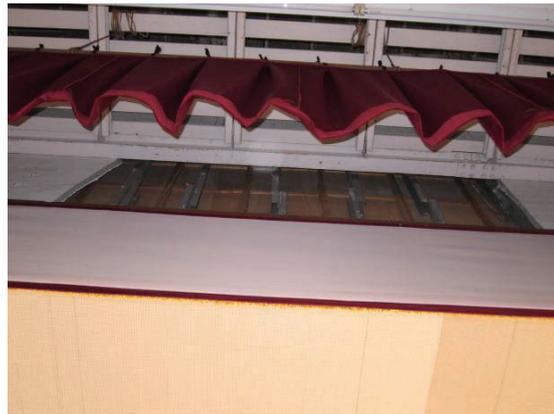
Photo 6.6-23 shows damaged walls above the stage in the gymnasium shown in Photo 6.6-19. Cement mortar finishes on the studs were broken and fell. Damage to the walls above the stage was observed also in some gymnasiums such as shown in Photo 6.6-15 or Photo 6.6-17.

Photo 6.6-23 Falling of cement mortar finish above stage

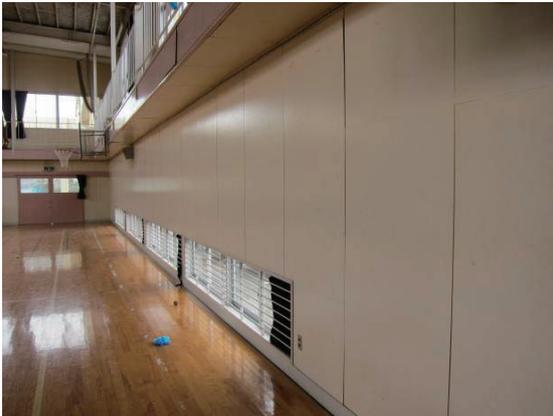
Photo 6.6-24 shows a lift of the nail fixing interior wall boards to the studs in the arena of gymnasium.

Photo 6.6-24 Loosen nails fixing board

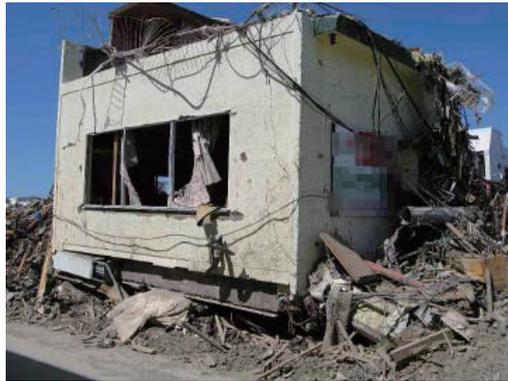
A case that column capitals and bases on the first floor in a building were subject to bending failure and subsequently to story collapse was seen in a 2-story building (Photo 7.2-1).

The building had column-to-beam frames. The first floor had relatively small number of walls, but many concrete block walls were placed on the second floor. The first and second floors of the building in Photo 7.2-1 were used as shop and dwelling, respectively. The relevant building was estimated to have structural characteristics of low strength and stiffness on the first floor. As an opening on the second floor was not large, it is assumed that the second floor suffered a large tsunami wave pressure and the shear force acting on the first floor exceeded the lateral load-bearing capacity, resulting in the collapse of the building. Story collapse of the first floor has not been observed in 3-story or higher buildings in the investigations. In 3-story buildings, in general, reinforced concrete walls are often used in the first floor. Therefore, the strength of the first floor of 3-story buildings is considered to have been larger than that of 2-story buildings.

Photo 7.2-1 Story collapse of a 2-story reinforced concreted building

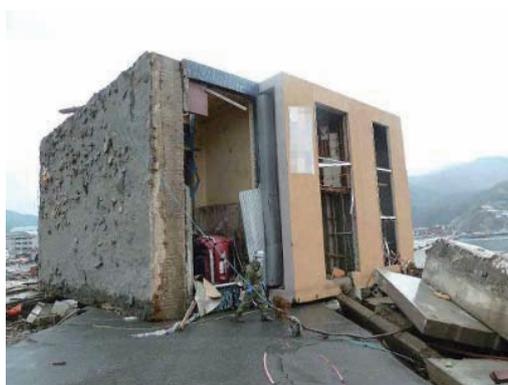
Overturning was observed in 4-story or lower buildings. In all overturned buildings, the maximum inundation depth exceeded their height. Overturning types include buildings that fell sidelong (Photo 7.2-2) and buildings that turned upside down. Most of the overturned buildings were of mat foundation. In some overturned buildings on pile foundation, piles were pulled out.

Photo 7.2-2 Overturning of a 3-story reinforced concrete building

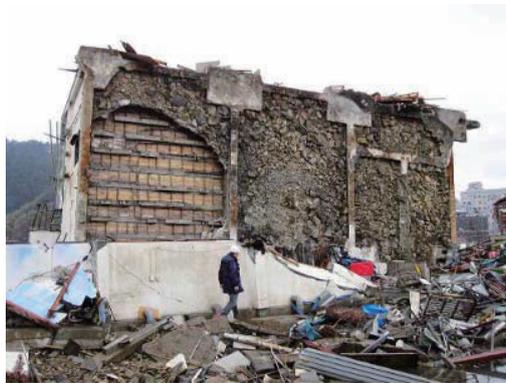
Most of the overturned buildings were moved from their original positions. It is estimated that large buoyancy acted on the buildings. Moved and overturned buildings left no dragged traces on the ground. One of the buildings moved over a concrete block fence that had about 2m height on an adjoining land without destroying the fence (Photo 7.2-3). The building seems to have floated up by buoyancy. Some of the 2-story apartment houses with the same shape that were overturned were washed away and missing. A buoyancy and large horizontal force seem to have acted on these buildings.

Photo 7.2-3 A 2-story reinforced concrete building that moved over the fence and overturned

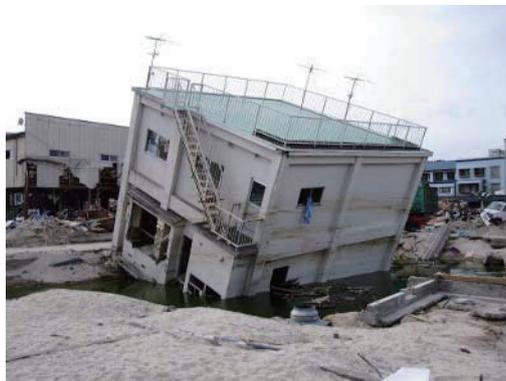
When tsunami acted on a building, a strong stream was generated around the corner of the building, resulting in many large holes on the ground that were bored by scouring. In one case, a building on mat foundation fell into a hole bored by scouring (Photo 7.2-4).

Photo 7.2-4 A 2-story reinforced concrete building that was tilted by scouring

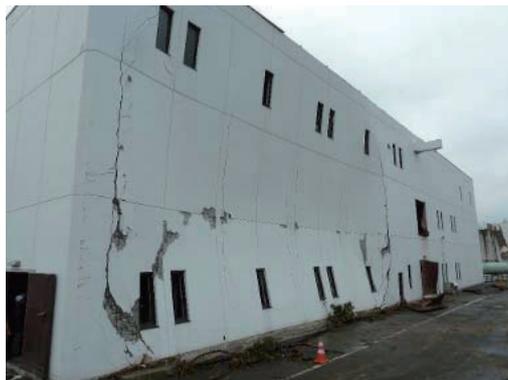
Cases that such wall reinforcement was fractured were often seen in wall members with single layer bar arrangement. In one damaged building (Photo 7.2-5), a 300 mm-thick shear wall with double layer bar arrangement and a support span of more than 10 m and without the second and third floor slabs was bent inside by tsunami wave pressure. However, a shear wall in an area (Photo 7.2-5 Back of the building, right-hand side), where there was a floor on the second story and a support span was not long in the same building, was not bent.

Photo 7.2-5 Out-of-plane fracture of reinforced concrete shear wall without floor

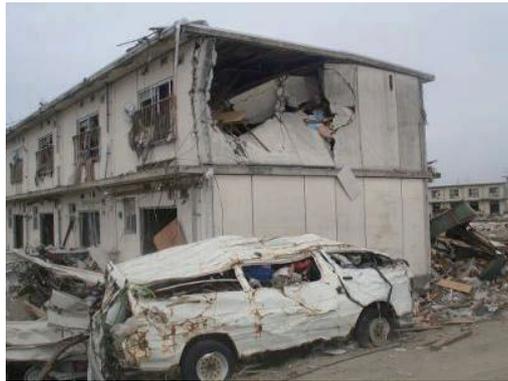
Debris impact was seen in most of the non-structural members such as window and ceiling materials. The number of cases of clear damage to skeletons was not large, but in one observed case, a multi-story wall in an apartment house was probably bored by debris impact (Photo 7.2-6).

Photo 7.2-6 Wall opening probably generated by debris impact

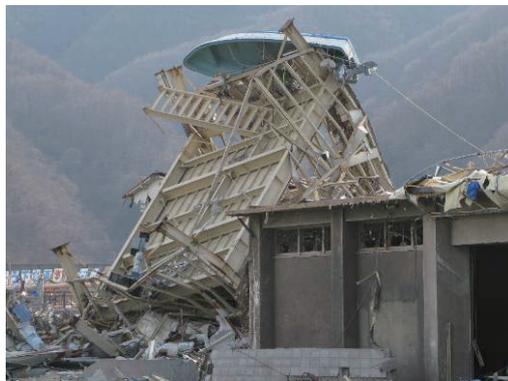
A typical case of building movement and washout was that a building moved and flew due to the fracture of anchor bolts and/or base plates at steel exposed column bases and the fracture of a weld between the column and the base plate (Photo 7.2-7). In most cases, foundation and some column bases were left in the site, but the upper structure of the building was moved beyond the site or missing.

Photo 7.2-7 Steel building overturned by fracture of column base anchor bolts

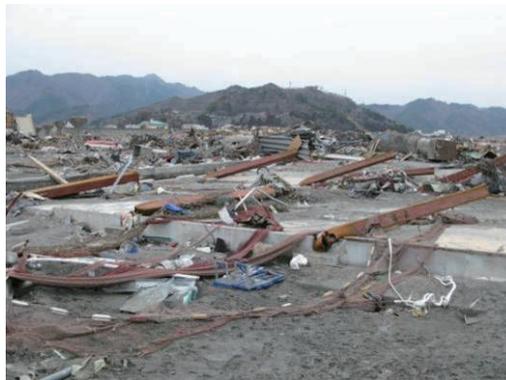
In damage cases relatively often seen that a capital connection on the first or second floor in a building was fractured, then the building was moved and washed away. When a column base has a large strength like concrete encases type or embedded type, this type of fracture is considered to occur. In one case (Photo 7.2-8), foundation in a building, and several columns on the first floor (or up to the second floor) were left on the site, and the columns fell in the same direction.

In most cases, welds between diaphragms with lower flanges and the first-floor columns were fractured and the sections of the columns were exposed. In one building, flanges of the second-floor H-shaped beams were torn. Based on the deformation states

near the column bases, it is estimated that a tensile force acted on the first-floor columns, and then the first-floor capital connections were fractured after the first floor was greatly tilted to the same extent as the inclination of the remaining columns.

Photo 7.2-8 First-floor columns falling in the same direction

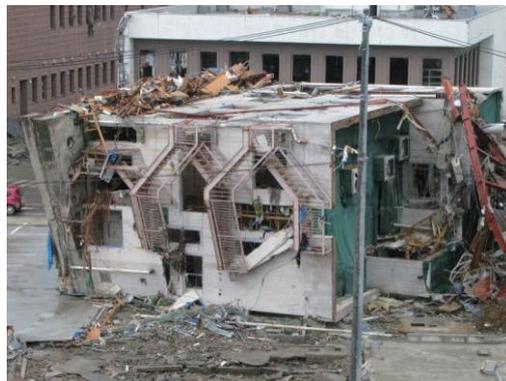
One case that a whole building including foundation was overturned, was confirmed. Most of the AAC panels of claddings were left (Photo 7.2-9).

Photo 7.2-9 Overturning of a 3-story steel building

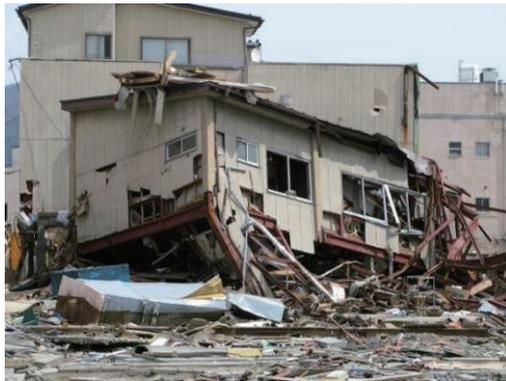
Skeleton collapse including story collapse of the first floor was seen in a 2-story steel building (Photo 7.2-10). Partial collapse of a warehouse was also seen on the coast.

Photo 7.2-10 Story collapse of first floor in a 2-story steel building

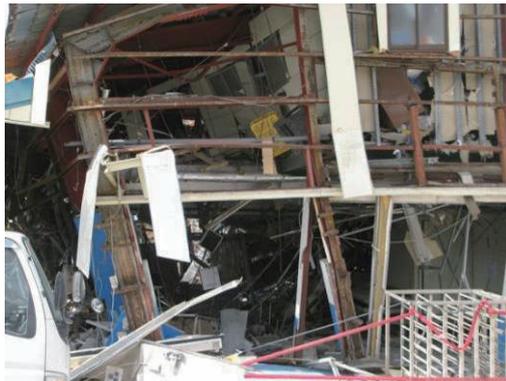
Slight tilting was often observed with remaining their skeletons in steel buildings. In one case (Photo 7.2-11), a gabled roof frame building did not collapsed despite large residual deformation.

Photo 7.2-11 Tilted gabled roof frame

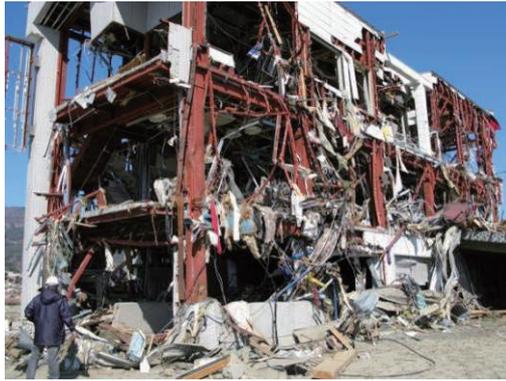
Cladding materials such as AAC panel were almost fully fractured and washed away, and then a steel frame as a skeleton was remaining. This case was often observed (Photo 7.2-12). It is considered that an external force that acted on the skeleton became small due to early washout of the cladding materials. In the remaining building, slight tilting of the skeleton, member deformation on the face affected by tsunami, and members locally damaged possibly by debris impact, were observed.

Photo 7.2-12 A remaining 3-story steel building
