September 2011

**Summary of the Field Survey and Research on  
“The 2011 off the Pacific coast of Tohoku Earthquake”  
(the Great East Japan Earthquake)**

National Institute for Land and Infrastructure Management (NILIM)  
Ministry of Land, Infrastructure, Transport and Tourism, Japan

Building Research Institute (BRI)  
Incorporated Administrative Agency, Japan

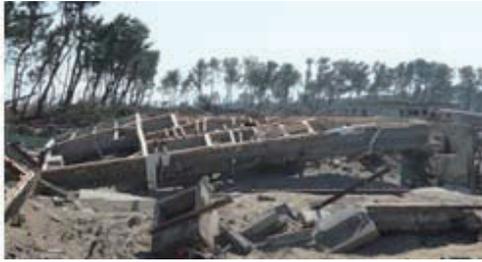
In the area with over 5 m water depth, most of the wood houses in the inundated area were washed away by the tsunami. How the houses were washed away; as for the case which the whole house including foundations was washed away (Photo 7.4-1), the case which only foundations were left (Photo 7.4-2), the case which sills and foundations were left (Photo 7.4-3), the case which sills, foundations and floor boards were left (Photo 7.4-4), and so on, were observed. There were several cases that the hold down fastener was failed, as shown in Photo 7.4-5. The foundations or wall of bath room made by concrete block often remained, as shown in Photo 7.4-2.

Photo.7.4-1. Foundations washed away.

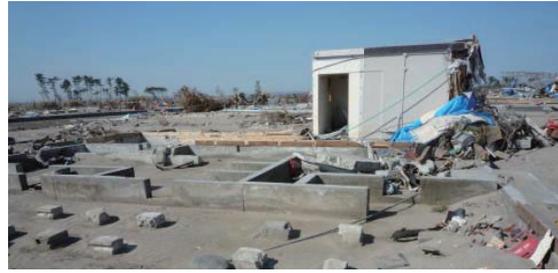
Photo.7.4-2. Only foundation remained.

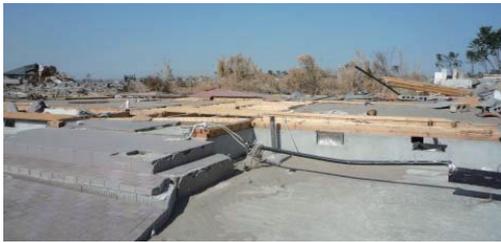
Photo.7.4-3. Foundation and sills remained.

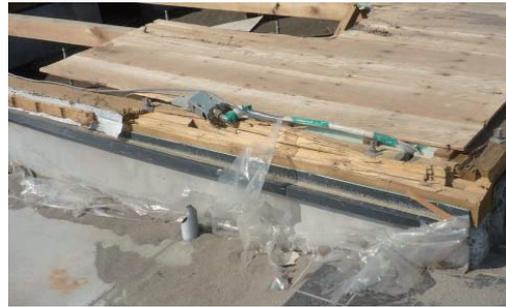
Photo.7.4-4. Sills, foundation and floor boards remained.

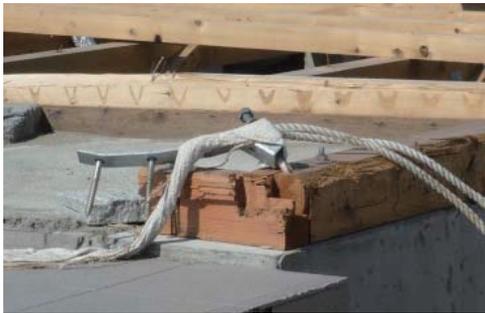
Photo.7.4-5. Failed hold down fastener.

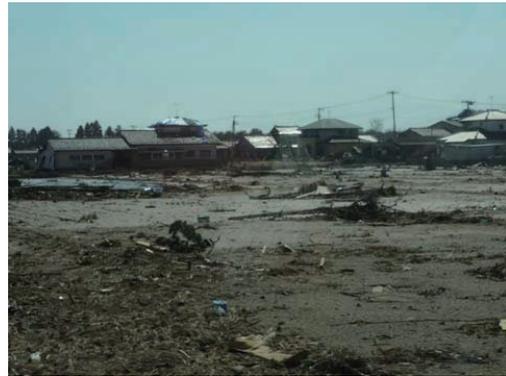
Photo.7.4-6. Many wood houses remained.

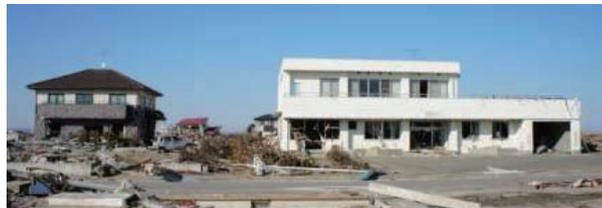
Photo.7.4-7. Wood house remained in the downstream of RC building in Arahama, Wakabayashi ward, Sendai city.

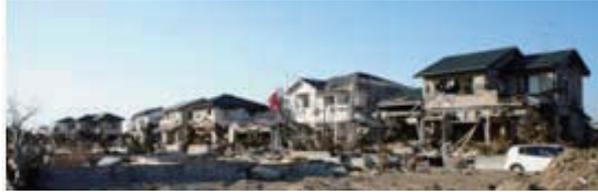
A line of wood houses remained were confirmed in Arahama-shin, Wakabayashi ward, Sendai city, as shown in Photo 7.4-8. The front survived house of the line was non-wooden. The water depth in this area was estimated at the level about 4-5 m. On the other hand, some wood houses which didn't have survived buildings in the direction where the tsunami came remained, but suffered heavy damage, as shown in Photo 7.4-9. Several such houses were confirmed in each surveyed area, and they were built by the construction methods with many metal fasteners.

Photo 7.4-8. A line of wood houses remained in Arahama-shin, Wakabayashi ward, Sendai city.

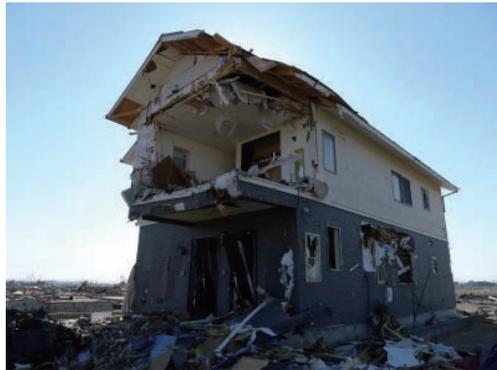
Photo 7.4-9. Remained house which didn't have survived buildings in the direction where the tsunami came in Arahama-shin, Wakabayashi ward, Sendai city.

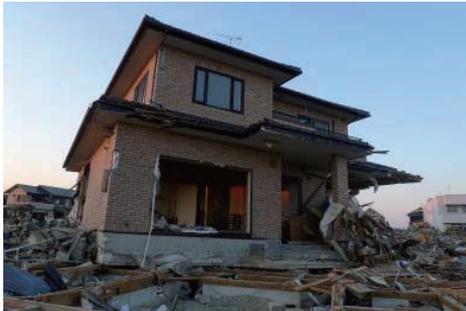
Photo 7.4-10. Wood house ([1]) that was carried away with the base in Yuriage, Natori city.

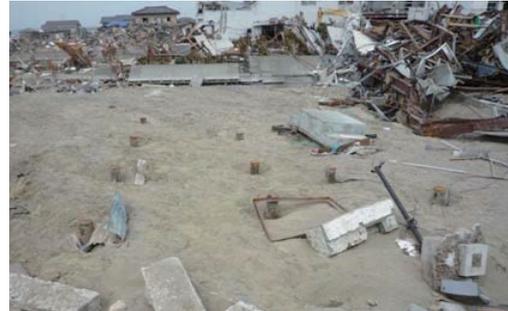
Photo 7.4-11. Steel tube pile left at the original position ([2]) of house in photo 7.4-10.

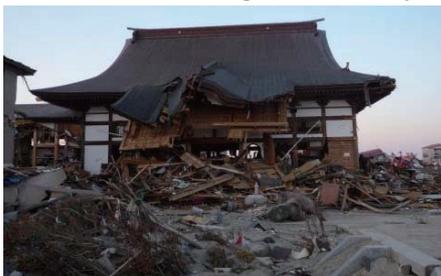
Photo 7.4-12. Heavily damaged temple ([3]) building in Yuriage, Natori city.

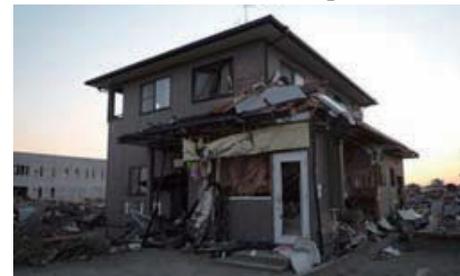
Photo 7.4-13. Wood house with store ([5]) remained in the downstream of the survived buildings in Yuriage.

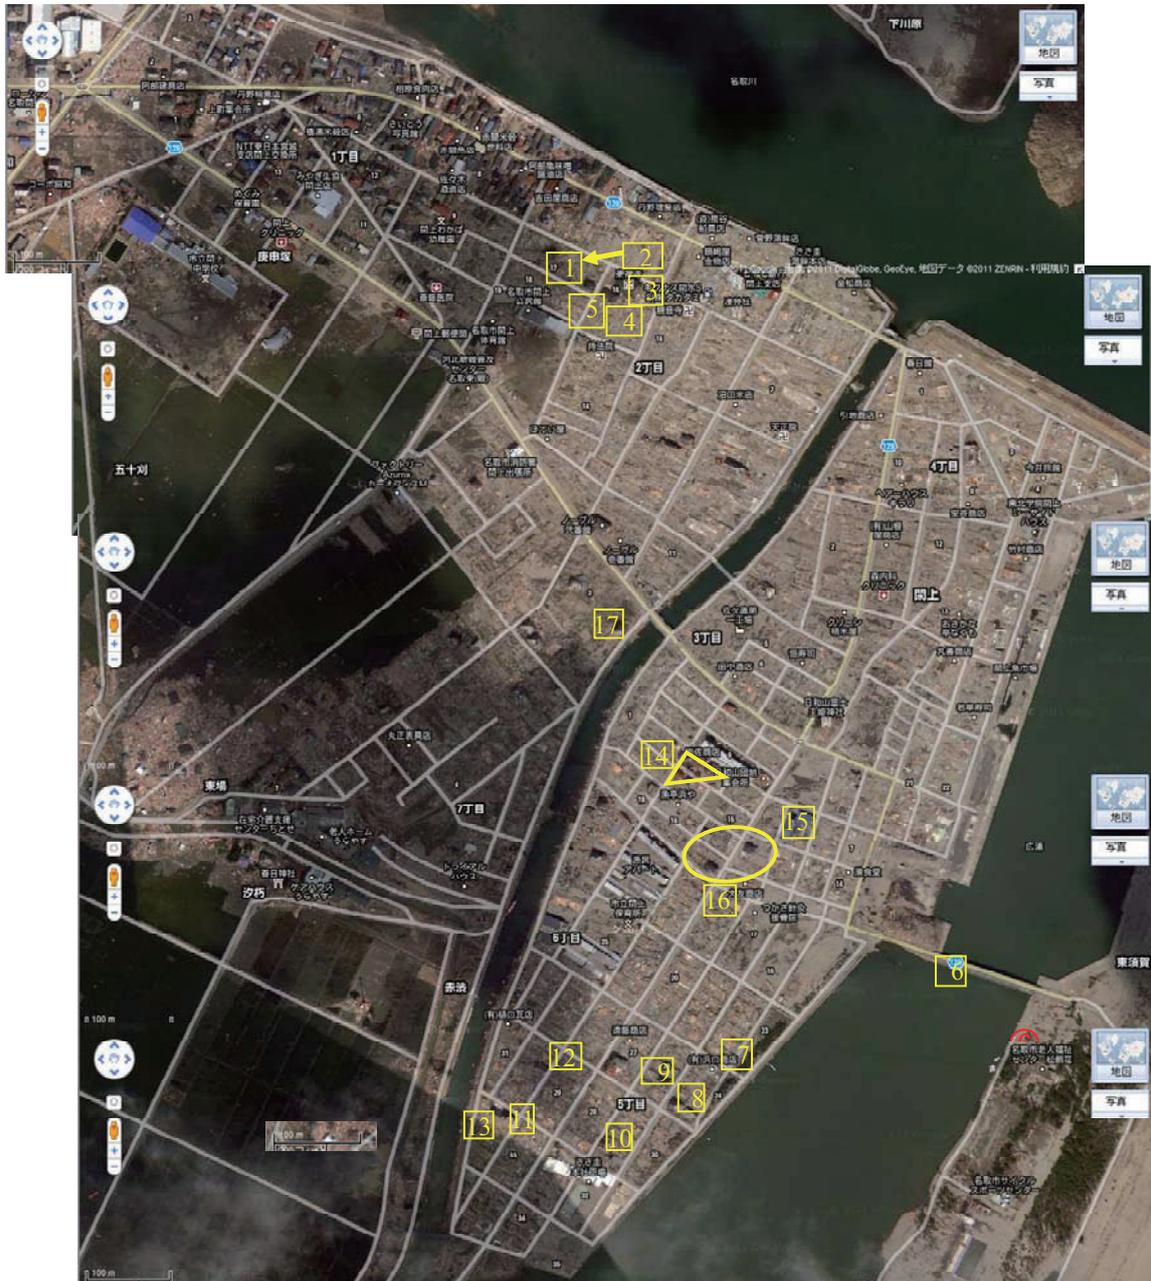
Wood buildings also suffered crushing damage due to tsunami, as shown in Fig. 7.4-2. The parts of buildings remained, for example foundation, sill, and so on, were as same as mentioned in (1). Figures in rectangles in Fig. 7.4-2 show the locations of buildings mentioned in the followings. The wood house (Photo 7.4-10:①) united with the foundation and carried away. In the original position of it, steel tube piles remained as shown in Photo 7.4-11(②). Because a temple building (Photo 7.4-12:③) and a steel-frame house (④) were damaged heavily and remained, tsunami wave force was reduced to some extent, and the neighboring wood house with store avoided being carried away, as shown in Photo 7.4-13 (⑤). It might be possible for the survived low-rise building to make wave force reduce.

Fig. 7.4-2. Aerial photograph and the location related to surveyed buildings in Yuriage, Natori city.

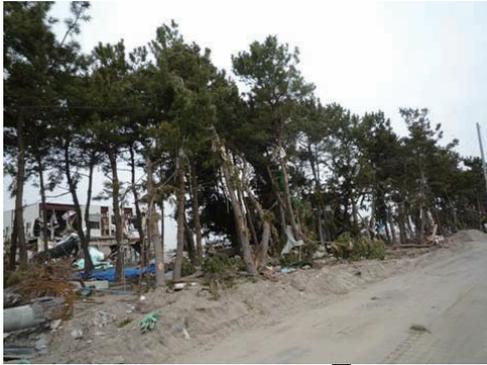
Photo 7.4-14. Protect forest (7) in Yuriage, Natori city.

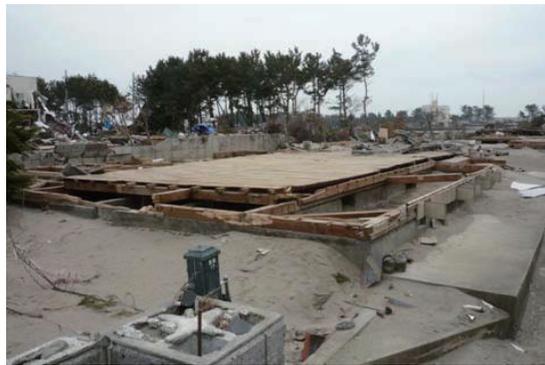
Photo 7.4-15. Fallen Protect forest and wood house (8) washed away in Yuriage, Natori city.

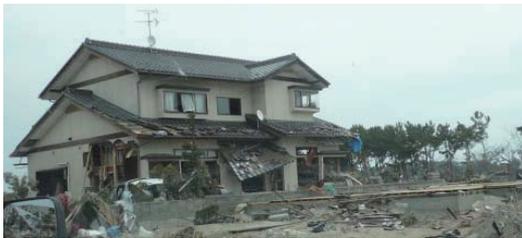
Photo 7.4-16. Protect forest and wood house (9) remained in Yuriage.

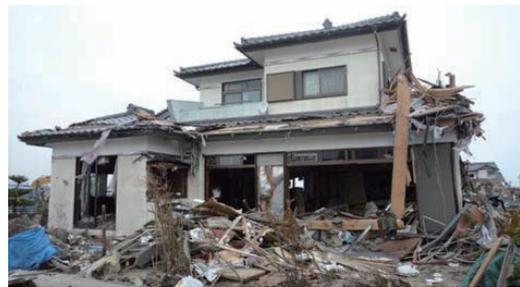
the tsunami were different by factors such as the depth of water or the submarine topography in this case. There was a house (Photo 7.4-17: [10]) remained in the area where there was no building and no protect forest existed in the direction of the wave. In addition, the relatively new Japanese conventional post and beam wood house (Photo 7.4-18 : [11]) and light frame construction house (Photo 7.4-19 : [12]) were confirmed at the location where there were no survived buildings in the direction of waves. Besides, in the downstream of the former, another Japanese conventional post and beam wood house ([13]) remained in. The water depth was estimated to be about 3.5 m in these locations.

Photo 7.4-17. Wood house (10) remained without the effect of protect forest.

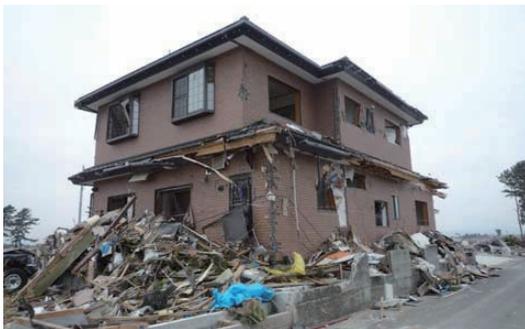
Photo 7.4-18. Japanese conventional post and beam wood house (11) remained alone.

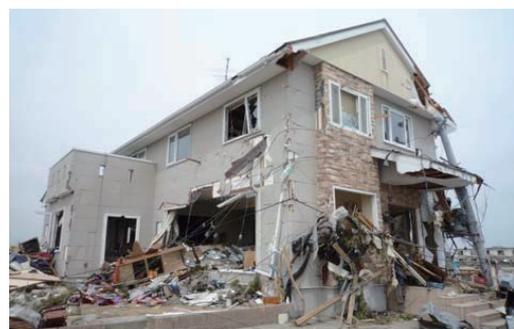
Photo 7.4-19. Light frame construction wood house (12) remained alone

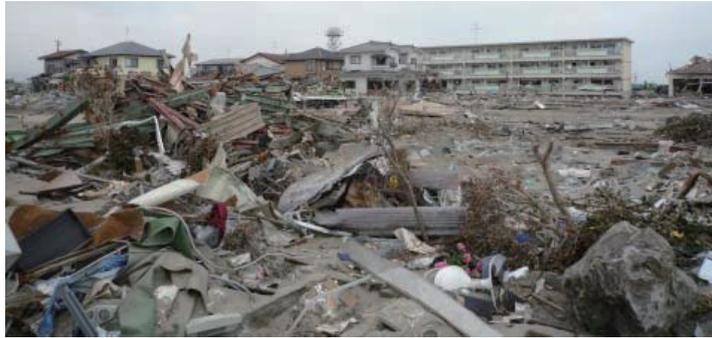
In the downstream of large RC building, houses with low structural specification (Photo 7.4-20 : [14]) also remained, as shown in Photo 7.4-20. On the other hand, in the location where was the downstream of the relatively large factory building (Photo 7.4-21 : [15]), the wood house ([16]) with relatively better structural specifications avoided being carried away, selectively.

Photo 7.4-20. Group of wood houses (14) which were not washed away in the downstream of a RC apartment house in Yuriage

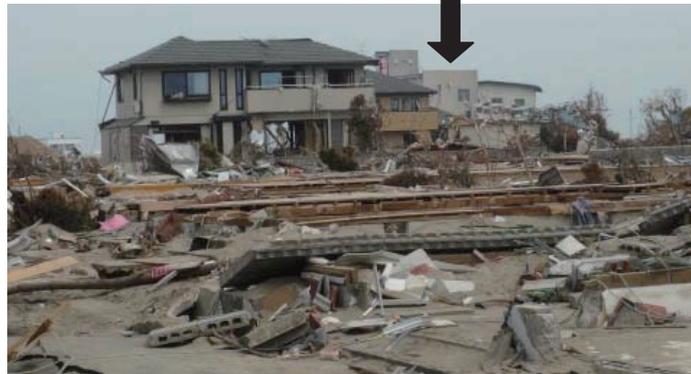
Photo 7.4-21. Wood houses (15) which were not washed away selectively in the downstream of a factory building.

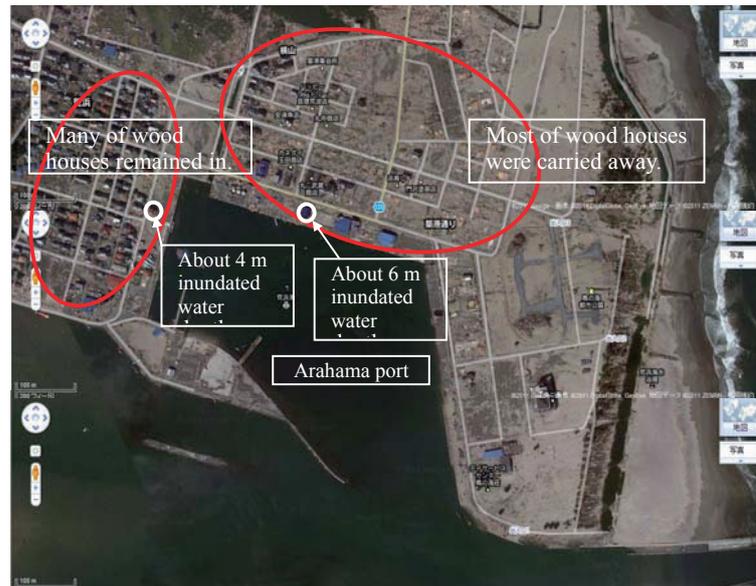
Arahama district in Watari town is surrounded with sea shore and faces the Pacific Ocean in the east, and there is a port in the south side, as shown in Fig. 7.4-3. In the area between Pacific Ocean and Arahama port, most of wood houses were washed away. In the north area of the Arahama port, the water depth was estimated about 6 m. Many of wood houses were washed away. On the other hand, in the west area of the Arahama port, the water depth was estimated about 4 m. Many of wood houses remained. Remained parts, for example foundation, sill, and so on, were as mentioned in (1).

Fig. 7.4-3. Aerial photograph and the water depth estimated in Arahama, Watari town.

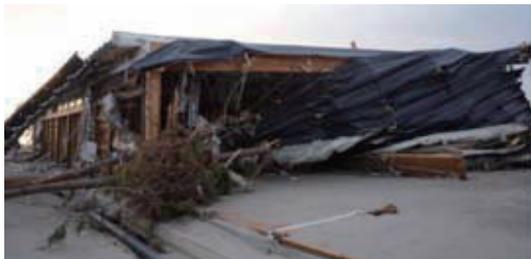
Photo 7.4-22. Glulam frame structure remained in Arahama, Watari town.

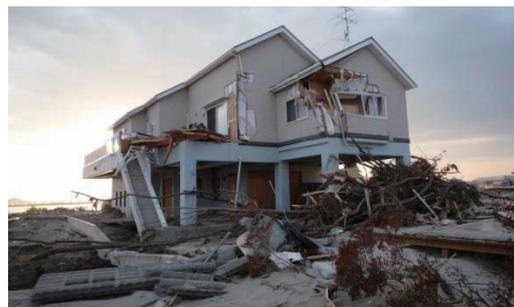
Photo 7.4-23. Mixed structure which has 1<sup>st</sup> story of RC structure and wooden 2<sup>nd</sup> story.

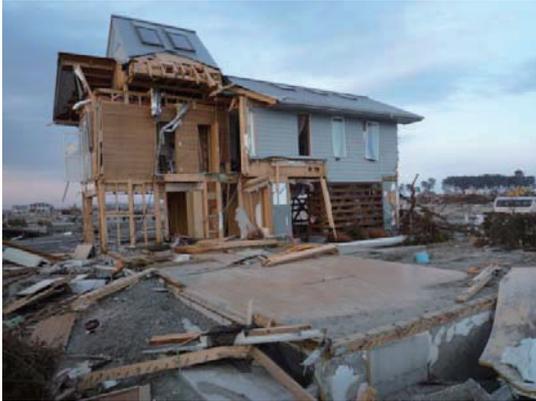
Photo 7.4-24. L-shaped wood house whose part was washed away in the east of Arahama port.

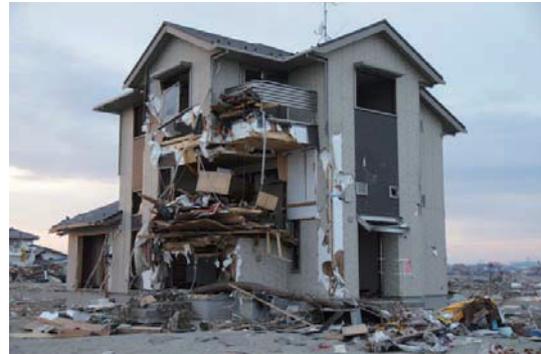
In the north area of the Arahama port, a 3-story wood house (Photo 7.4-25) remained. The reason might be that the lateral strength of 1<sup>st</sup> story in 3-story building was larger than that in 2-story building.

Photo 7.4-25. 3-story wood house remained in the north of Arahama port.

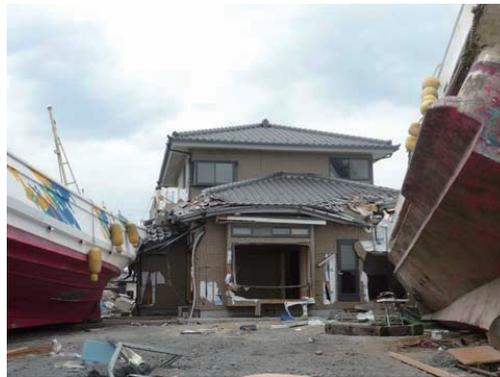
In the west area of the Arahama port, it was confirmed that the wood house (Photo 7.4-26) was crashed by two ships but remained. The reason was that the wave pressure was low and the structural performance of the house was high because the house was relatively new.

Photo 7.4-26. Wood house remained in spite of ships' crashing in the west of Arahama port.

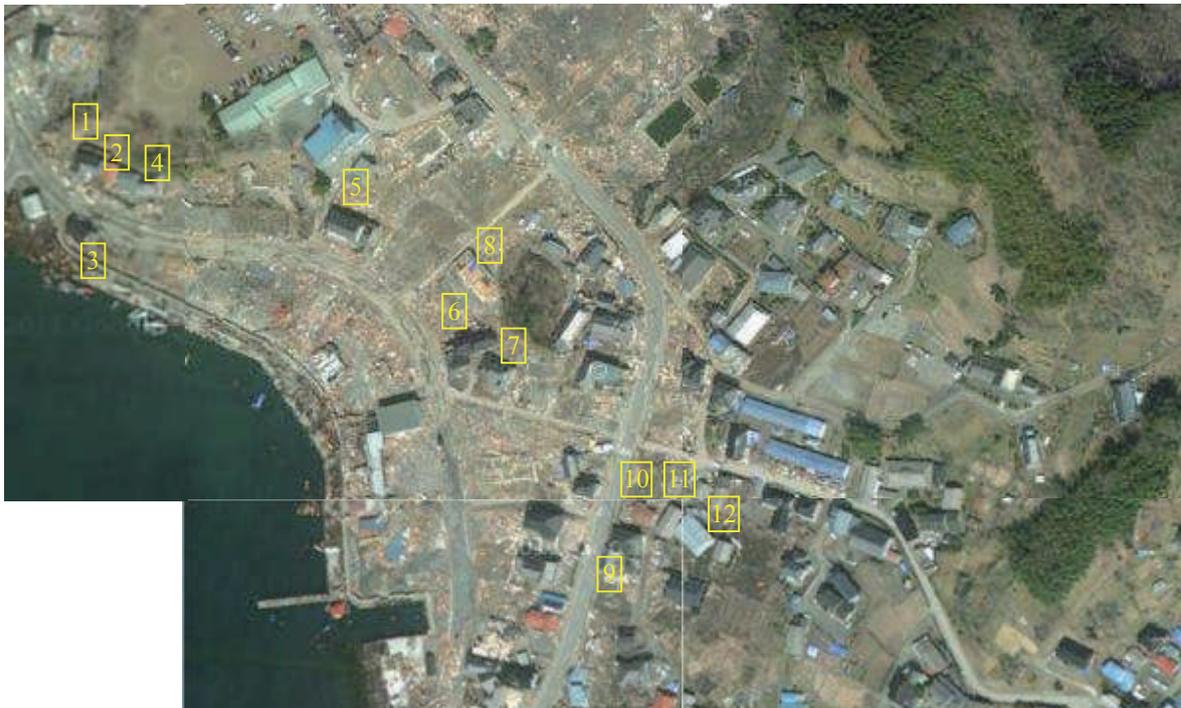
The damage in Akasaki-cho, Oofunato city was reported as an example of the tsunami damage in several surveyed slope lands. Akasaki-cho is located in the east of Oofunato bay, and is a gradual slope land. Fig. 7.4-4 shows the aerial photograph and the locations related to surveyed buildings. Similar to plain areas, many of wood houses were washed away by tsunami here in Oofunato. According to the resident of a house (Photo 7.4-27:<sup>①</sup>) located just near the shore, the height of the tsunami reached to the top of 2<sup>nd</sup> story, and the house went under the water completely. The house was damaged in a part, however it remained. The neighbouring work shed (<sup>②</sup>) whose sill came off from floor concrete moved. On the other hand, a 2-story wood house (Photo 7.4-28:<sup>③</sup>) opposite to the house (<sup>①</sup>) across the street along the sea suffered almost no damage. Two houses next to the house (<sup>①</sup>) and shed (<sup>②</sup>) remained. There is a hill in the back of them (in the north side), and there is a possibility that the hill affected the strength of the wave force caused by the tsunami. A Japanese traditional post and beam frame house (Photo 7.4-29:<sup>④</sup>) built on the street along the sea remained under the water depth of about 5-6 m, in spite of partial

Fig. 7.4-4. Aerial photograph and the locations related to surveyed buildings in Akasaki-cho, Oofunato city.

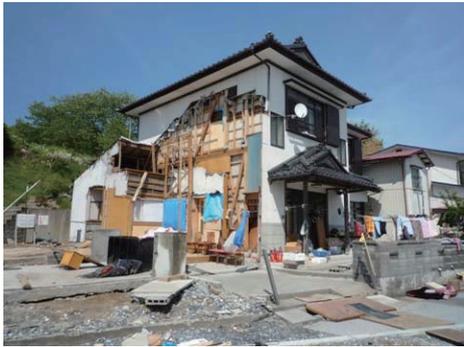
Photo 7.4-27. Wood house (11) remained under the water depth of over 7 m in Akasaki-cho, Oofunato city.

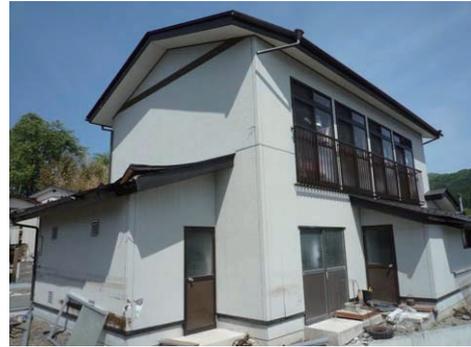
Photo 7.4-28. Wood house (3) without damage under the water depth of over 7 m in Akasaki-cho, Oofunato city.

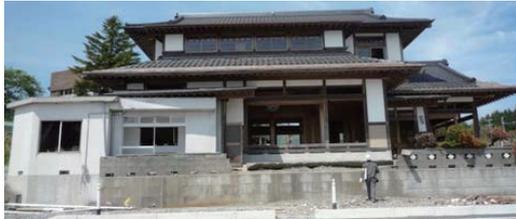
Photo 7.4-29. Japanese traditional wood house (5) which was not carried away under about 5 m water depth in Akasaki-cho, Oofunato city.

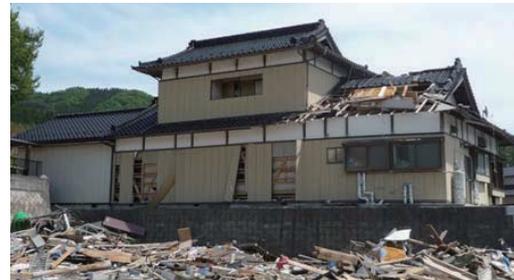
failure of walls. Close to this house, a wood house (Photo 7.4-30:6) remained under about 6 m water depth in spite of partial failure in the roof system. It was considered that this failure caused by the floating materials. There was a house (7) remained in the next, but a house which was guessed to have many hold down fasteners (8) was washed away. The house with hold down fastener may not remain by severe tsunami.

Photo 7.4-30. Wood house (6) which was not carried away in spite of damage on 1<sup>st</sup> floor roof system in Akasaki-cho, Oofunato city.

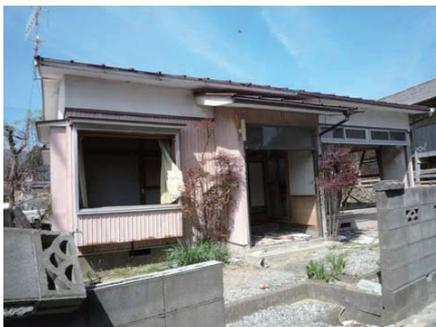
At the location where we went up the slope land from these houses, a light steel-frame house (9) remained in under the about 5 m water depth. In the next of this house, the 1-story old wood house (Photo 7.4-31:10) whose structural specification was not so good, but the anchor bolts were installed remained. In addition, a warehouse with mud walls (Photo 7.4-32:11) was remained and an old wood house without anchors (Photo 7.4-33:12) turned and moved horizontally. Because the wood house under about 5 m water depth were almost washed away in plain areas, it might be possible for the slope land to make lateral force caused by tsunami a little smaller.

Photo 7.4-31. Survived house (9) which seemed to have comparatively slight structural specifications in Akasaki-cho, Oofunato city.

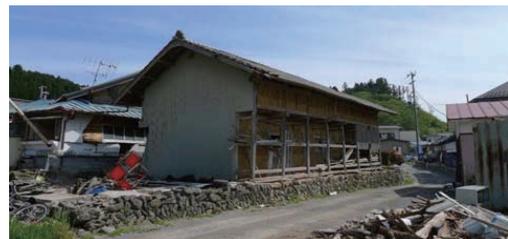
Photo 7.4-32. Survived soil warehouse (10) which seemed to have comparatively slight structural specifications in Akasaki-cho, Oofunato city.

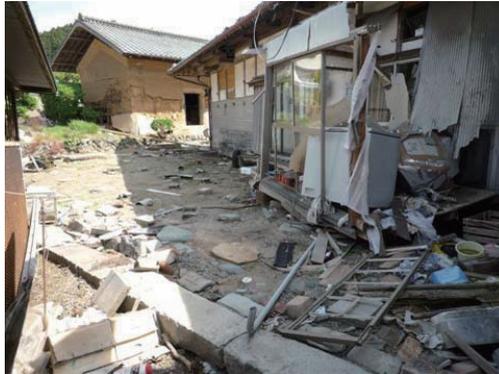
Photo 7.4-33. Survived old house (12) which rotated and moved horizontally in Akasaki-cho, Oofunato city.

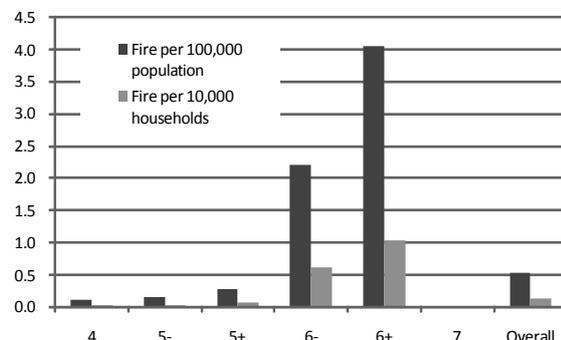
The relation between seismic intensity and fire break-out ratio in this earthquake is shown in Fig. 8.1-1 and Table 8.1-2. The numbers of fires in some municipalities without seismic intensity data are omitted.

Fig. 8.1-1 Relation between fire break-out ratio and seismic intensity

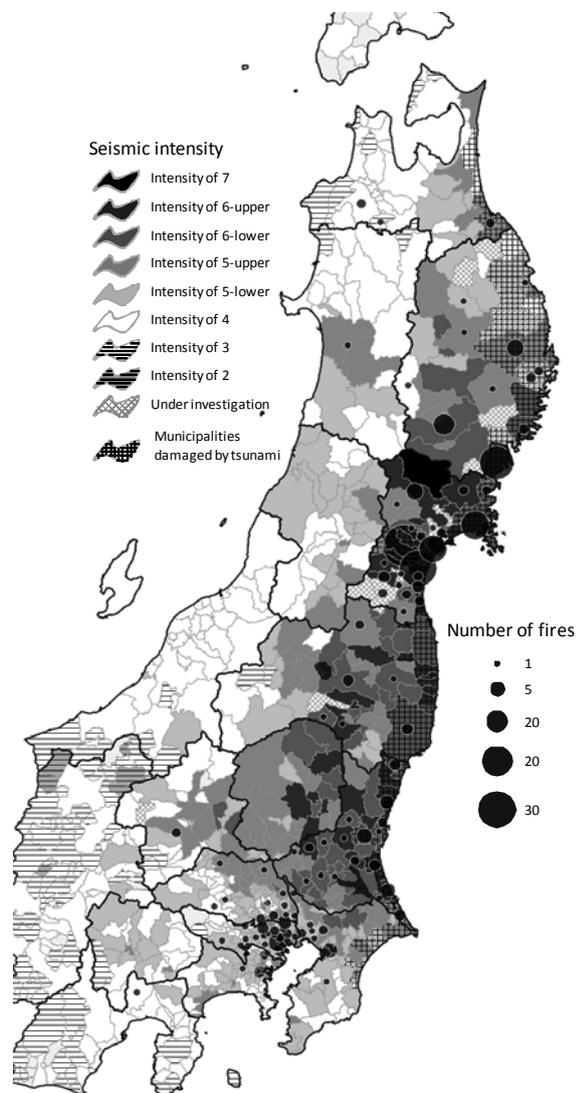
In only one area where seismic intensity 7 was observed, however, no fire was reported. The tendency that the higher the seismic intensity, the higher the fire break-out ratio, is observed in the municipalities where seismic intensity 6 lower (6-) or less was recorded.

Fig. 8.1-2 Distribution of seismic intensity, number of fires and municipalities damaged by tsunami

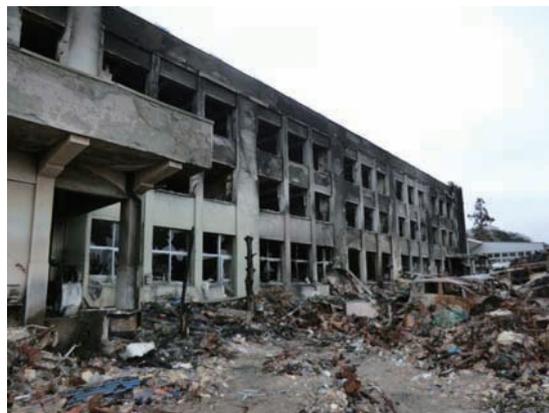
Photo 8.2-1 Tsunami fire at an elementary school (Ishinomaki city, Miyagi prefecture)

Photo 8.2-1 shows a fire scene of an elementary school building located at about 1 km from the coast. Almost all of the 3-story school building had been burnt by the flame flared up from cars, combustible debris and oil and so forth that drifted and accumulated by tsunami in the schoolyard in front of the building.

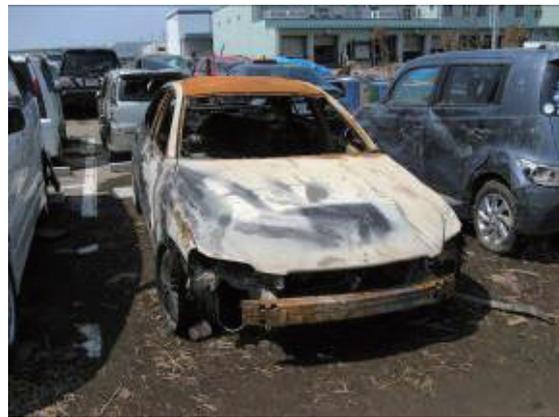
Building at a port was one of the most damaged buildings by tsunami with not only tidal wave but also debris, cars and ships and so forth drifted by tsunami (Photo 8.2-2 and 8.2-3). Several hundred automobiles which have been parked in a parking zone, being drifted to a port warehouse by the tsunami, caused fire at the place where it accumulated.

The cause of the fire is unclear, but it is assumed that the car collided severely each other, the gasoline tank of the cars were damaged, and sparked by malfunction of the electrical system by the seawater. There was no spread of fire in the interior of the building, only the external wall has been damaged by fire.

Photo 8.2-3 Vehicle fire due to tsunami at a parking lot (Iwanuma city, Miyagi prefecture)

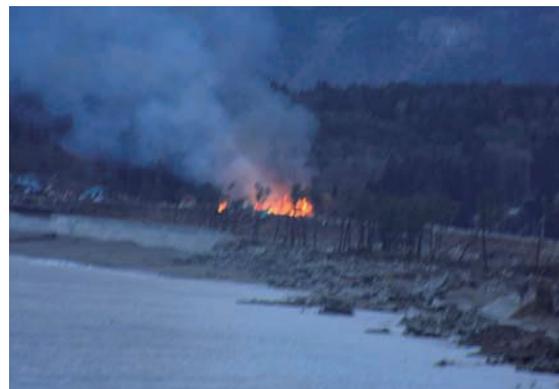
Photo 8.2-4 shows the fire at a coastal village after several hours of tsunami invasion. The fire continued for

Photo 8.2-4 Fire at a site of 8 buildings due to tsunami (Noda-village, Iwate prefecture), Courtesy of Noda-village

over 12 hours. Firefighters could not access to the site because the road had been destroyed by the tsunami.

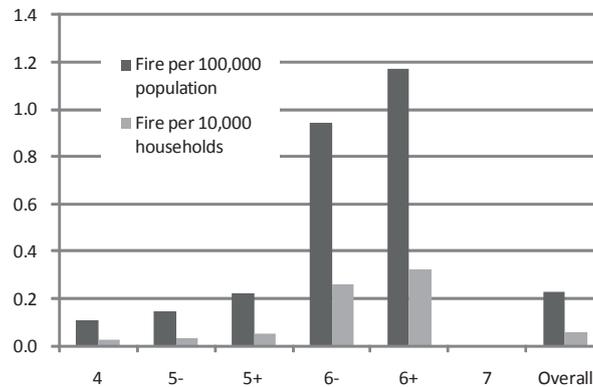
Fig. 8.3-1 Relation between break-out ratio of fire due to earthquake motion and seismic intensity

The relation between seismic intensity and break-out ratio of fire due to earthquake motion is shown in Fig. 8.3-1 and Table 8.3-1. Mass media have reported intensively fire due to tsunami, but many fire cases due to earthquake motion were also identified by this data. Some building fires were presented in the following.

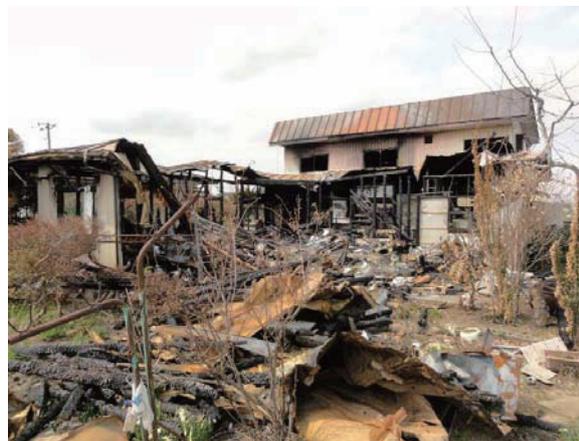
Photo 8.3-3 shows another house fire case in which two wooden houses were completely burnt out and three houses were partly burnt. The cause of fire is assumed to be misuse of candlelight for lighting in the midst of power failure on the night of the next day of the mainshock.

Photo 8.3-3 Fire scene at a house (Oushu city, Iwate prefecture)

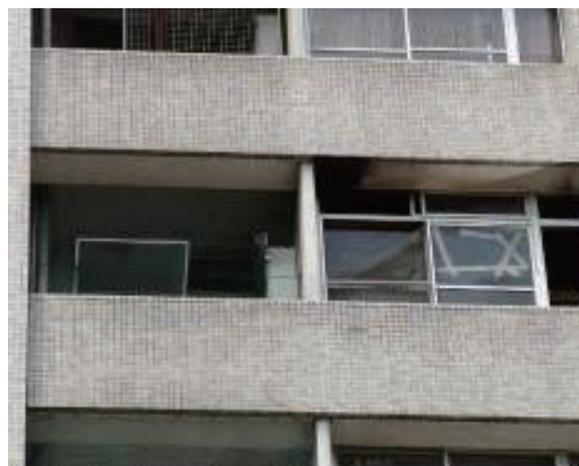
For a condominium fire, one case has been investigated: the fire broke out when electricity supply has been recovered at the night of the next day of the mainshock. The fire broke out on the 7<sup>th</sup> floor of a 17-story medium scale condominium. The residents of the room of fire origin were absent at the time, but some neighbors were aware of the fire and informed the fire station. Because of early suppression by firefighters, there was no spread of fire to the upper floor and the next rooms (Photo 8.3-4).

Photo 8.3-4 Fire scene at a condominium (Sendai city, Miyagi prefecture)

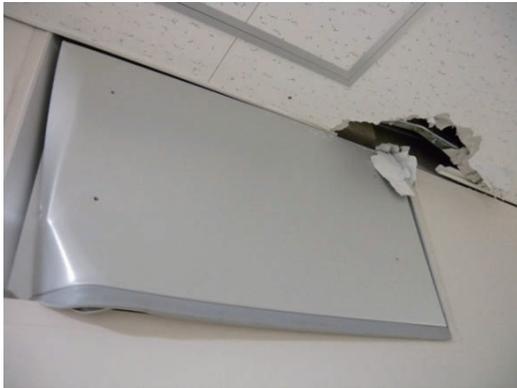
- According to the person in charge of the building, no furniture was turned over and no structural damage was observed.
- However, some damage was observed at the cover-panels of fire protection and the expansion joints near the boundary between isolated and non-isolated floors (Photo 9.2-2). It seems that parts of expansion joints were not well operated due to the large displacement of SI floor during the earthquake.
- The ground surrounding the building partially subsided around 10 cm.

(a) Damage to the panel

Photo 9.2-2 Damage near the boundary between isolated and non-isolated floors

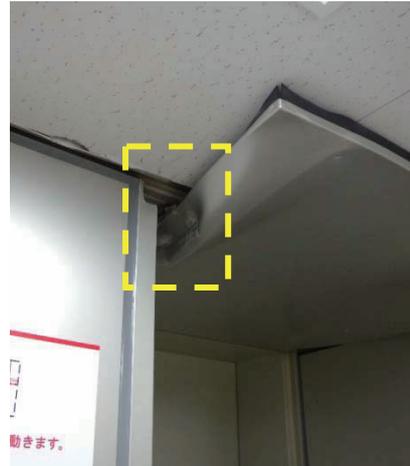
(b) Damage to the expansion joint

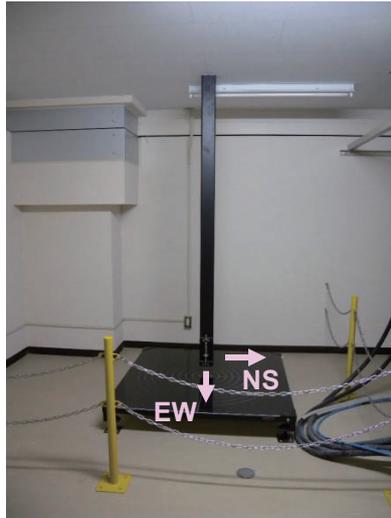
From the trace on the scratch board installed on the SI floor (Photo 9.2-3), the maximum displacement was estimated as around 18 cm at the mainshock on 11 March, 2011 and around 10 cm at an aftershock on 7 April, 2011 (Photo 9.2-4).

Photo 9.2-3 Scratch board installed on the SI floor

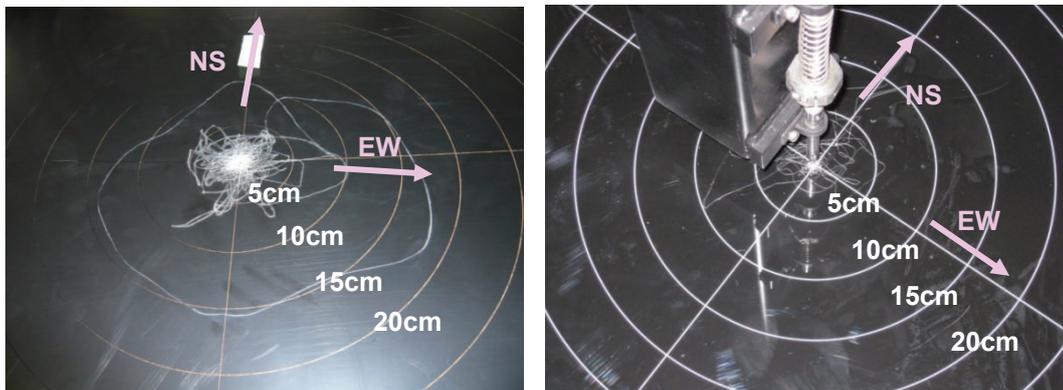
(a) Trace at the mainshock on 11 Mar. (b) Trace at an aftershock on 7 Apr.

Photo 9.2-4 Trace of displacement of SI floor during earthquake

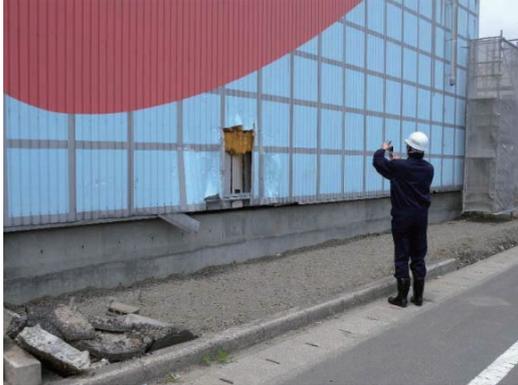
Since the building is located near the Sendai-Shiogama bay, tsunami reached the building and the SI floor was submerged under water. The building also suffered the damage to outer walls by the collision of floating debris (Photo 9.2-6). Observation results are summarized as follows:

Photo 9.2-6 Damage due to debris

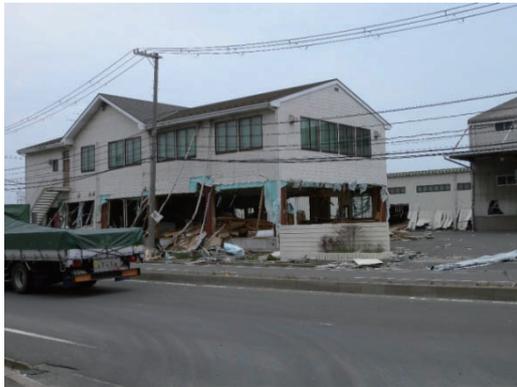
- b) Tsunami height was estimated around 4.0 m from the trace of water on the wall (Photo 9.2-7) and damage situation of surrounding buildings (Photo 9.2-8). There was no information about the direction and impact force of tsunami.

Photo 9.2-8 Tsunami damage to surrounding buildings

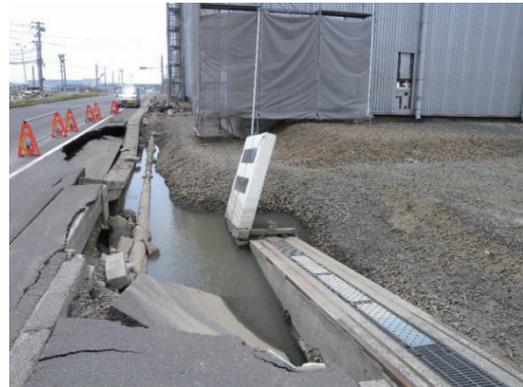
- c) The ground was excavated in northeast corner of the building around 1.0 m depth, probably because of the water flow from the building at the moment of tsunami (Photo 9.2-9).

Photo 9.2-9 Excavation of ground

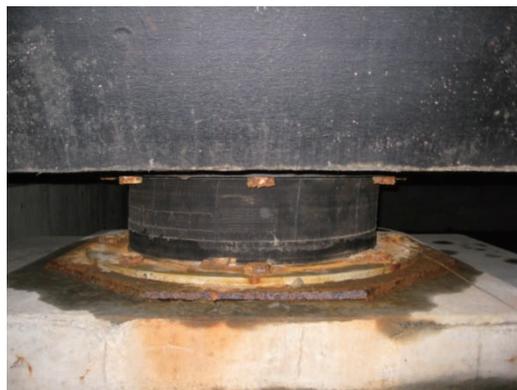
- d) From visual inspection, there was no harmful scratch or inflation of the rubber of HRB, however, severe rust was observed at the steel plates and bolts (Photo 9.2-10).

Photo 9.2-10 Rust of High-damping rubber bearing

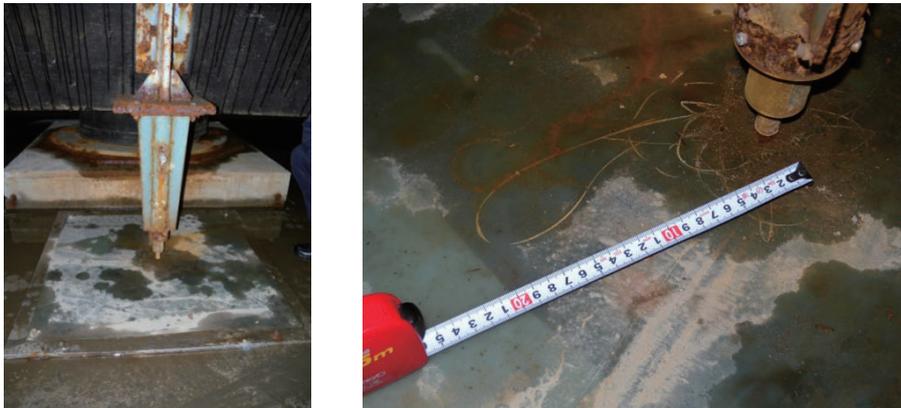
From the trace on the scratch board in the SI floor, the maximum displacement

was estimated as around 21 cm at the mainshock (Photo 9.2-11).

Photo 9.2-11 Trace of displacement of the SI floor on the scratch board

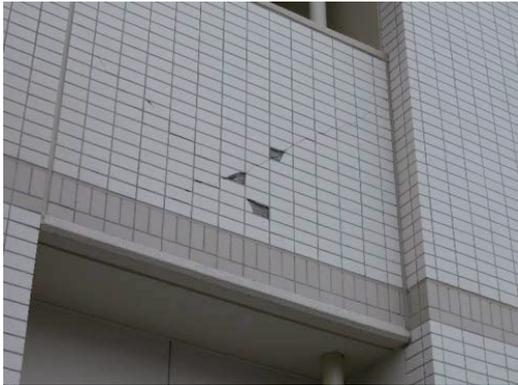
- a) According to the person in charge of the building, no furniture was turned over and no structural damage was observed inside of rooms. However, the damage to the expansion joint was observed.
- b) Drop of the ceramic tiles on outer wall (Photo 9.2-13) and shear crack on the wall in

Photo 9.2-13 Drop of ceramic tiles

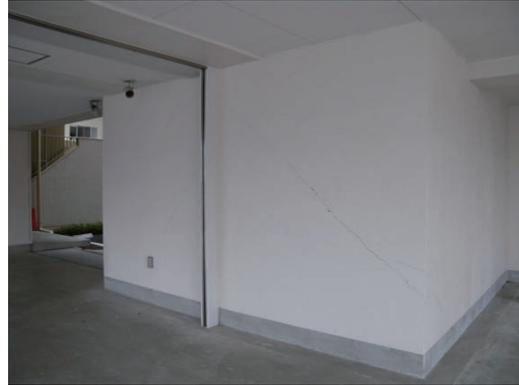
the first floor parking space (Photo 9.2-14) were observed. The subsidence of ground around 10 cm was observed around the building.

Photo 9.2-14 Shear crack on the wall

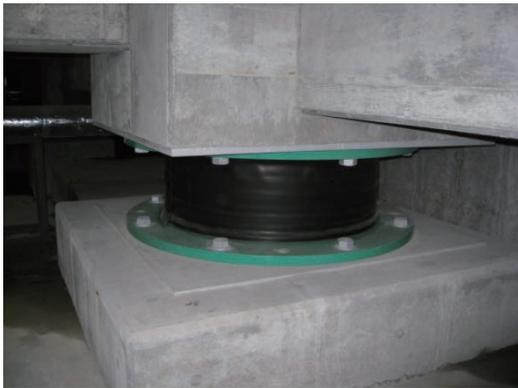
- c) No damage was found to RBs by visual inspection (Photo 9.2-15), however, paint of USDs was peeled off (Photo 9.2-16) and many cracks were found on LDs (Photo 9.2-17).

Photo 9.2-15 Natural rubber bearing

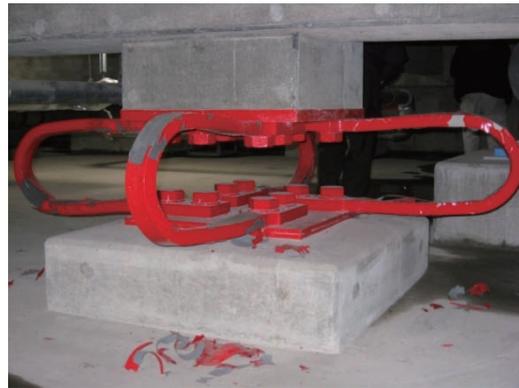
Photo 9.2-16 U-shaped steel damper

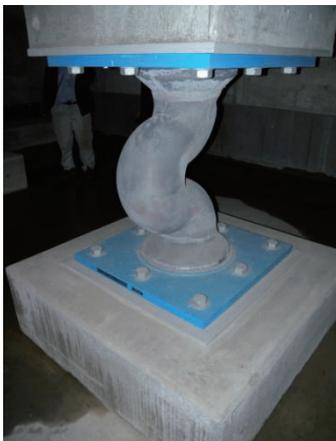
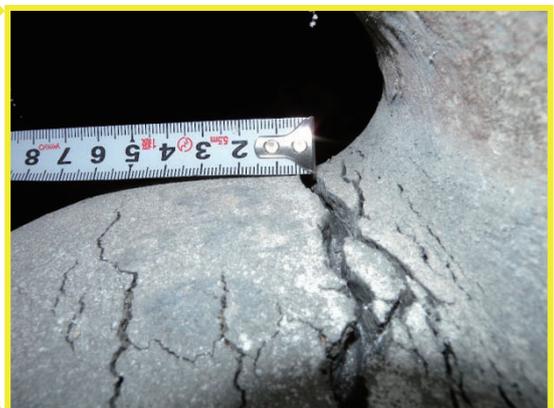
Photo 9.2-17 Lead damper and cracks on the surface

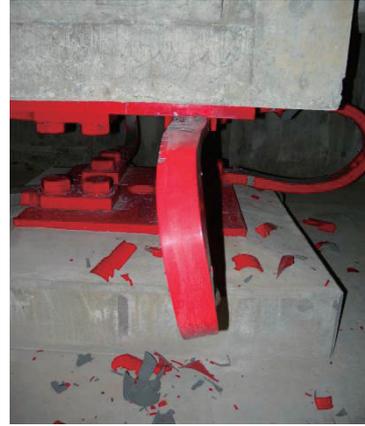
- According to the person in charge of the building, no furniture was turned over and no structural damage was observed.
- Because of the movement of the SI floor during the earthquake, the bolts of steel dampers became loose and the paint on the dampers was peeled off widely. Furthermore, a large amount of residual deformation of steel was remained (Photo 9.2-19).

(2) Deformation of steel

Photo 9.2-19 Deformation of U-shaped steel damper

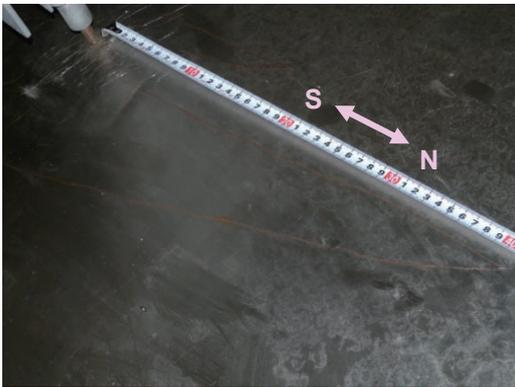
According to the scratch board in the SI floor, the maximum displacement was estimated as around 40 cm northward (Photo 9.2-20). The displacement was also confirmed from the trace of scratch found at the expansion joint outside of the building.

(a) Around 40 cm northward

Photo 9.2-20 Trace of displacement of the SI floor on the scratch board

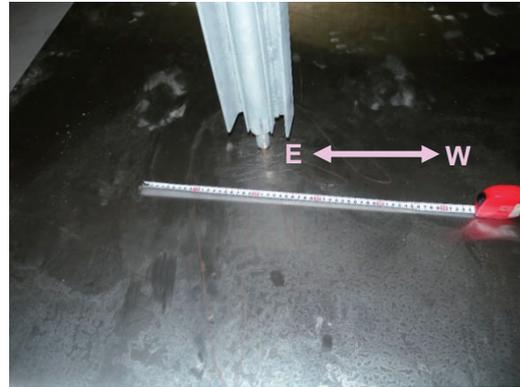
(b) Around 15 cm eastward  
and 22 cm westward

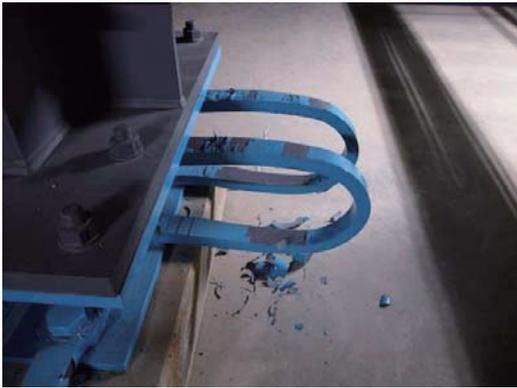
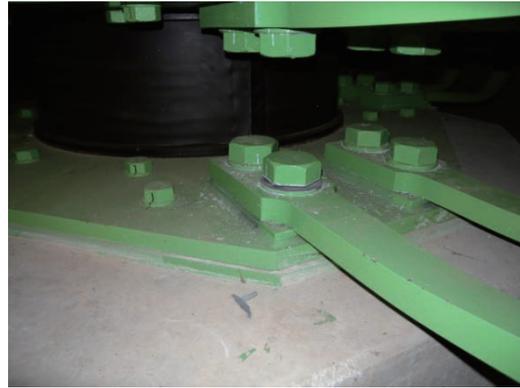
- a) According to the person in charge of the building, up-down shaking happened together with horizontal shaking during the earthquake. On the 6<sup>th</sup> floor, contents inside of the rooms such as refrigerators and shelves were moved or turned over, and the fire protection steel door moved to open and hit against the ceiling by vertical shaking causing the damage to the lamp covers. Above the 4<sup>th</sup> floor, PC monitors were turned over.
- b) In the penthouse, anti-vibration rubber of a power generator was moved and the bottom part of a water tank was broken.
- c) Because of the movement of the SI floor during the earthquake, the bolts of the steel dampers became loose and the paint on the dampers was peeled off (Photo 9.2-22).
- d) The ground around the building subsided around 20 cm.

Photo 9.2-22 Peeling off of paint and loose of the bolts of U-shaped steel dampers

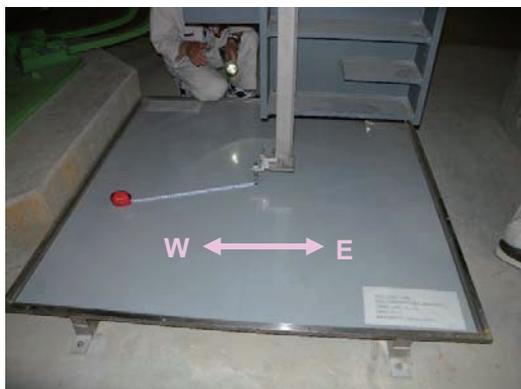
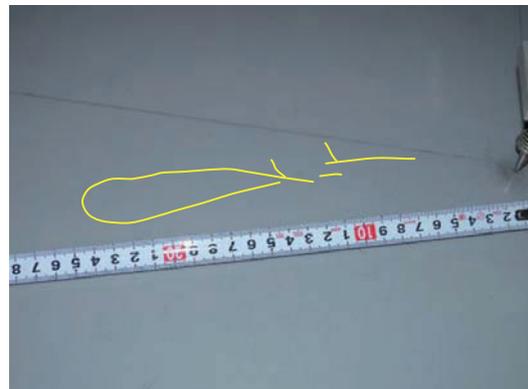
From the trace on the scratch board in the SI floor, the maximum displacement was estimated as around 25 cm westward (Photo 9.2-23). The displacement was also confirmed from the trace of displacement of the ESB (Photo 9.2-24).

Photo 9.2-23 Trace of displacement of the SI floor on the scratch board

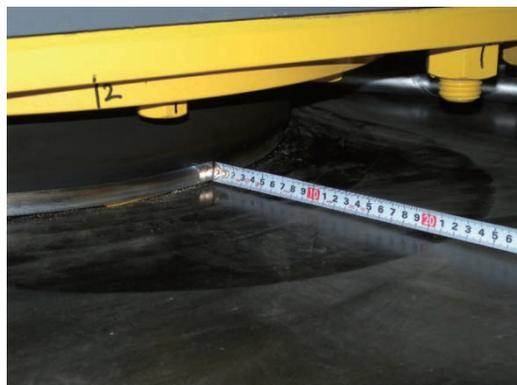
Photo 9.2-24 Trace of displacement of elastic sliding bearing
