Preliminary Reconnaissance Report of the Chile Earthquake 2010

Hiroto Kato, Seitaro Tajiri**
Department of Structural Engineering, Building Research Institute, Japan

Preface

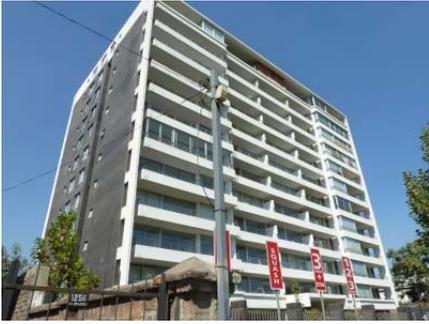
Photo1-1 Appearance

A condominium was completed in 2009 and has 12 floors (2 basements) with reinforced concrete (RC) wall construction (Photo 1-1). The basements are parking garage and span direction wall of the first basement was smashed up as Photo 1-2, and axially compressed. Wall thickness was 150mm.

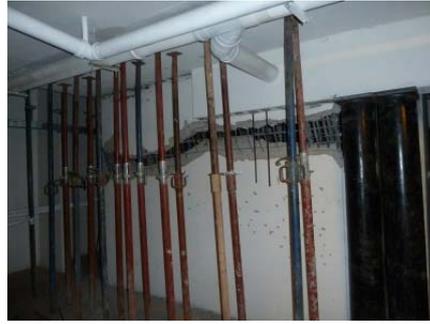
Photo1-2 Smashed RC wall

Photo 39-1 Smashed RC wall (Photo 1-2 reprinted)

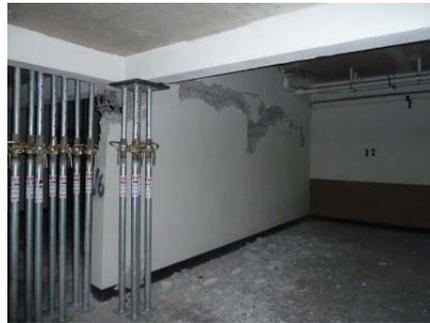
A condominium has 18 floors (2 basements) with RC wall construction. A similar building is in front of Photo 2-1 and the basements for parking garage are between two buildings. Most of RC walls in span direction were smashed at the upper part of walls on the first level basement (Photo 2-2 and Photo2-3). Axial reinforcement is D25 and hoop is D8 ^{#3}. Extensive damage happened on a part of capitals and streamed through the slab at the first floor (Photo 2-4).

Photo 2-2 Smashed RC wall

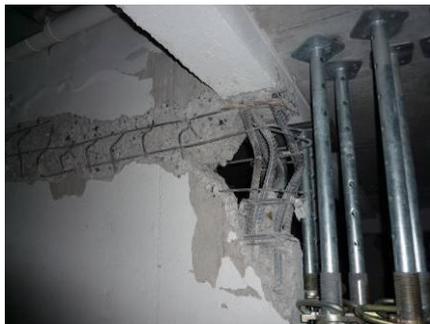
Photo 2-3 Close-up of wall column

Photo 39-2 Smashed RC wall (Photo 2-3 reprinted)

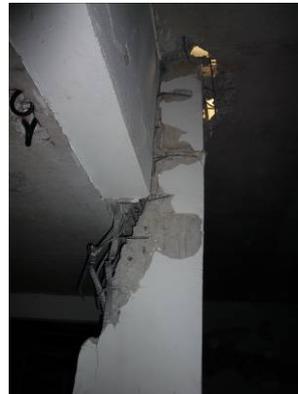
Photo 2-4 Damaged RC column

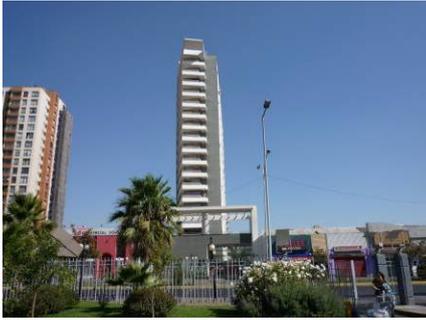
Photo 3-1 Appearance

This is a high-rise condominium with slender form and has 20 floors. Although it was informed that the whole building was slightly sloped, internal building could not be investigated without permission. This building was already determined uninhabitable by the municipal authorities (Photo 3-1 and Photo 3-2).

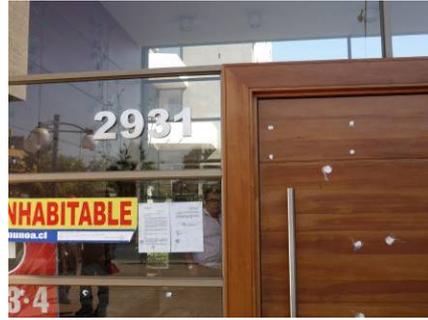
Photo 3-2 Determination by the municipal authorities

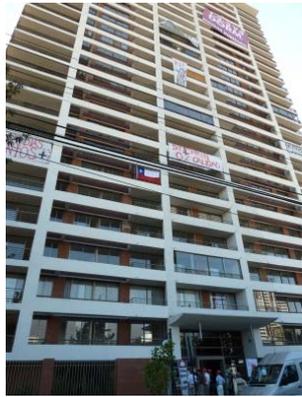
Photo 4-1 Appearance

Photo 4-1 is a high-rise condominium of RC wall construction with 26 floors (1 basement). The bottom of RC wall column next to the entrance was crushed as shown in Photo 4-2 (axial rebar is D35 and hoop is D13). Photo 4-3 shows the internal view of the column. Additionally, the beam-column joint of relevant wall at the first level basement was severely damaged (Photo 4-4). This possible causes are multistory shear wall is lost at the underground.

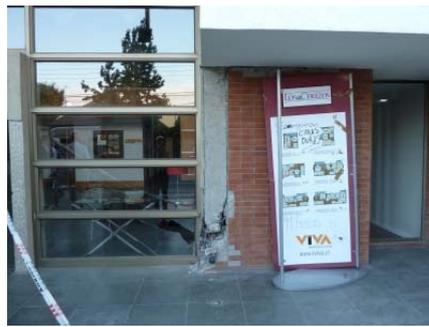
Photo 4-2 Crushed column bottom

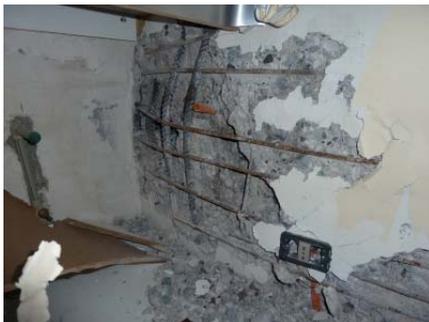
Photo 4-3 Internal view of Photo 4-2

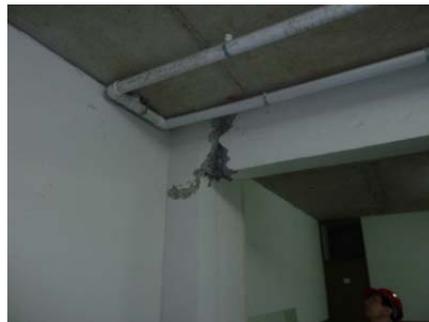
Photo 4-4 Underground portion of Photo 4-2

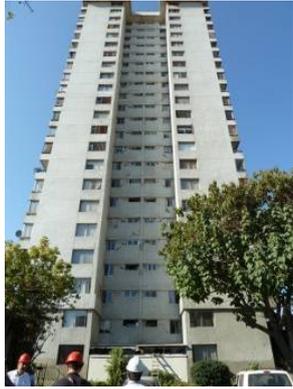
Photo 5-1 Appearance

Photo 5-1 shows a high-rise condominium with RC construction and the number of floors is 22 with 38 years after construction. The exterior of nonstructural brick walls were cracked almost all floors as shown in Photo 5-2. Notable damages could not be seen in structural members.

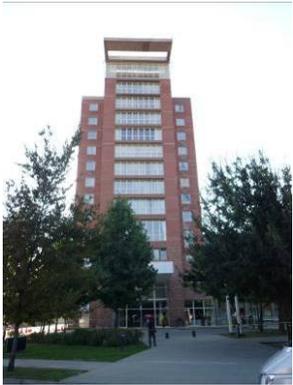
Photo 6-1 Appearance

This is an accommodation with 12 floors and only appearance was investigated since access to this building was prohibited (Photo 6-1). The beam-ends of low-rise building, the joint part with high-rise building, and the joint parts of column capital were damaged (Photo 6-2). According to an investigator of this internal building, some crush occurred on RC angle posts at the basement.

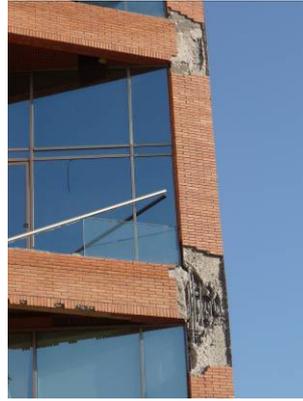
This building group is a commercial establishment with five floors and with other four (Photo7-1). The blindfold wall of external staircase was crumbled. The short spanned wall beams because of nonstructural wall were severely damaged and a part of beam-column joint were broken (Photo 7-2). The penthouse was inclined because of the slab just below was crumbled (Photo 7-3). Earthquake induced ground deformation could be seen on its property (Photo 7-4).

Photo 7-3 Crumbled penthouse

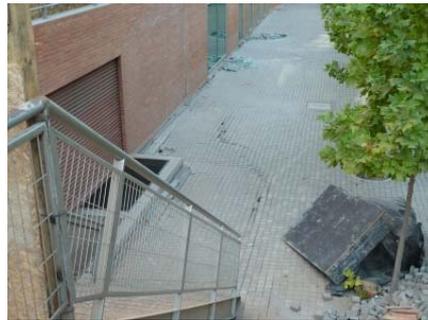
Photo 7-4 Ground deformation

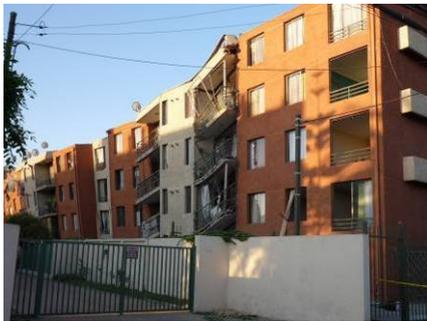
Photo 8-1 is the situation of a five-story building with RC construction for residence. The site is sloped along span direction of building (right side in Photo 8-2). The wall columns in longitudinal direction were in destruction and story collapse was confirmed at first story.

Photo 8-1 Appearance (longitudinal direction)

Photo 36-1 Collapse of soft first story
(Photo 8-1 reprinted)

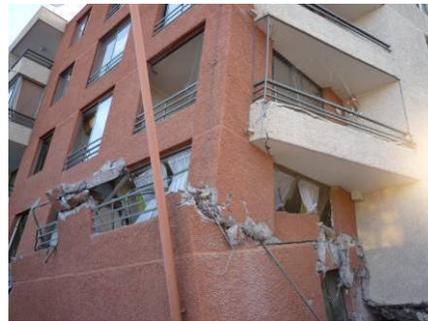
Photo 8-2 Appearance (span direction)

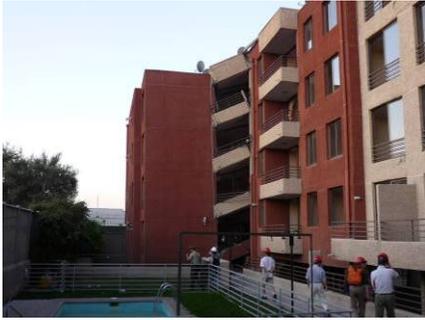
The building is a condominium of RC construction with five floors and soft first story (Piloti). Number of bearing wall is lacking at the first story; parking garage (Photo 9-2). Hinges occurred on capital and bottom of wall columns because of tensile axial force and bending, further story collapse was confirmed at the first story (Photo 9-3). The bearing walls without lateral columns showed shear failure (Photo 9-4).

Photo 9-1 Appearance

Photo 36-2 Collapse of soft first story (Piloti)
(Photo 9-1 reprinted)

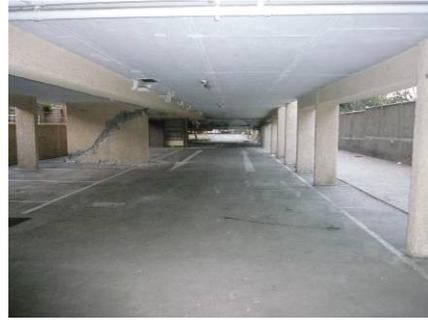
Photo 9-2 First floor parking garage (Piloti)

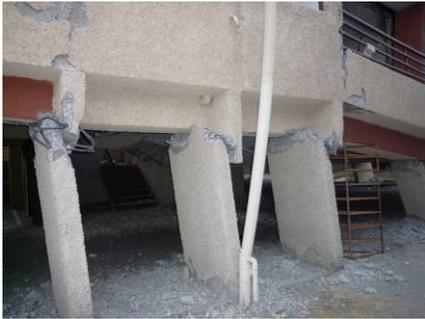
Photo 9-3 Wall column with bended hinge

Photo 40-1 Flexural hinges on wall columns
(Photo 9-3 reprinted)

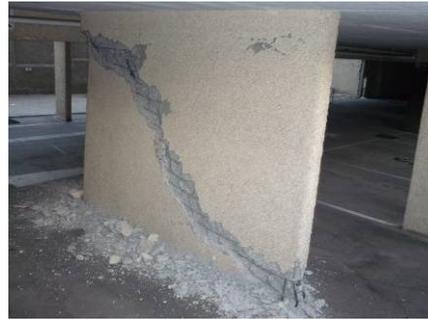
Photo 9-4 Shear failure

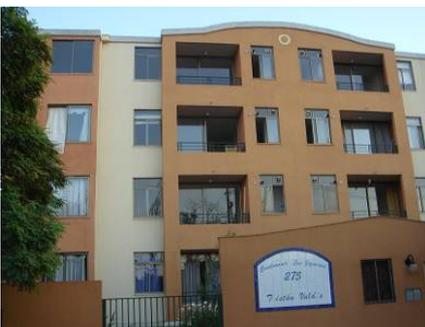
Photo 10-1 Appearance

This building is a condominium of RC construction with soft first story (Piloti) and has four floors (Photo 10-1). Outer parts of building at the first floor are composed of T-shaped wall columns and multistory shear walls construct center part. T-shaped wall columns were severely damaged around 500-600mm high as Photo 10-2 shown and concrete of them were fallen off and could not bear the axial force. Concrete of bearing walls at the first story dropped and damage was severe. Fillers like polystyrenes were found at the top of wall at left side of the entrance, therefore it is estimated that the bearing wall at periphery does not work effectively against earthquake force.

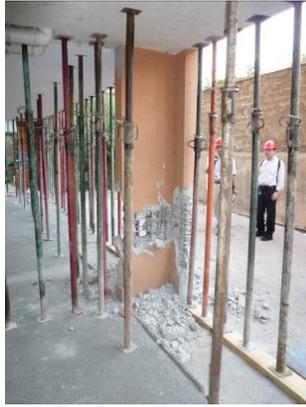
Photo 10-2 Damaged T-shaped wall columns and bearing walls

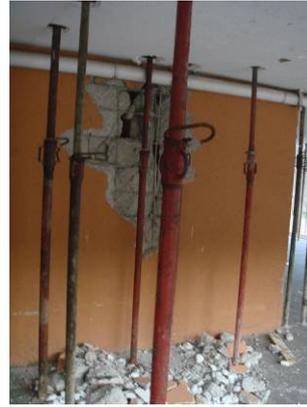
Photo 10-3 Fillers like polystyrenes

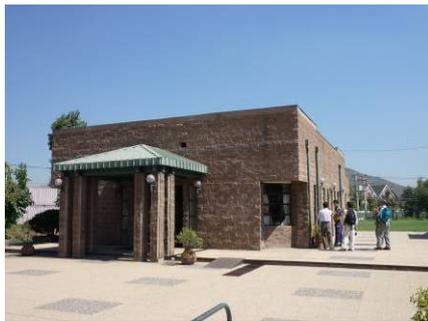
Photo 11-1 Appearance

The building in Photo 11-1 is the auditorium of Japanese school in Chile and has two floors with concrete block construction. Minimal crack was observed in joint part of block walls and cantilever walls which thrown out from the building frame (Photo 11-2). Small gap was found in a part of ceiling panel, but they were small damage as a whole (Photo 11-3).

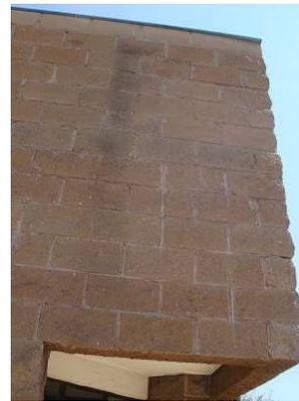
Photo 11-2 Crack of cantilever walls

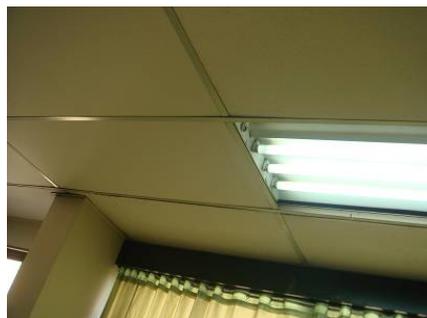
Photo 11-3 Ceiling gap

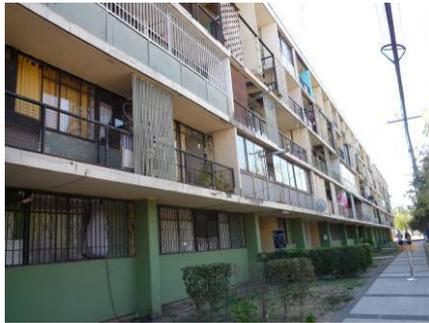
Photo 12-1 Appearance

An apartment house for low-income group constructed by SERVIU, it has four floors with double-loaded corridor and 54 years after completed (Photo 12-1). The structure is moment resisting frame with RC bearing walls and nonstructural brick walls (Infilled Wall structure #4).

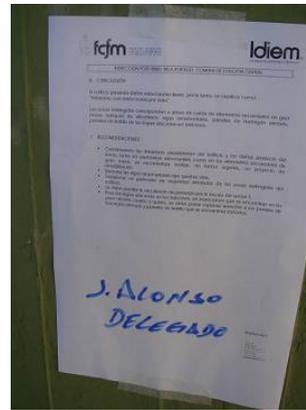
SERVIU requested IDIEM for damage investigation and already completed. A document posted at the entrance shows the inspection results and precaution statement (Photo 12-2). Cracks were appeared on masonry walls in double-loaded corridor and party wall, and some parts were completely fallen off (Photo12-3). This building was kept using through earthquakes happened in Chile in 1960 (Mw9.5) and in 1985 (Mw7.8). Renovation of cracks was found on masonry walls. Meanwhile, some cracks occurred on beam elements, which support the external staircase landing, and vertical deformation with long-term loadings on them were observed (Photo12-4). In other building, a roller supported beam at roof was fallen off because of the earthquake (Photo 12-5), and should be taken measures as a part of reinforcement work.

Photo 12-2 Inspection results

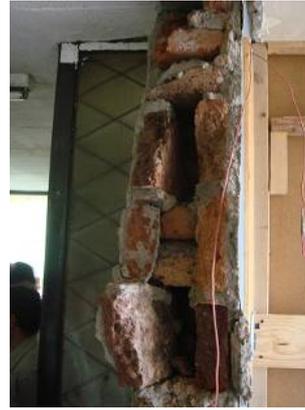
Photo 12-3 Damages of masonry walls

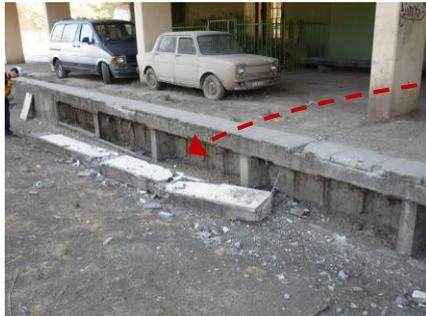
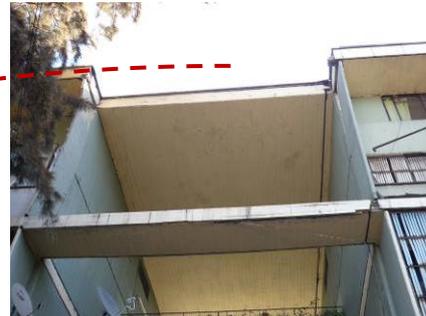
Photo 12-5 Fallen beam from roof

Photo 46-1 Drop of beam (Photo 12-5 reprinted)

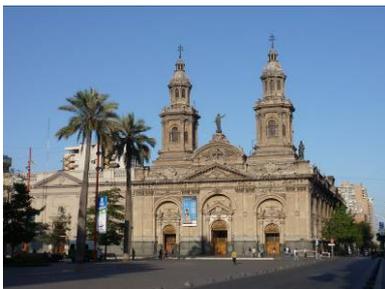
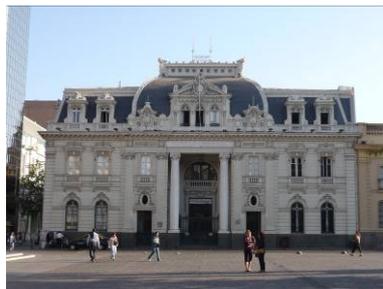
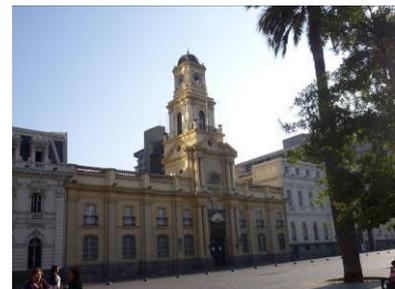
In most cases, old masonry buildings (stone masonry or brick construction) in the investigated areas of Santiago did not show damages. Some minor problems as door was not opened might happen in many ordinary buildings however, apparent damages were not seen ^{#6}. Adobe structure buildings did not exist anymore in Santiago. Furthermore, it is explained that construction of Adobe structure buildings will not be allowed in the future even if in local areas.

Photo 13-1 Masonry structure buildings in Santiago (No damage)

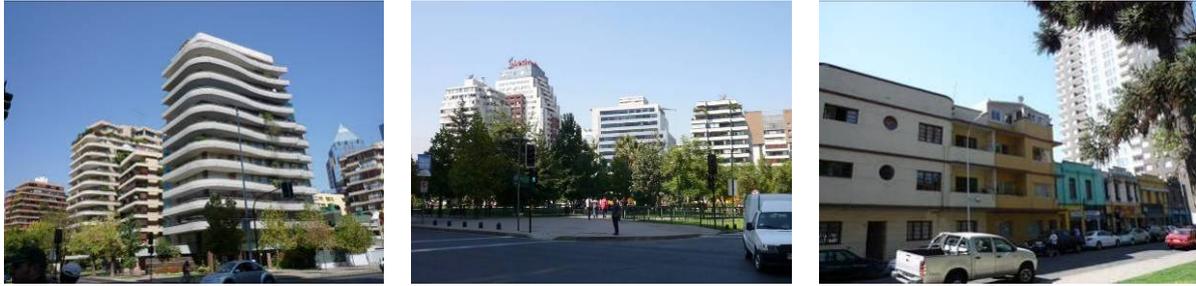
Photo 13-2 General buildings in Santiago (No damage)

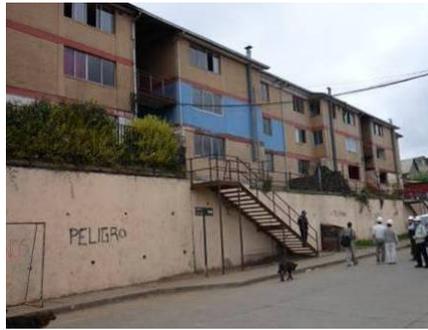
Apartment houses of Confined Masonry (CM) structure with three floors exist on hillside, which were constructed by SERVIU around 10-15 years ago for low-income group (Photo 14-1). Dimensions of columns are 200x300mm. Axial reinforcement is D10 and hoop is $\phi 4$ with about 150mm spacing. Hollow bricks composed walls and horizontal rebar at masonry joint reinforced the wall every 4-5 layer of bricks, but no vertical reinforcing bars (Photo 14-2).

Photo 14-1 Appearance

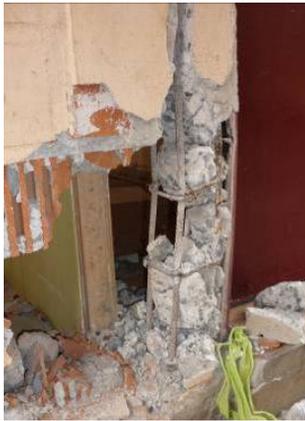
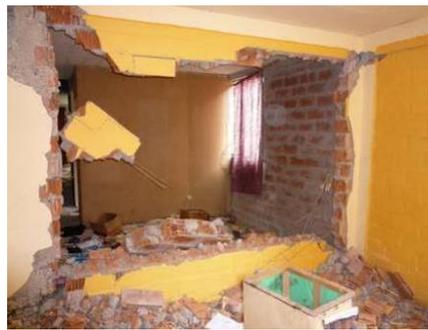
Photo 14-2 Columns and walls with CM structure

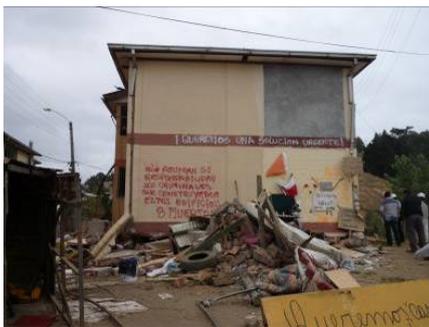
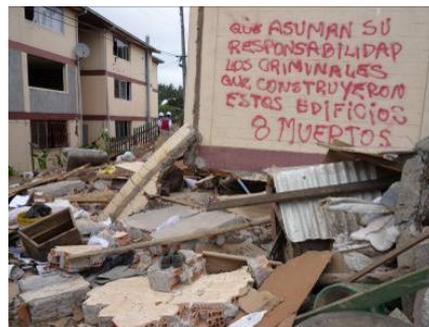
Story collapse at the first story was confirmed in a building built in the highest place near the cliff (Photo 14-3), and two families with eight people were dead. Cracks appeared on the upper of the cliff and it might be banking structure. There was no hoop in beam-column joint (Photo 14-4).

Photo 14-3 Buildings with story collapse at first story

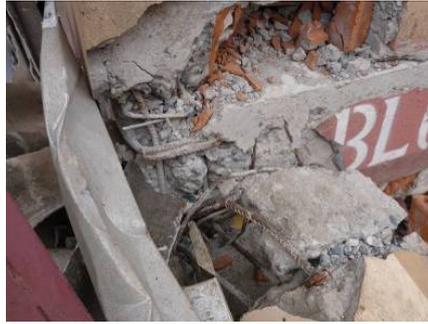
Photo 14-4 Beam-column joint

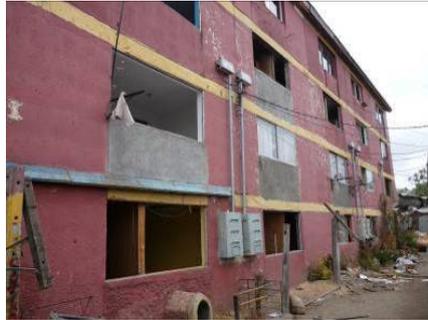
Apartment houses constructed by SERVIU are near the river mouth. The buildings were CM structure with bricks and have four floors after 20 years construction (Photo 15-1). Tsunami marked a trace at about 400mm high of floor.

Photo 15-1 Appearance

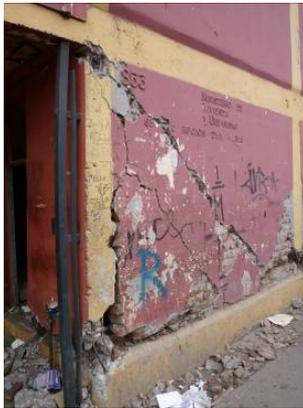
Shear failures of transverse wall were found, and the floor height was down in a building out of four (Photo 15-2). There were rock pockets and rusted reinforcing bars in the broken part. Beam of top of transverse wall came down in another building (Photo 15-3 and Photo 15-4).

Photo 15-2 Shear failure of transverse wall

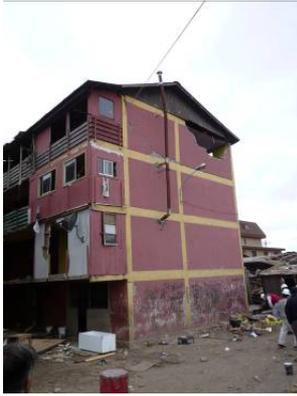
Photo 15-3 Damaged beam for top of transverse wall

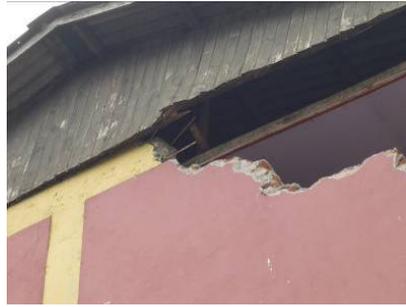
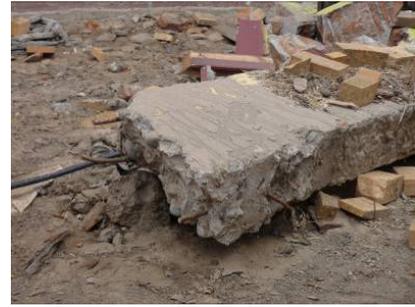
Photo 15-4 Fallen beam

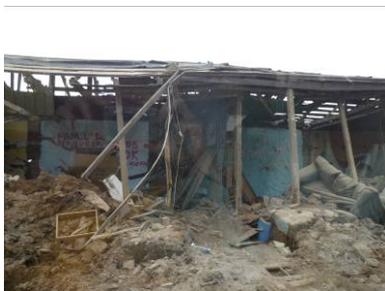
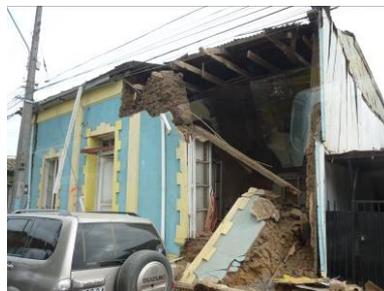
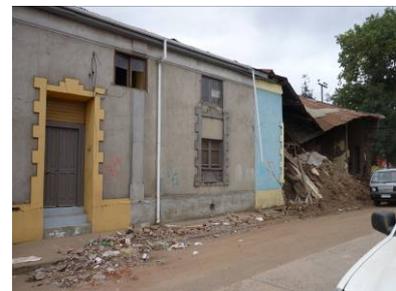
Buildings with old brick construction and Adobe structure were damaged in many places in Constitucion, while the damage of new low-rise houses built on mountainside were slight.

Photo 16-1 Damages of old brick structure and Adobe structure

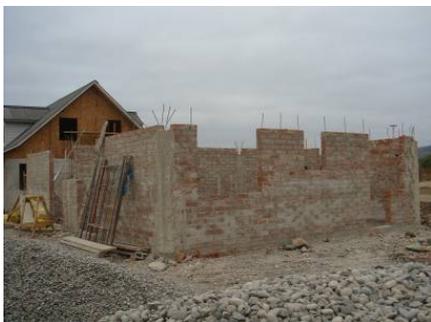
Photo 18-1 shows construction work of low-rise houses with two-story of which the first floor is CM structure and the second floor is wooden structure. Vertical reinforcements of columns, and those of walls (500mm spacing) were arranged on concrete foundation, and hollow bricks were subsequently stacked as walls. The walls contain horizontal reinforcing steels, and the top of walls and columns were unified by cast-in-place concrete beam. Main reinforcements in column and footing beam were straightly anchored in the joint, and corner bars of 90-degree bend with 400mm (40d) length were arranged on main reinforcement (Photo 18-2). The spacing of hoops in column was around 200mm, but the angle of hook end was not 135-degree. The slab was one-way joist slab using concrete blocks (Photo 18-3). Masonry walls were collapsed to out-of-plane direction before concrete was casted in columns (Photo 18-4).

Photo 18-1 CM structure house under construction

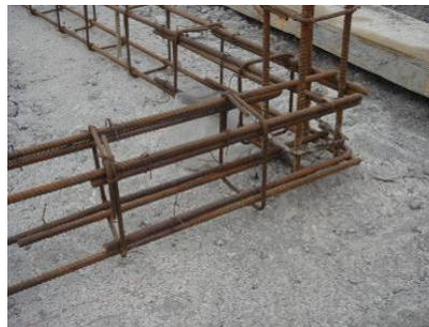
Photo 18-2 Bar arrangement of footing beam and corner

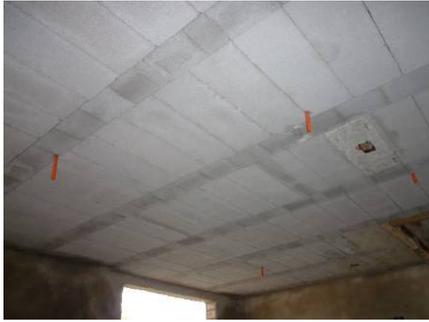
Photo 18-3 Joist slab

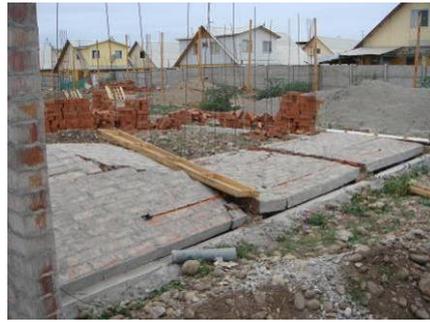
Photo 18-4 Fallen Masonry walls

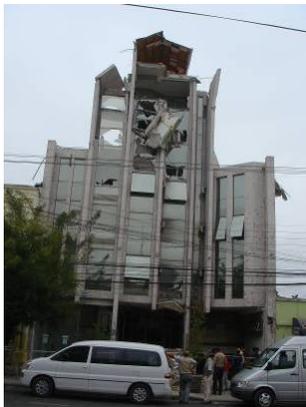
Nonstructural elements of an office building with RC structure were fallen off (Photo 19-1). Granular foamed polystyrene were contained in concrete materials (Photo 19-2).

Photo 19-1 Appearance

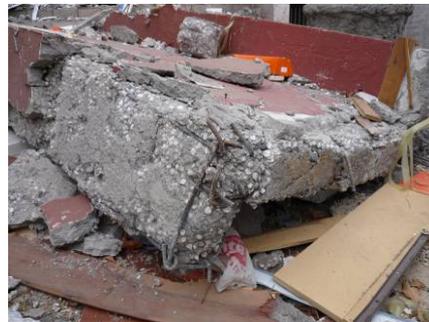
Photo 19-2 Foamed polystyrene contained in concrete

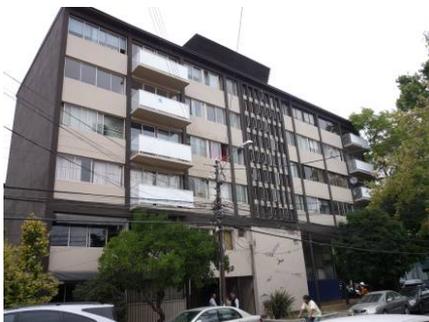
A SERVIU office building of RC structure in Talca with 30 years after construction had six floors (top three floors are apartment), and steel columns composed the outer frames in longitudinal direction (Photo 20-1). Broken windows were scattered on outdoor passage (Photo 20-2). Shear failure of masonry walls at the front, RC bearing walls, and most short span beams of top of the door were observed (Photo 20-3). Four axial reinforcements were arranged in wall edge, but the spacing of reinforcement was narrow (Photo 20-4).

Photo 20-1 Appearance

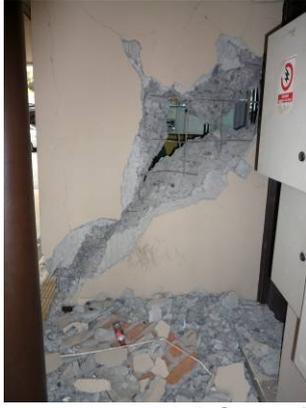
Photo 20-3 Shear failure of bearing walls and short span beam

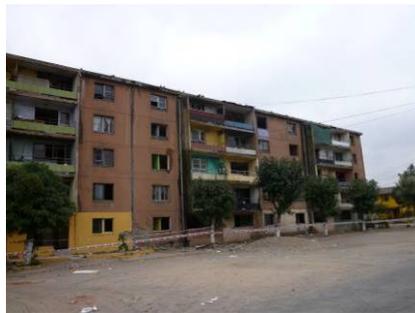
This is a public housing for low-income group with 50 years after construction, and the dimension is long side 47.4m x short side 7.7m and five floors with RC construction (Infilled Wall structure, Photo 21-1). Back of the front wall in Photo 21-2 is an adjacent house, and those were built with EXP.J without any space, so masonry structure walls were damaged because of shock and vibration of the earthquake and almost fallen from the RC structure. Other than above, damages of nonstructural brick walls, and exposure of reinforcing bars of transverse wall edges were found (Photo 21-3). Damages seem moderate, but SERVIU officials told this housing would be demolished.

Photo 21-1 Appearance

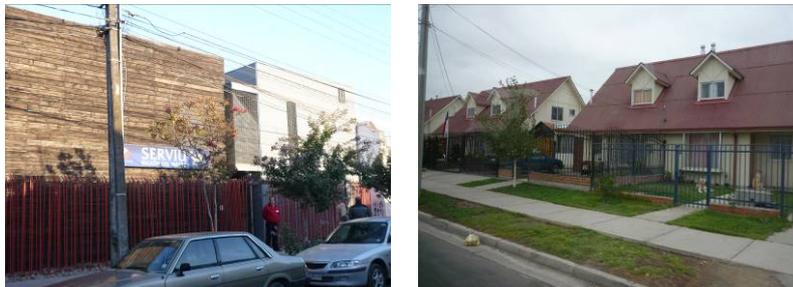
Old brick constructions and Adobe structures everywhere in the city were severely damaged (Photo 22-1). Comparatively new buildings and houses did not receive so much damage (Photo 22-2).

Photo 22-2 Comparatively new buildings and houses

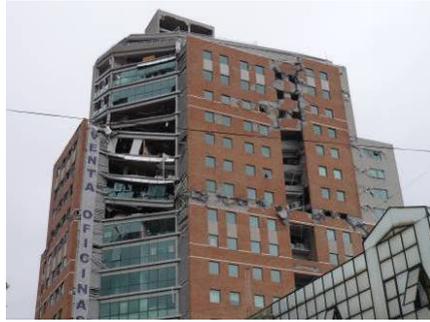
A high-rise office building of 21 floors with RC structure constructed in 2008 was in urban area (Photo 23-1). Story collapse occurred in the middle story near the 12th floor at the front of the building (Photo 23-2). Upper stories were inclined to roadside, and the front street was impassable. Setback was found near the story-collapsed floor. There were multistory bearing walls in backside of the building, and no remarkable damage. According to SERVIU officials, the owner will plan to demolish only the upper stories of the story-collapsed and continue to use the building.

Photo 23-2 Story collapse near 12th floor

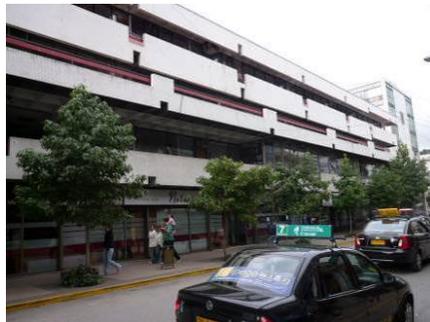
This is an office building constructed by SERVIU and has four floors with RC structure (Photo 24-1). Masonry walls of inside and stairway were smashed (Photo 24-2) and documents were scattered. Bending-shear cracks occurred at regular interval on the capital of circular RC columns of 3rd and 4th floor (Photo 24-3). Nonstructural walls had severe damages, but the building will be able to use after adequate restoration.

Photo 24-1 Appearance

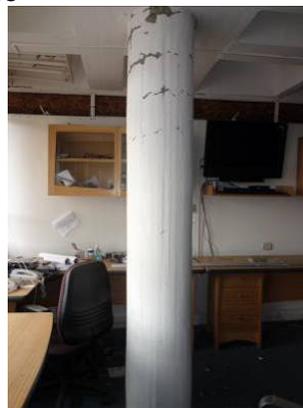
Photo 24-3 Bending-shear cracks of circular column

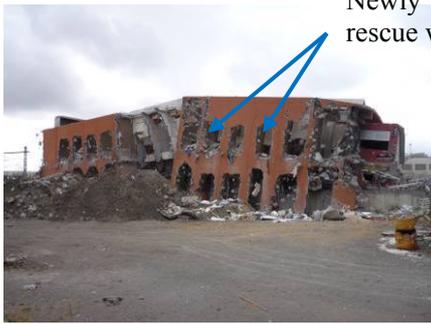
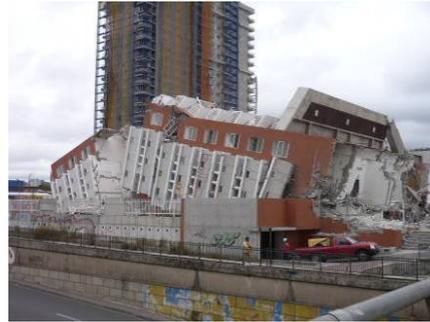
This condominium was built in 2008, had 15 floors and 2 basements (parking garage) with RC structure. The building had a fall from the bottom of the first story (Photo 25-1). Destructions of walls on the Photo 25-1 were openings for rescue works. According to the hearing from a resident who lived in the 5th floor at the earthquake, the building sank about one minute after the earthquake and began collapsing. Photo 25-2 shows that all reinforcements of columns and bearing walls were drawn out or cut at the first floor when collapsing. There was no damage in the basement walls for the gable plane of structure (Photo 25-3).

Newly opened for
rescue works

Photo 25-1 Appearance

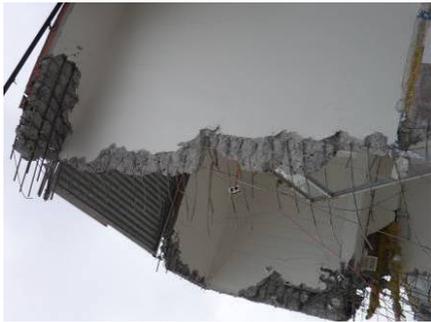
Photo 25-2 Torn wall columns and bearing walls

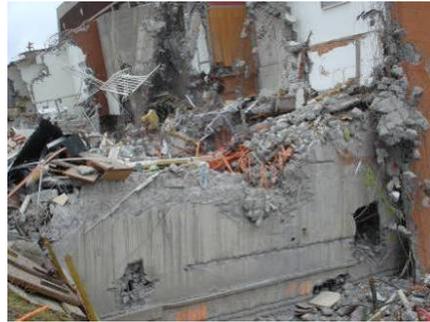
Photo 25-3 Walls at basement

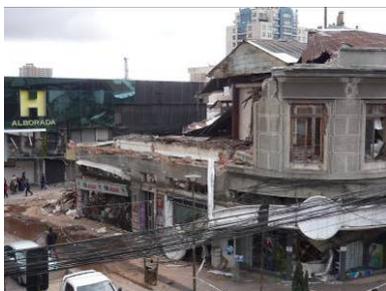
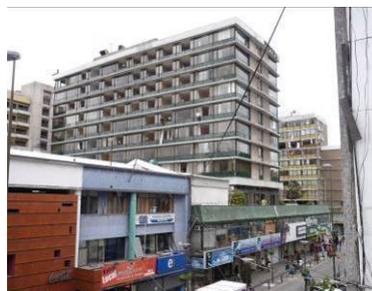
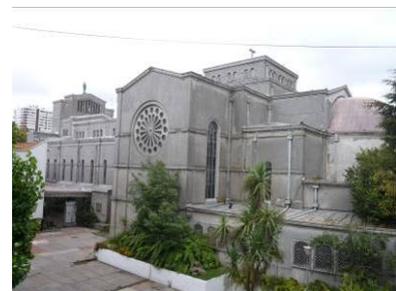
A lot of old brick construction and Adobe structure buildings were damaged in Concepcion. Many buildings suffered from damage in some parts or glasses were under renovation, but not so many middle and low-rise buildings with RC structure were damaged. Photo 26-1 shows devastated details in the city.

Photo 26-1 Concepcion

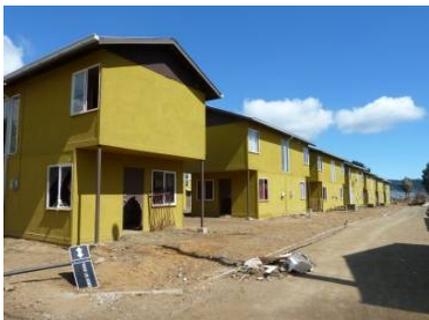
Those are houses constructed by SERVIU in 2008, which steel frame and precast RC construction are mixed (about 4.8m eave height, Photo 27-1 and Photo 27-2). Most damage of buildings was caused by Tsunami, not the earthquake as itself.

Photo 27-1 Appearance

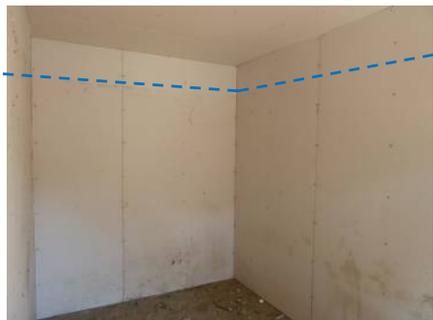
Photo 27-3 Trace of Tsunami (Wall at the second floor)

Photo 27-3 shows the trace of Tsunami which remained on the wall. It is imagined that the height of Tsunami was about 9m because, the altitude of the nearest house from the seashore is about 5m and the trace of Tsunami was near the ceiling of the 2nd floor.

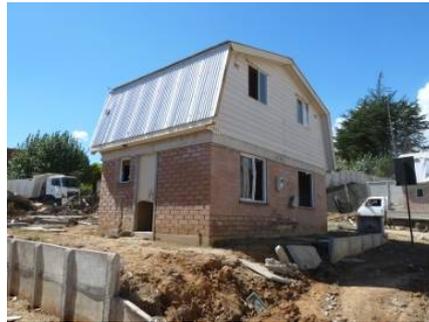
They are houses constructed by SERVIU in 2008. The 1st story was masonry structure with bricks and the 2nd story was wooden structure (Photo 28-1). Not so big damages received by the earthquake, but the most damage was because of Tsunami, and wooden structure parts of the 2nd story were swept away (Photo 28-2). Damages of northern part of houses were severe, and wooden structure part of the 2nd story was deformed to south side, so it is imagined Tsunami was attacked from the north. There were foundations and girders, but not columns at the 1st story, and vertical and horizontal reinforcements were arranged in the walls. The size of the vertical reinforcement was about D10 (Photo 28-3).

Photo 28-1 Appearance

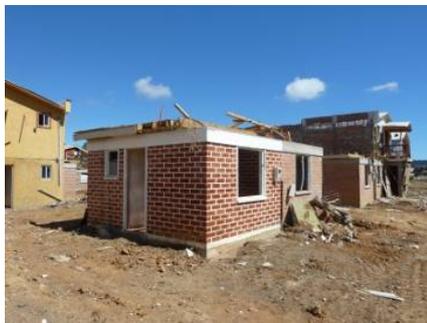
Photo 28-2 2nd story were swept away by Tsunami

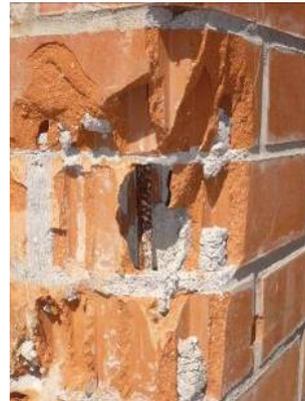
Photo 28-3 Vertical reinforcement

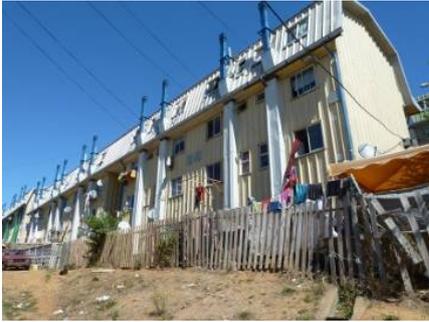
This is an apartment house offered by SERVIU and has four floors (Photo 29-1). The structure is light-steel frames and braces, and exterior walls were composed of steel folded plates. Some residents used to remove the brace or column in a part of houses, but there was no big damage by the earthquake. Steel folded plates of exterior walls were deformed in some parts as Photo 29-2, and it is imagined that they worked properly as earthquake resistant elements.

Photo 29-1 Appearance

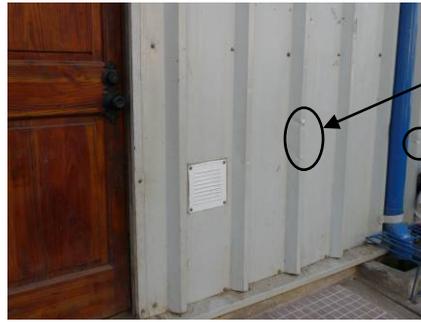
Photo 29-2 Deformation of folded plates

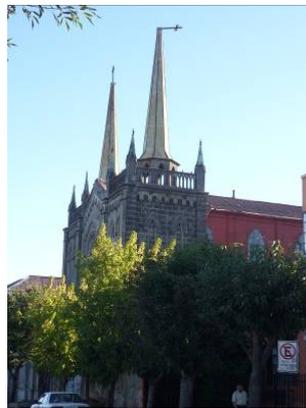
Investigation in Chillan was not conducted, but the church near the hotel was severely damaged (Photo 30-1). Building frame is RC structure, but the steeple penetrated the roof and came down. The top of colonnade of a chapel and walls were also damaged (Photo 30-2 and Photo 30-3).

Photo 30-1 Church

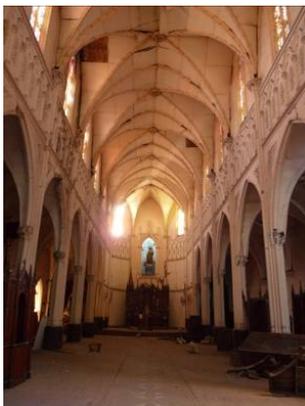
Photo 30-2 Inside of church

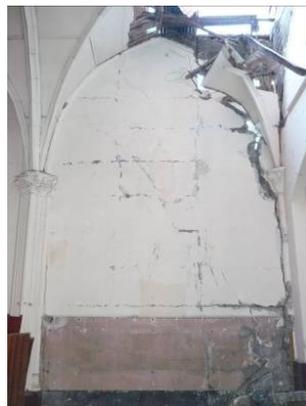
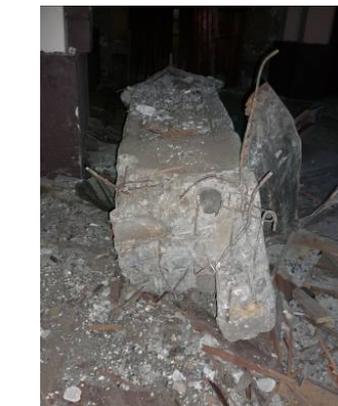
Photo 30-3 Fallen steeple

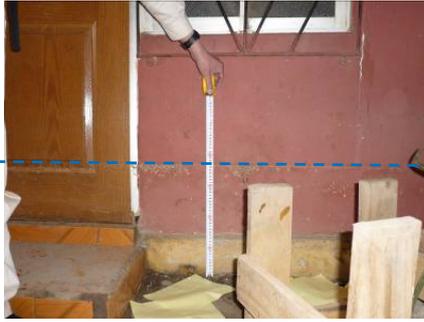
The traces of Tsunami in Constitucion were shown in Photo 31-1 and Photo 31-2.

Photo 31-1 Apartment house of SERVIU near estuary region (About 400mm high)

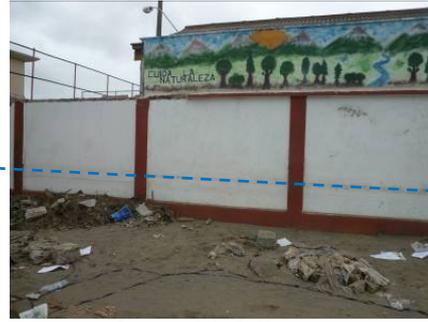
Photo 31-2 City area

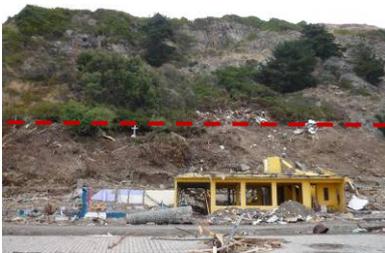
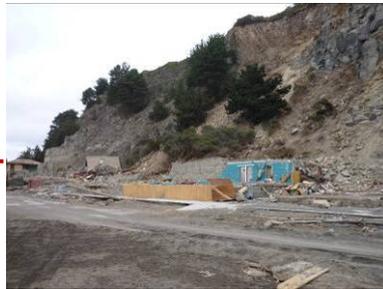
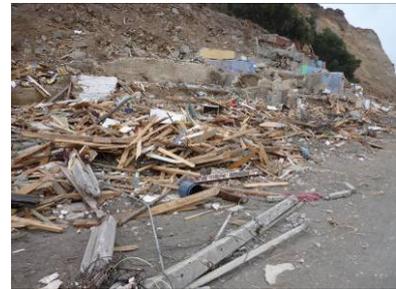
All of restaurants built at the seacoast were destroyed. Discolored plants by seawater were up to halfway of the cliff, and it estimated that Tsunami reached about 20 to 30m (Photo 31-3). All streetlights on the coast were turned over from the foot to same direction (to the south). A wood chips factory near the seacoast also received damages (Photo 31-4).

Photo 31-3 Trace of Tsunami

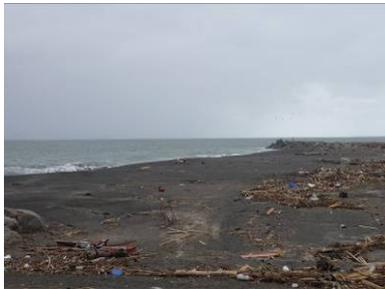
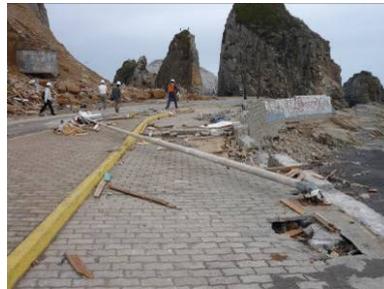
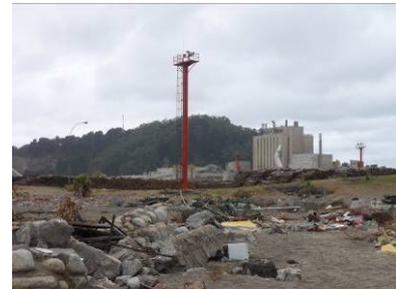
Photo 31-4 Seacoast area

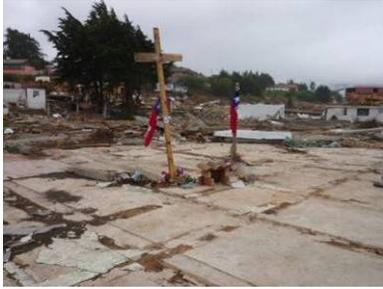
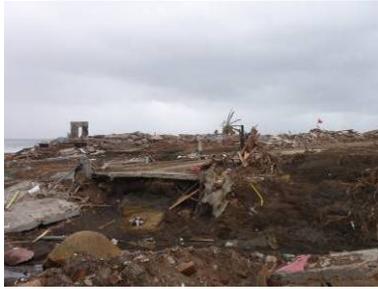
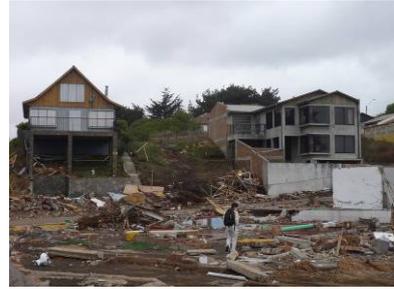
Pelluhue is a small settlement facing the Pacific Ocean, and located the closest point to the earthquake source. This area was severely damaged by Tsunami, and most buildings near the coast were swept away, except for concrete foundation and a part of walls remained (Photo 32-1). According to the residents, there was no human suffering because they evacuated voluntarily on the hill by cars immediately after the earthquake. It is assumed that emergency drills were conducted on a routine basis, and awareness of disaster prevention was raised. It is reported that Tsunami was not so large in the earthquake in 1960. Signs to indicate the evacuation direction and safe places from Tsunami were settled on the road, not only in this district but also in many places.

Photo 32-1 Seacoast area

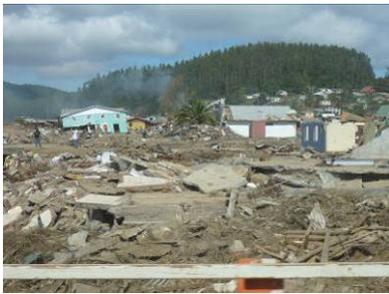
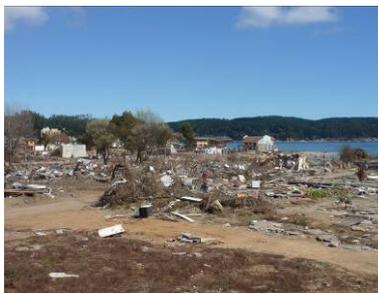
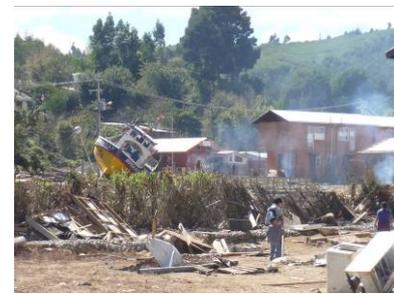
Wooden structure buildings were destroyed by Tsunami and received extensive damages, and rubbles were piled up near the seacoast (Photo 33-1). As described in 2.6, the trace of Tsunami was seen in RC and brick construction buildings, but building frames remained without big damages. Residents evacuated on the hill after the earthquake and were safe, but there were some victims who went back to their houses to bring baggage after the first wave went out, and who stayed in the vacation houses near the seacoast as tourists. This district was under control of the military at the point of this investigation (Photo 33-2).

Photo 33-1 Seacoast area

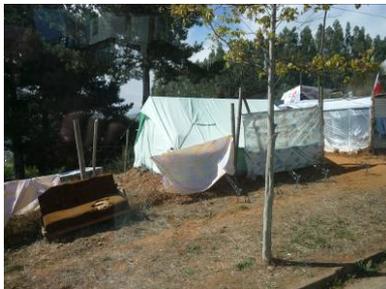
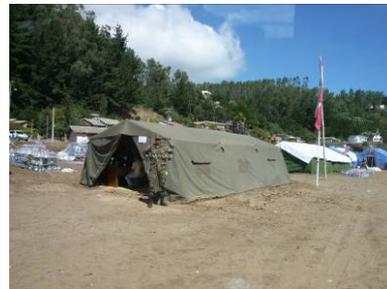
Photo 33-2 Tent of refugees and military

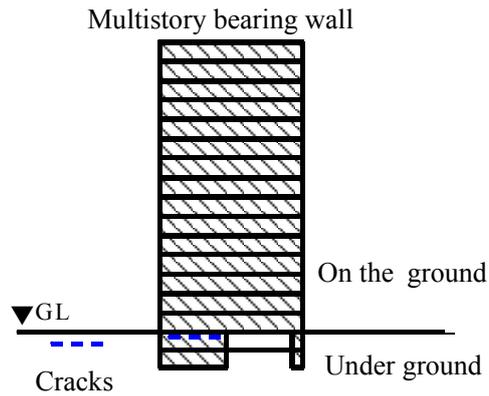
This is a case of a RC condominium collapsed, which had 15 floors (Photo 34-1, reprinted photos shown in Chapter 2). The basements are parking garage (3.3(1) is the similar case) and the length of bearing walls are shorter (smaller) than upper floors, so it seemed the damage at this portion brought on the overturn of the building (refer to Photo 39-1 and Photo 39-2). A schematic illustration of multistory bearing wall that has a large opening at basement is shown in Figure 8. The cause of collapse needs to be considered in detail.

Figure 8 Schematic illustration of multistory bearing wall with large opening at basement

Apartment houses newly-built in urban city area are designed to set up the opening in a part of multistory bearing wall to secure the drive zone at the basement which is used as parking garage (Figure 8). Photo 39-1 is corresponding to the left-side wall underground shown the image in Figure 8. Failure on the Photos occurred because large tensile axial force and shear force were affected on.

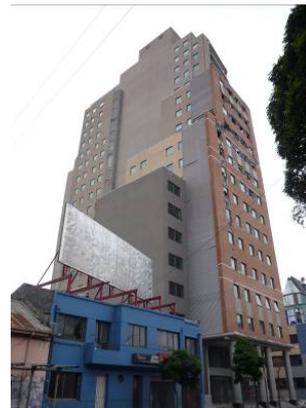
This is an example that the intermediate story in RC high-rise building was collapsed (Photos 35-1 and 35-2). Entire story collapse was observed in the front of the building, but the backside of it was a multistory bearing wall with small opening, and the damage was small. Story collapse occurred at the floor with setback. Information of the building structures and the investigation results did not be obtained yet, so the cause of damages should be considered after time.

Photo 35-2 12th floor (Photo 23-2 reprinted)

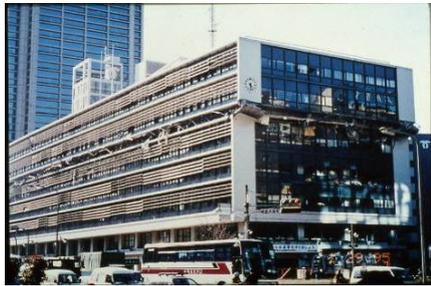
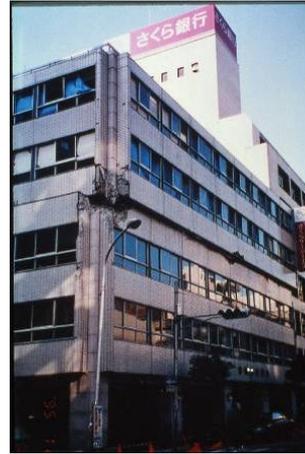
In the Great Hanshin-Awaji Earthquake, Japan, 1995, similar cases of the collapse of intermediate story were reported (Photo 35-3). As for the cause of them, the change of structural system from SRC to RC was pointed out.

Photo 35-3 Collapses of intermediate story (The Great Hanshin-Awaji Earthquake, Japan, 1995)

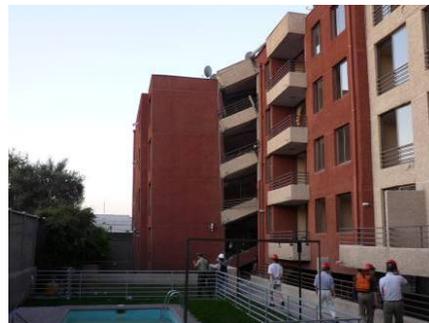
This is an instance that the first story in RC mid-rise building (condominium) was collapsed (Photos 36-1 and 36-2). The building shown in Photo 36-2 is the soft first story (Piloti) structure and the deformation in the earthquake centered on the first story.

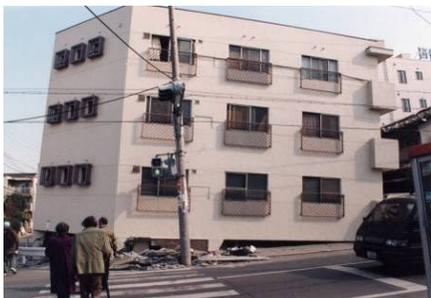
Collapse of the soft first story has been frequently reported as earthquake damages, Photo 36-3 indicates the case in the Great Hanshin-Awaji Earthquake, Japan, 1995, and Photo 36-4 is the case in L'Aquila Earthquake, Italy, 2009.

Photo 36-3 Collapse of soft first story structure
(The Great Hanshin-Awaji Earthquake, Japan, 1995)

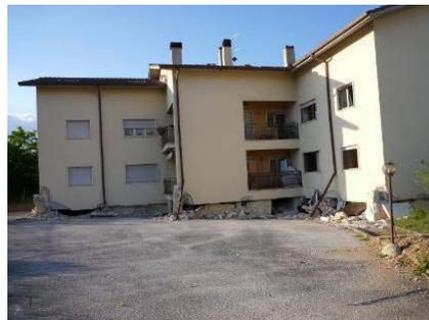
Photo 36-4 Collapse of soft first story structure
(L'Aquila Earthquake, Italy, 2009)

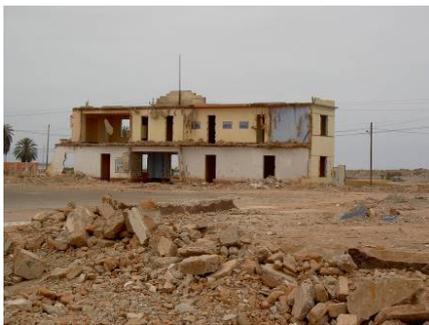
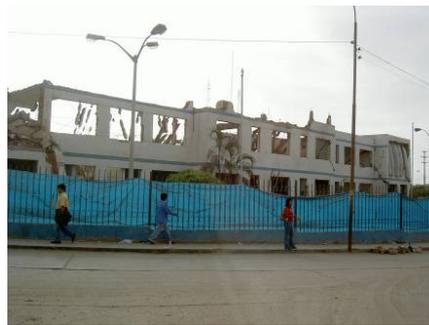
Photo 37-1 indicates a case that an apartment house of CM structure collapsed at the first story, and upper stories fell down. These structures have a tendency to use same member section, bar arrangement, and wall quantity in every story; that causes the shortage of wall at the first story compared to upper, because large opening is set to the entrance. Seismic force against building generally acts on the first story the most, so it leads to the first story relatively breakable. Damages of CM buildings are reported in many earthquakes, and here let me introduce a case in Pisco Earthquake, Peru, 2007 (Photo 37-2).

Photo 37-3 Collapsed CM buildings (Pisco Earthquake, Peru, 2007)

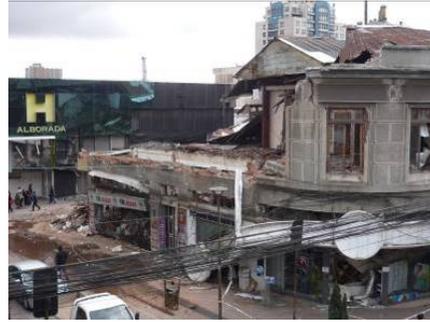
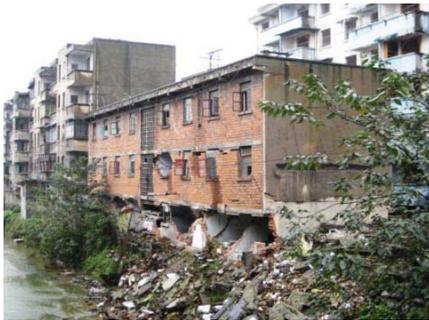
Photos 38-1 and 38-2 show examples of damages of masonry structure buildings as brick constructions and Adobe structures. As cases of recent earthquakes, for example, damage of brick construction buildings in Sichuan Earthquake, China, 2008 (Photo 38-3), and masonry structure buildings in L'Aquila Earthquake, Italy, 2009 (Photo 38-4) are quoted.

Photo 38-3 First floor collapsed brick construction building (Sichuan Earthquake, China, 2008)

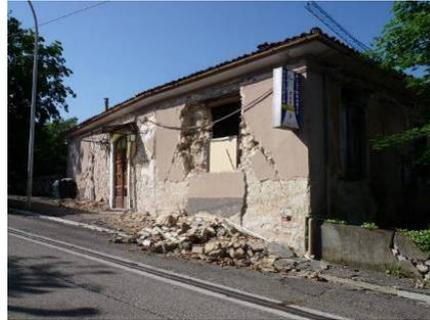
Photo 38-4 Masonry structure (L'Aquila Earthquake, Italy, 2009)

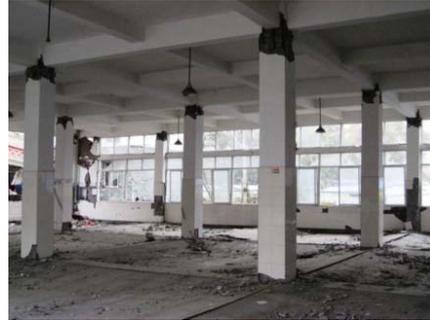
occurred on the capital. These wall columns are imagined that deformation centered to the capital after bending to weak axis direction, and could not support the vertical load with losing the horizontal strength. Similar damages of columns are confirmed in Sichuan Earthquake, China, 2008 (Photo 40-2), but the damage of wall column is presumed the specific failure type in Chile.

Photo 40-2 Flexural hinge on column capitals
(Sichuan Earthquake, China, 2008)

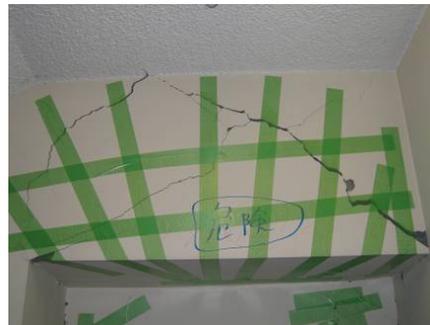
Similar failure of short spanned beam at the stairway of a hospital was confirmed in Niigata-ken Chuetsu Earthquake, Japan, 2005 (Photo 41-2).

Photo 41-2 Shear cracks of short spanned
beam (Niigata-ken Chuetsu Earthquake,
Japan, 2005)

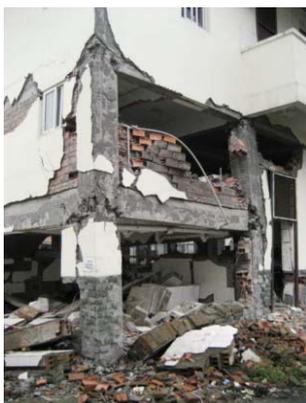
Similar damages of beam-column joint were investigated in Sichuan Earthquake, China, 2008 (Photo 43-3), and in L'Aquila Earthquake, Italy, 2009 (Photo 43-4).

Photo 43-3 Failure of beam-column joint (Sichuan Earthquake, China, 2008)

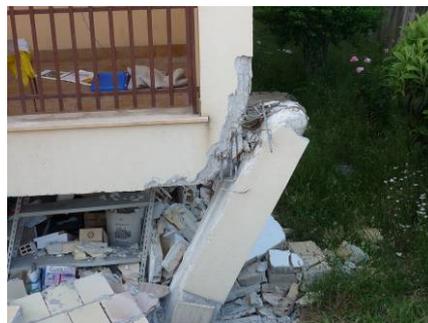
Photo 43-4 Failure of beam-column joint (L'Aquila Earthquake, Italy, 2009)

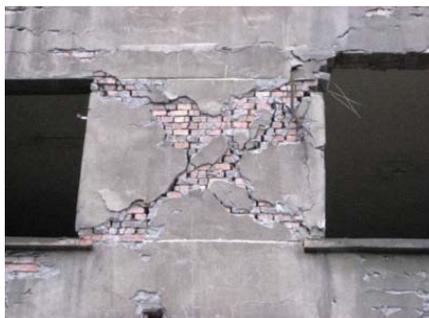
Photo 45-1 is the damage of brick walls in RC high-rise building (Infilled Wall structure). These walls are designed as nonstructural wall, so some damages must be allowed, but measures should be taken in order to prevent falling off in out-of-plane direction even if cracks occurred by earthquake. Similar damages are reported in many earthquakes, Photo 45-2 is seen in Sichuan Earthquake, China, 2008 and Photo 45-3 is seen in L'Aquila Earthquake, Italy, 2009.

Photo 45-2 Collapse of nonstructural wall
(Sichuan Earthquake, China, 2008)

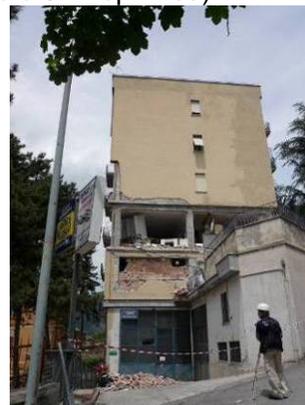
Photo 45-3 Collapse of brick walls
(L'Aquila Earthquake, Italy, 2009)

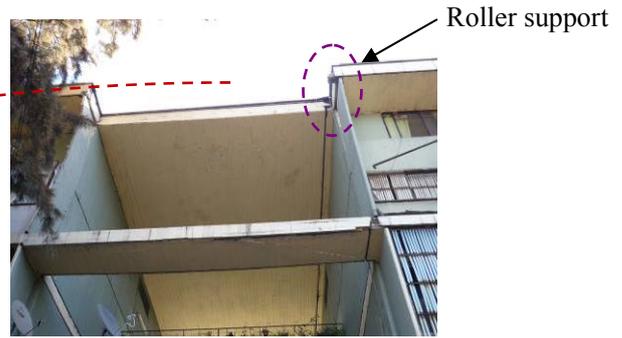
Photo 46-1 shows a roller-supported beam at one end fell down the place 7 to 8m away because of the earthquake. Photos 46-2 and 46-3 are the nonstructural walls of RC office buildings dropped. In both cases, heavy RC materials are used, and such phenomena bring a risk to get passer-by and vehicles involved in accidents. Many decoration materials are attached to the external walls on buildings in this investigation.

Further caution should be needed in design and construction from here on.

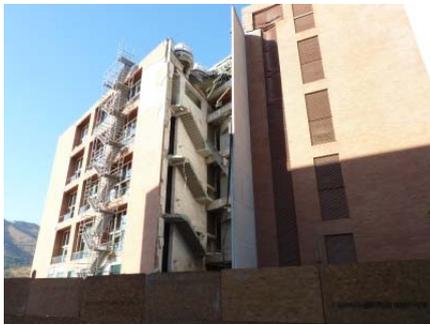
Photo 46-2 Collapse of External wall (Photo 7-1 reprinted)
