Preliminary Reconnaissance Report of the Chile Earthquake 2010

Hiroto Kato, Seitaro Tajiri**
Department of Structural Engineering, Building Research Institute, Japan

Preface

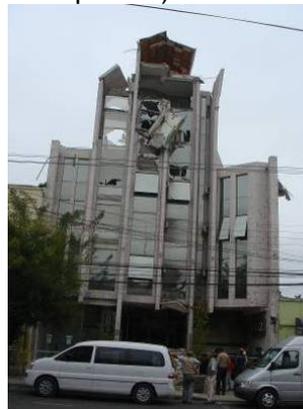
Nonstructural elements of an office building with RC structure were fallen off (Photo 19-1). Granular foamed polystyrene were contained in concrete materials (Photo 19-2).

Photo 46-1 shows a roller-supported beam at one end fell down the place 7 to 8m away because of the earthquake. Photos 46-2 and 46-3 are the nonstructural walls of RC office buildings dropped. In both cases, heavy RC materials are used, and such phenomena bring a risk to get passer-by and vehicles involved in accidents. Many decoration materials are attached to the external walls on buildings in this investigation.

Photo 46-3 Collapse of External wall (Photo 19-1 reprinted)

Further caution should be needed in design and construction from here on.
