3 Damage Analysis and Suggestion of Damage Causes

3.1.6 Evaluation of the Current Design Seismic Force for the Building Based on the Damage during the Hyogoken-Nanbu Earthquake

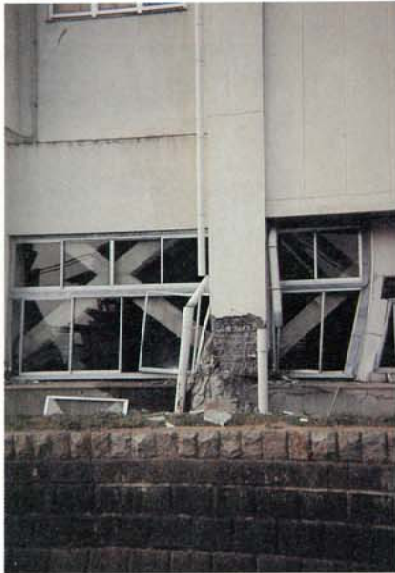
Photo. 3.2.1.8 4 story SRC structured office building
The half of the column at the bottom of the anchor plate
of the base of column was slipped to the north.

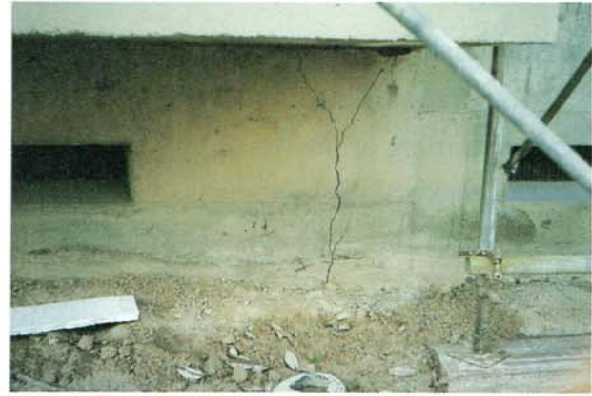
Photo. 3.2.1.13 Cracks of the base

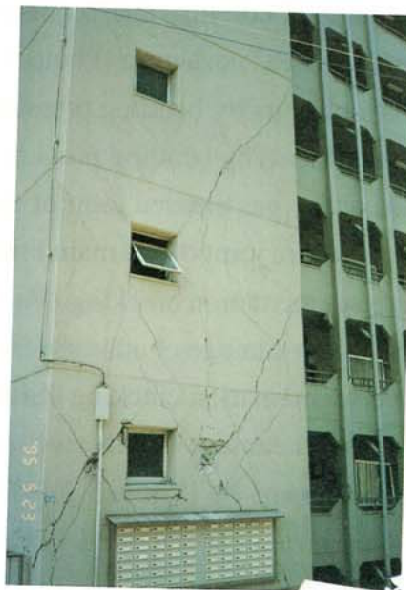
Photo. 3.2.1.15 Damage condition of the neighboring building (7 story frame structure; different one from the one of Photo. 3.2.1.14)

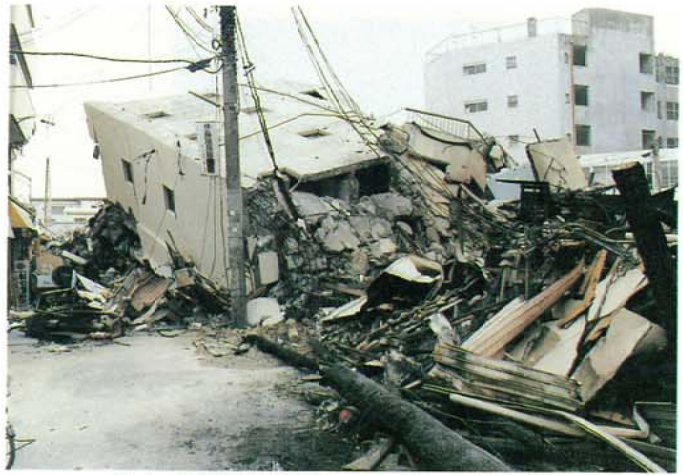
Photo. 3.2.1.17 Overturning of the whole building

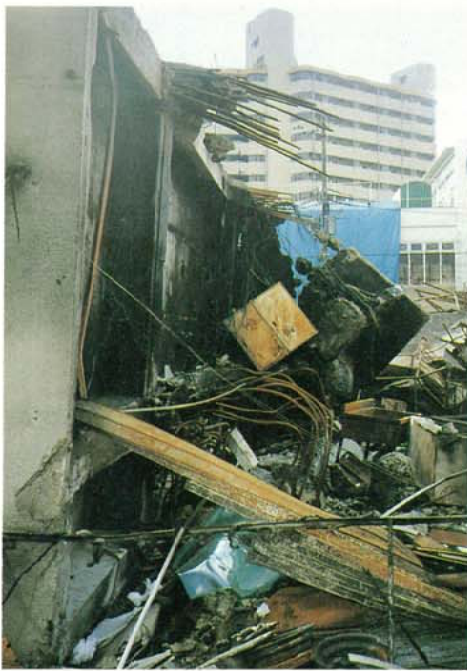
Photo. 3.2.1.18 Overturning of the whole building

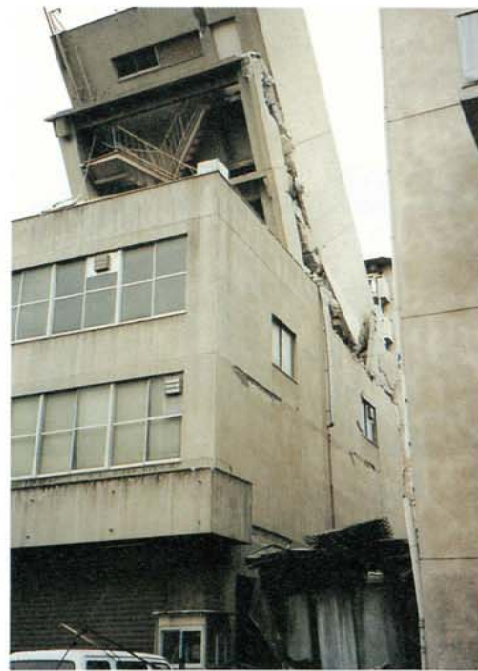
Photo. 3.2.1.23 Overturning of a penthouse

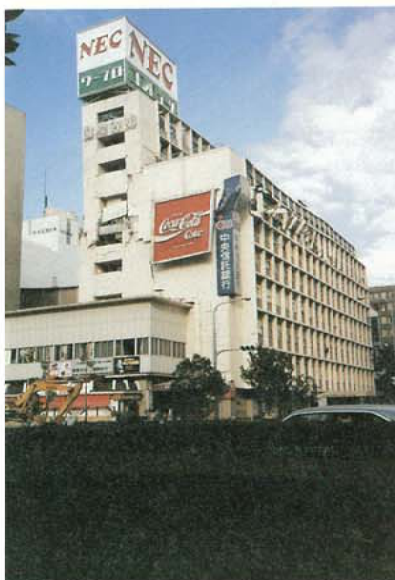
Photo. 3.2.1.24 Story collapse influenced by a set back

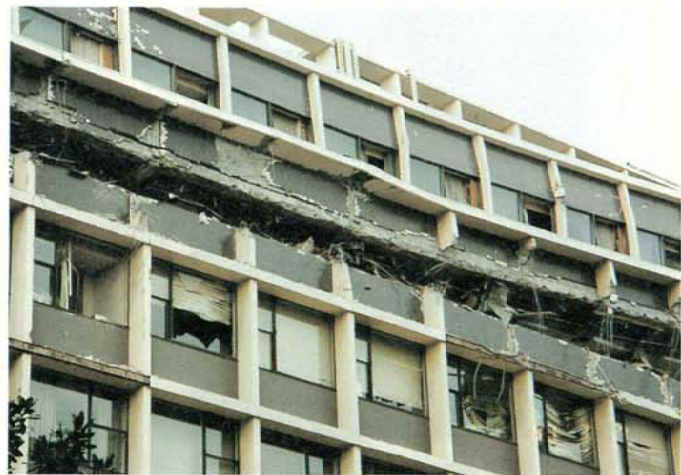
Photo. 3.2.1.25 Story collapse influenced by a set back

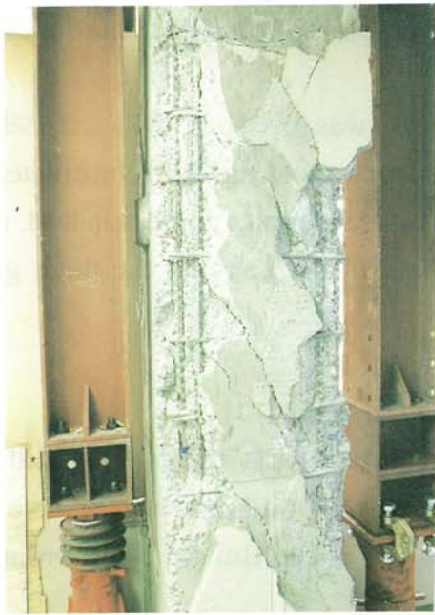
Photo. 3.2.1.39 Bond splitting failure of a column

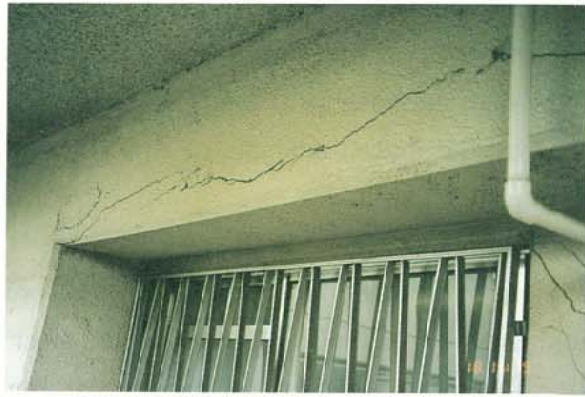
Photo.3.2.1.40 Bond splitting failure of a beam

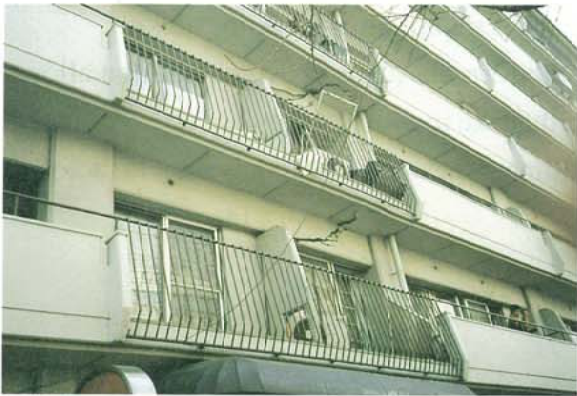
Photo. 3.2.1.41 Damage of beams mullion non-structural wall

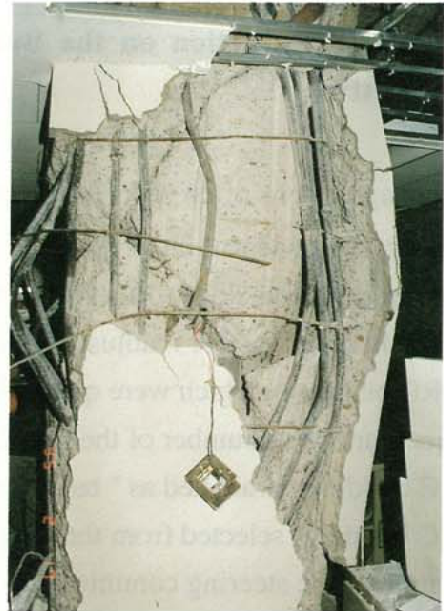
Photo. 3.2.1.46 Column of the 5th floor

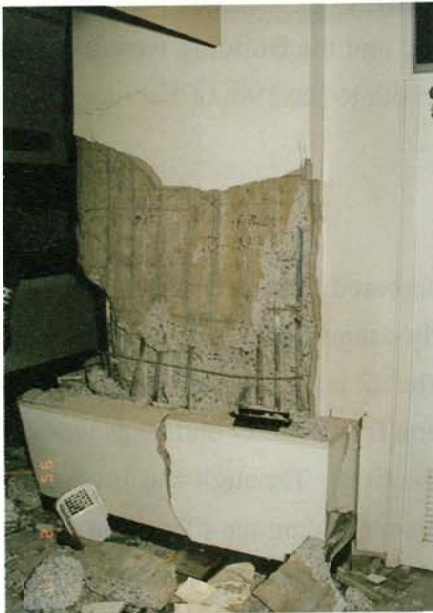
Photo.3.2.1.44 Basement ;Side column of the bearing wall column reinforcement

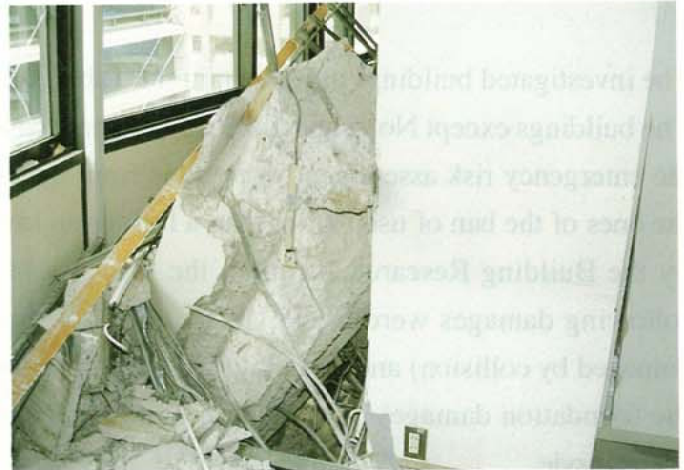
Photo.3.2.1.47 Floor slab of the 7th floor Column

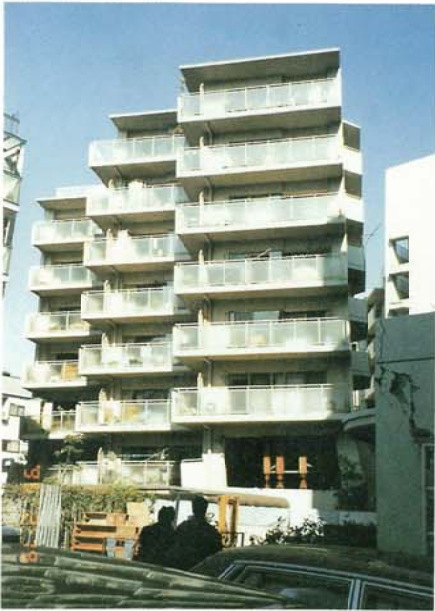
The collapse was occurred in the west side of the 1st story to make the whole building inclined 4 degrees to the west. (Photo.3.2.1.49). The damage is concentrated in the first story and is very small at the higher story, which is like shear cracks, are only seen on the wall. (Photo 3.2.1.50) Connection corridors (pin connected at the main building side and the pin-roller connected at the next building side) of all stories are fallen down. (Photo. 3.2.1.51)

Photo. 3.2.1.49 South Facade of 8 story Apartment Housing

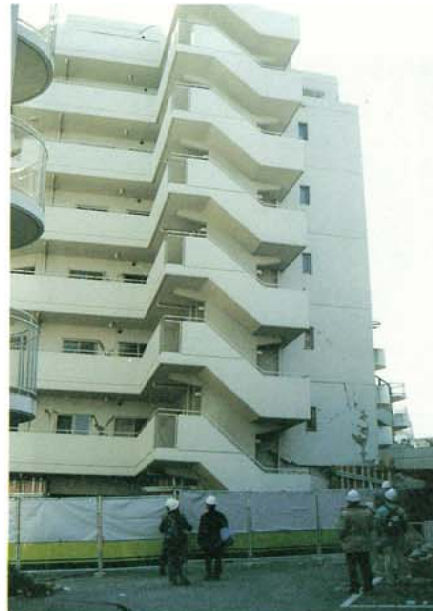
Photo. 3.2.1.50 North Facade ,Same Bldg.

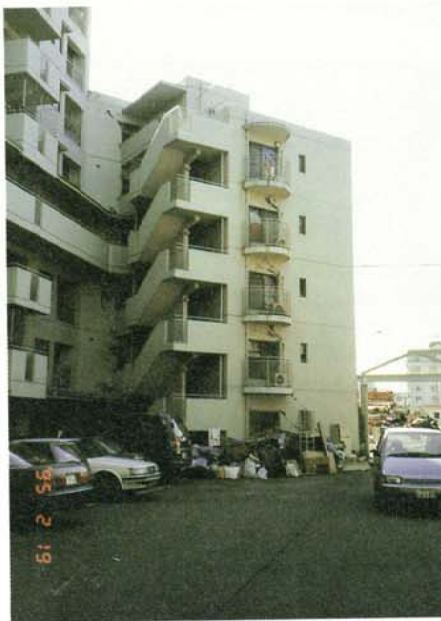
There are three story RC apartment housing(9-11 story) in the same site, which were designed and constructed at the same time. They had rather much damage only in the non-structural walls. (Photo 3.2.1.57) Only the main building of which 1st story was constructed as piloti had unrecoverable damage.

Photo. 3.2.1.57 South Facade of 5 Story Building

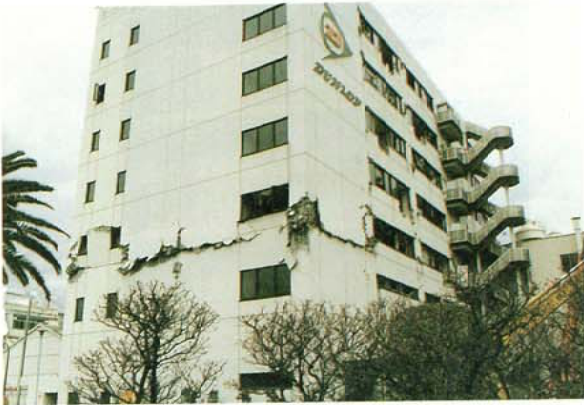
Photo . 3.2.1.60 Damage of relatively New Office Building

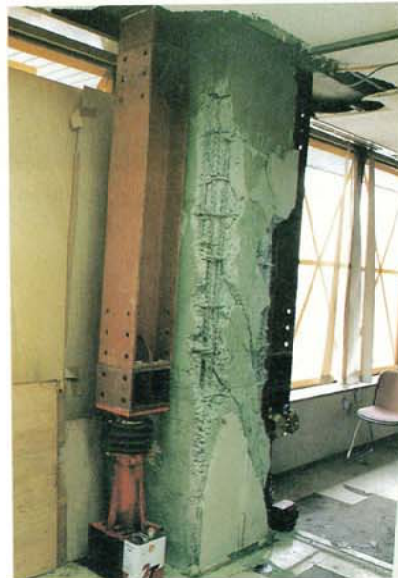
Photo.3..2.1.62 shows the bond splitting failure of a SRC column with built-up steel in a 8 stories office building in Nishinomiya. This building consists of wall frame system with a center core. In the seventh story, severe damage were observed and the bond splitting failure as shown Photo.3..2.1.62 occurred in a large number of outer columns.

Photo . 3.2.1.62 Bond Splitting Failure of SRC Column

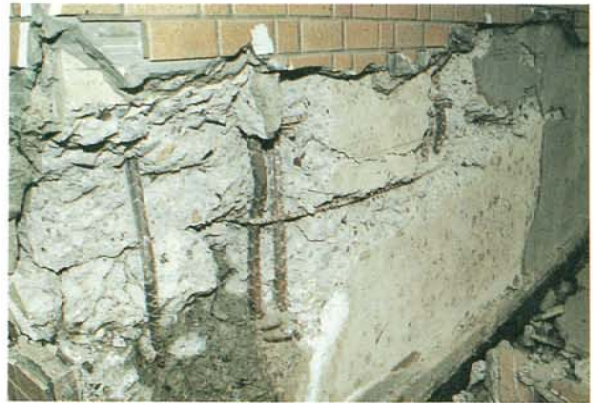
Photo.3..2.1.64 shows the damage of a SRC boundary column with a gable wall in the fifth story of a 8 stories office building in Nishinomiya. In this damage, the fractures of splice steels in the SRC column occurred due to tension which was transferred by overturning moment in the shear wall. And then buckling of longitudinal reinforcing bars in the column occurred due to compression from the shear wall as well as the above-mentioned fracture in column bases.

Photo . 3.2.1.64 Fracture of Splices of Steel

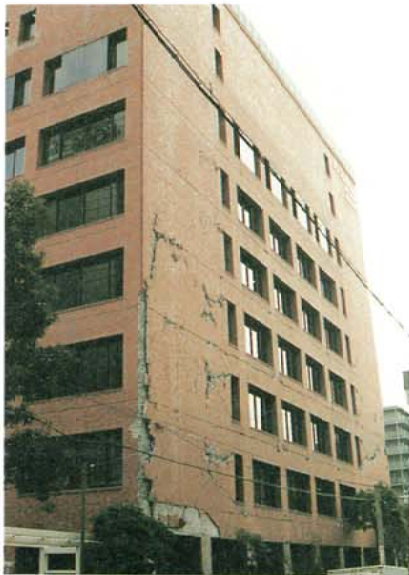
Photo.3..2.1.65 shows the damage of a 9 stories office building in Chuoh ward of Kobe, which consists of SRC with full-web members. Although the damage to the main frames was not so severe, the fractures of anchor of transverse reinforcement in shear walls to boundary columns occurred. It was difficult to anchor reinforcing bars in shear walls into the core of columns because there were steels in the columns. As a result, anchor of the reinforcing bars were arranged in the outside of the core. Although rational detailing and placing of reinforcement for SRC structures are recommended in the recent AIJ guidelines, this building may have been designed by the old codes.

Photo . 3.2.1.65 Fracture of Anchor of Reinforcement

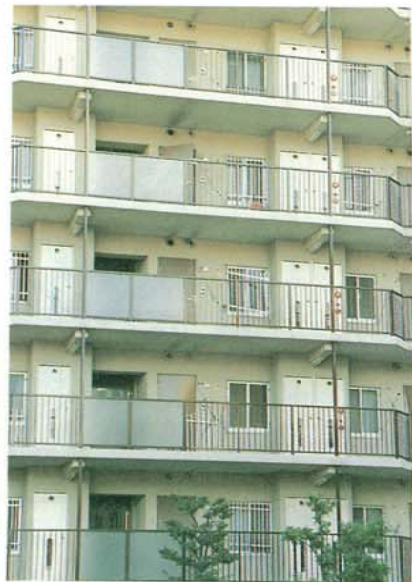
During the 1978 Miyagiken-oki Earthquake, the non-structural partitions of many medium-and high-rise SRC buildings were severely cracked. Doors were stuck and egress was inhibited similar damage frequently occurred in this earthquake. Photo.3..2.1.66 shows an example of damage to a 11 stories apartment building in observed in almost all houses. A lot of repairs may be required for this building although the structural members have not subjected to damage so much. Therefore the extent of permission for this kind of damage should be reevaluated.

Photo . 3.2.1.66 Damage of Non-structural Partitions

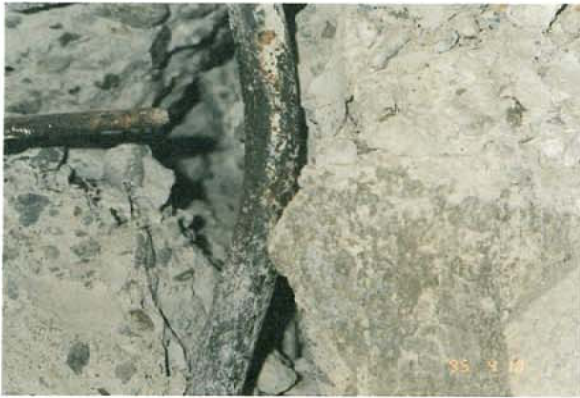
Photo.3.2.1.67 damaged hook by corrosion

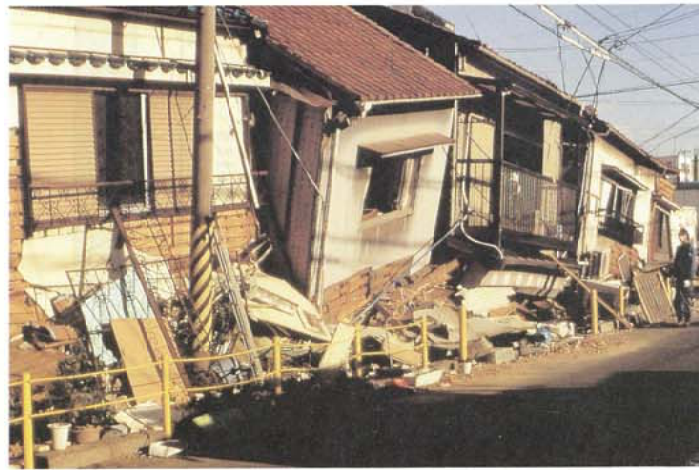
Photo 3.2.3.2 Collapse of the first story

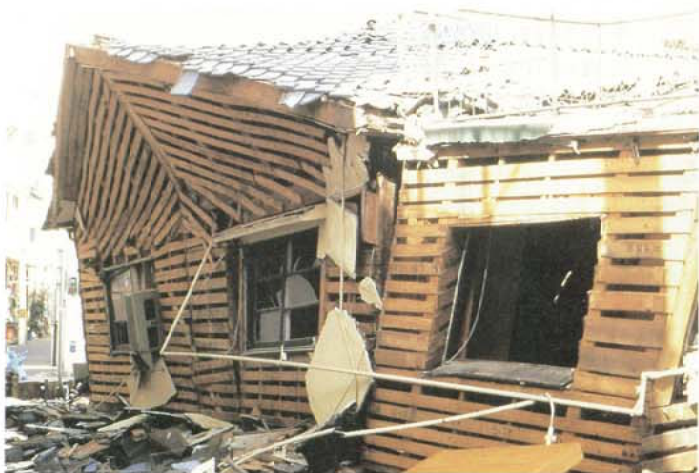
Photo 3.2.3.3 Collapse of the first story

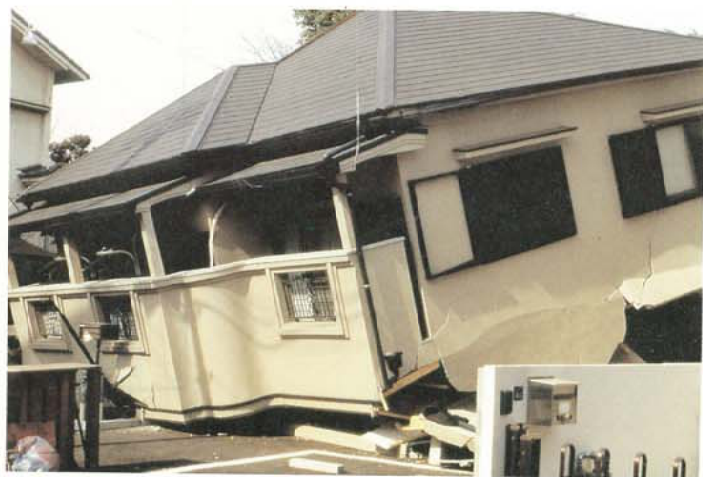
Photo 3.2.3.4 Collapse of the first story

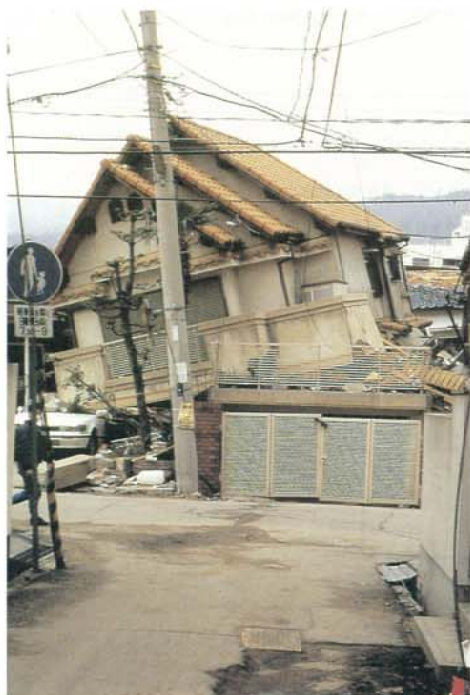
The second story of some wooden buildings having a reinforced concrete garage in the first story were heavily damaged. It is supposed that the first level of the wooden structure was shaken excessively because of the difference of mass and stiffness between the reinforced concrete and the wooden structure, however further study should be done to verify this fact.

Photo 3.2.3.5 Collapse of the second story
(a garage of RC in the first story)

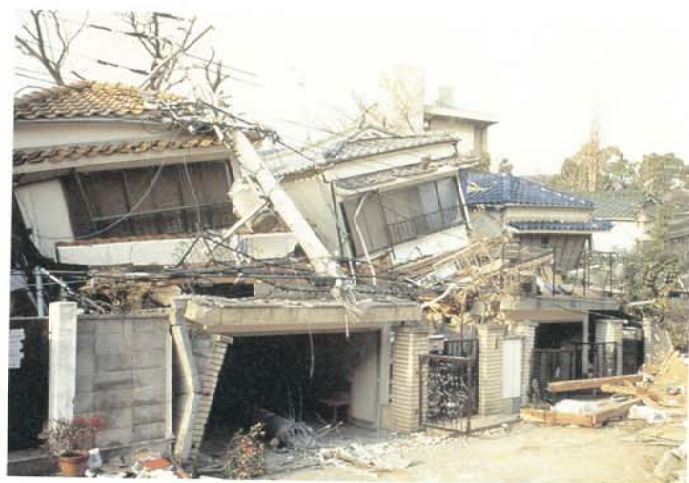
Photo 3.2.3.6 Collapse of the second story
(a garage of RC in the first story)

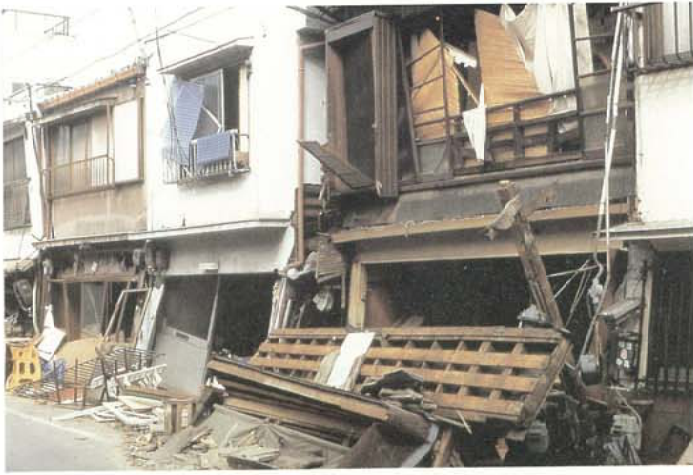
Photo 3.2.3.7 Building with a large opening

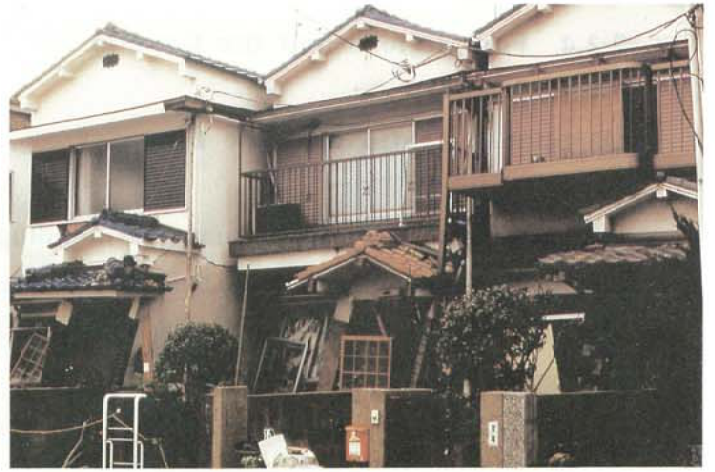
Photo 3.2.3.8 Wooden building with a small width

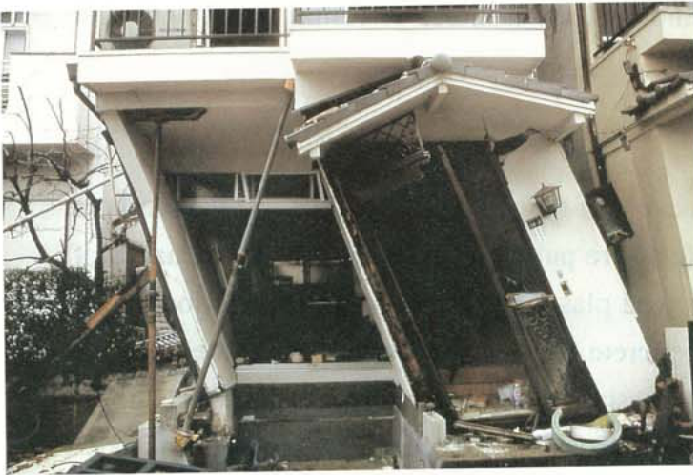
Photo 3.2.3.9 Wooden building with few shear walls

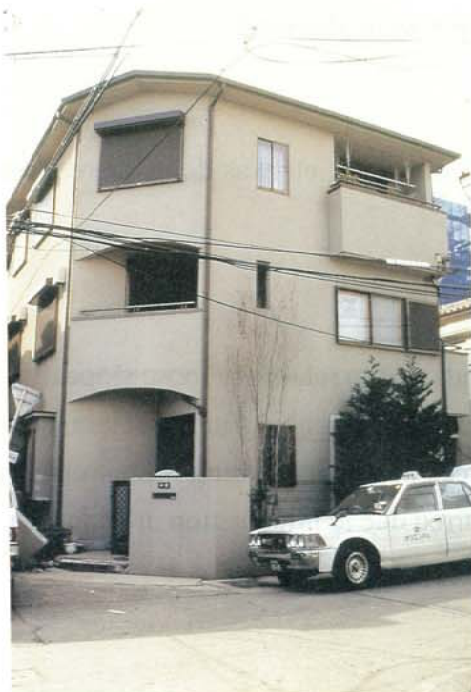
Photo 3.2.3.11 Three storey wooden building without damages
