7. Damage to Buildings in Inundation Areas Induced by Tsunami

7.1 Introduction

8. Damage of Buildings, etc. due to Fire

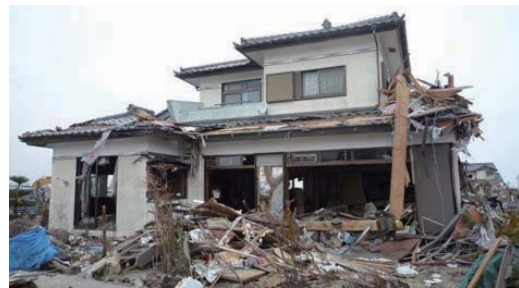
Photo 7.4-17. Wood house (10) remained without the effect of protect forest.

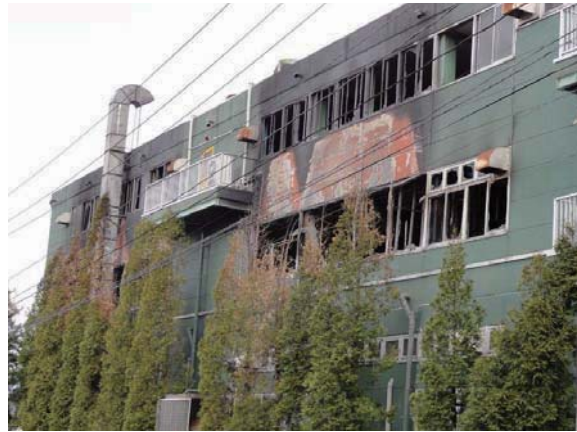
Photo 8.3-2 shows a factory building fire in which half of the building burned. The cause of the fire is assumed to be ignition by falling of fluorescent light on the ceiling to the floor where the thinner spilled due to earthquake motions by the mainshock.

Photo 8.3-2 Fire scene at a factory building (Oushu city, Iwate prefecture)

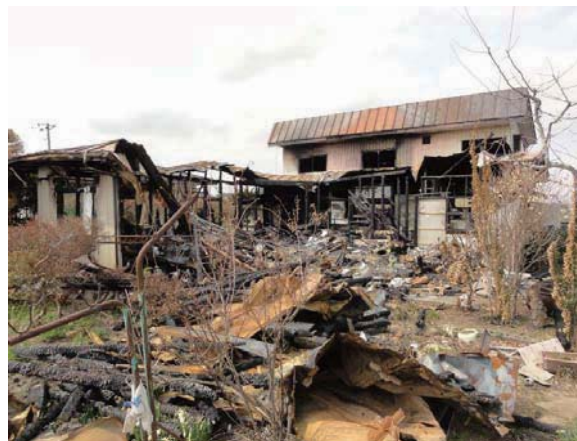
Photo 8.3-3 shows another house fire case in which two wooden houses were completely burnt out and three houses were partly burnt. The cause of fire is assumed to be misuse of candlelight for lighting in the midst of power failure on the night of the next day of the mainshock.

Photo 8.3-3 Fire scene at a house (Oushu city, Iwate prefecture)

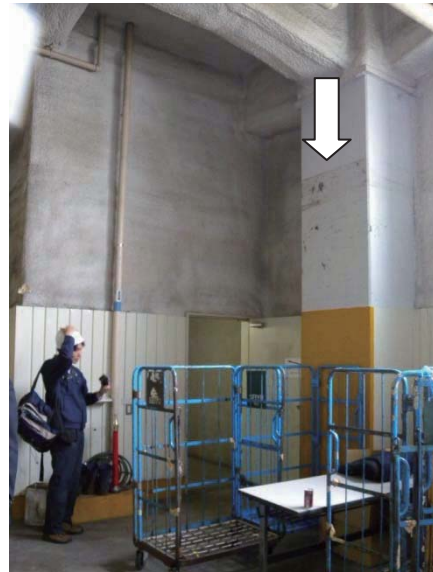
Photo 9.2-7 Trace of tsunami water
