*Collaborative Research and Development Project for Disaster Mitigation
in Earthquake Prone Areas in Asia*

**STUDY ON SEISMIC PERFORMANCE AND STRUCTURAL
INSPECTION OF RETAINING WALL**

Kosh Nath Adhikari

27 September, 2007

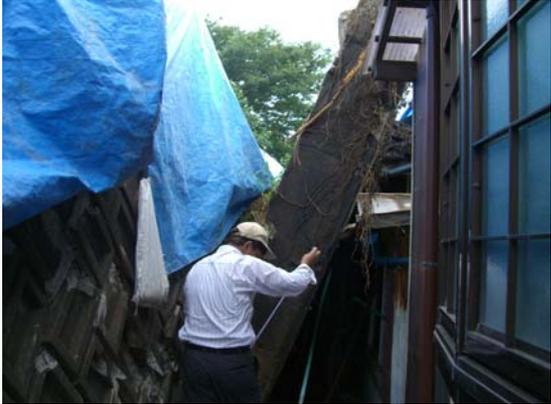
Slope of wall 78°

Nearly vertical after Earthquake

Overturning after 2 or 3 days

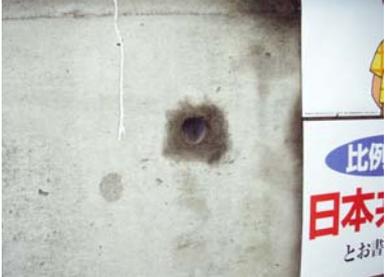
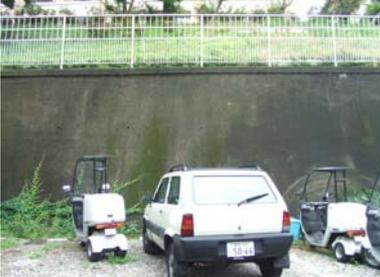
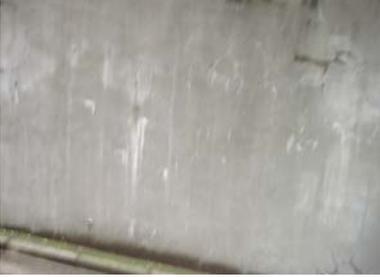
1	1 in 3m ²	Small weep hole	No weep hole
Weep holes

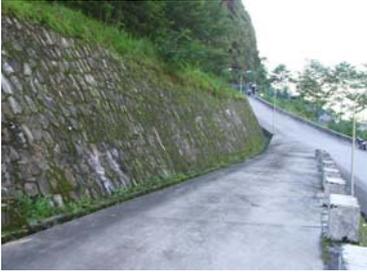
2	<75°	75° ~80°	>80°
Front slope of retaining wall

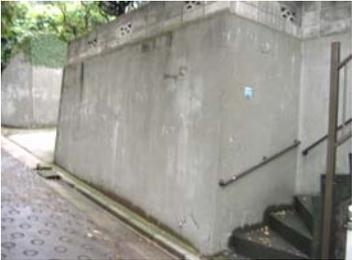
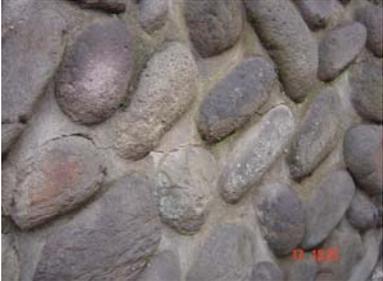
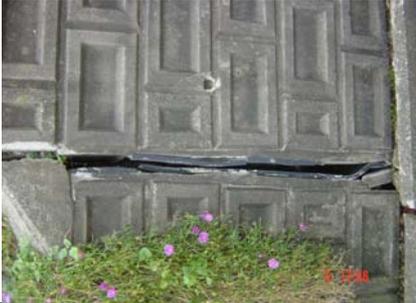
3	No cracks	Width of 1~20(5)mm	Width >20(5)mm
Horizontal cracks

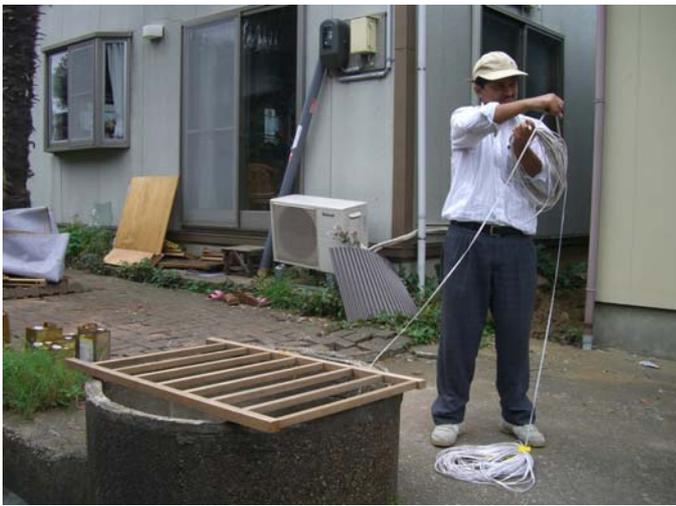
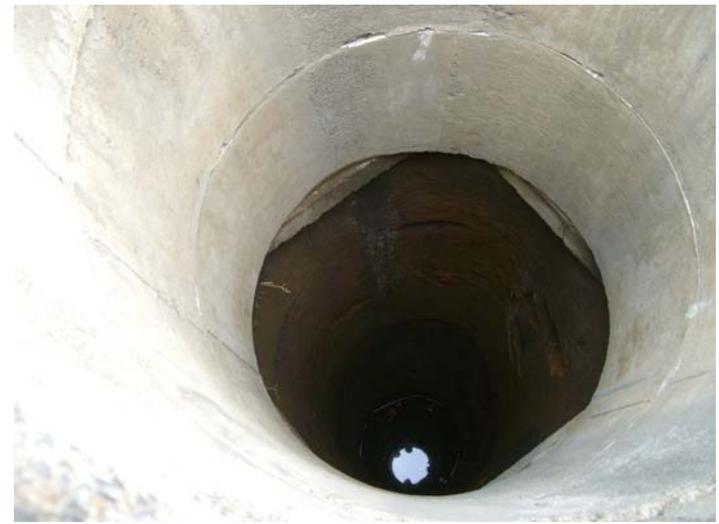
Checking of ground water table from the existing wells
