3 Damage Analysis and Suggestion of Damage Causes

3.1.6 Evaluation of the Current Design Seismic Force for the Building Based on the Damage during the Hyogoken-Nanbu Earthquake

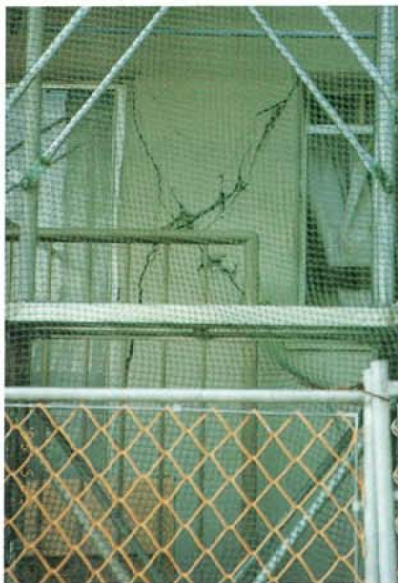
Photo. 3.2.1.12 Shear fracture creeping to the corners of the open part of the building ; windows & doors.

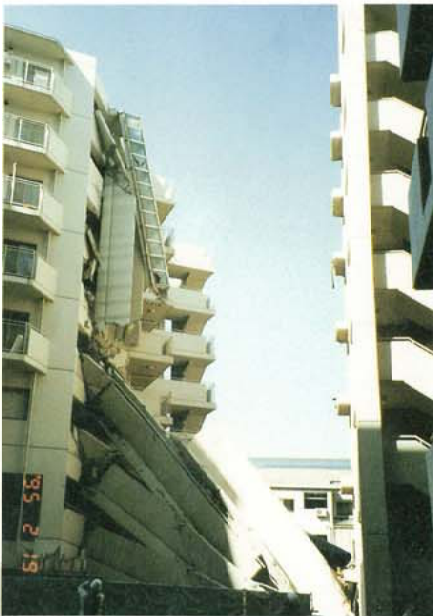
The collapse was occurred in the west side of the 1st story to make the whole building inclined 4 degrees to the west. (Photo.3.2.1.49). The damage is concentrated in the first story and is very small at the higher story, which is like shear cracks, are only seen on the wall. (Photo 3.2.1.50) Connection corridors (pin connected at the main building side and the pin-roller connected at the next building side) of all stories are fallen down. (Photo. 3.2.1.51)

Photo. 3.2.1.51 Roofed Passage

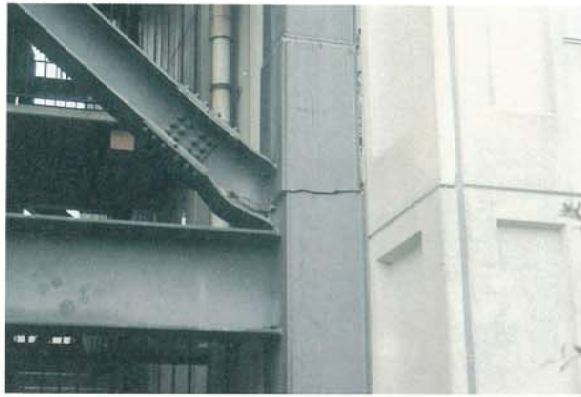
Photo 3.2.2.16
The fracture of vertical member with square-hollow-box section and H-shape brace.
